# Riverside Cemetery

## Condition Assessment

Report to Queanbeyan-Palerang  
Regional Council

May 2026

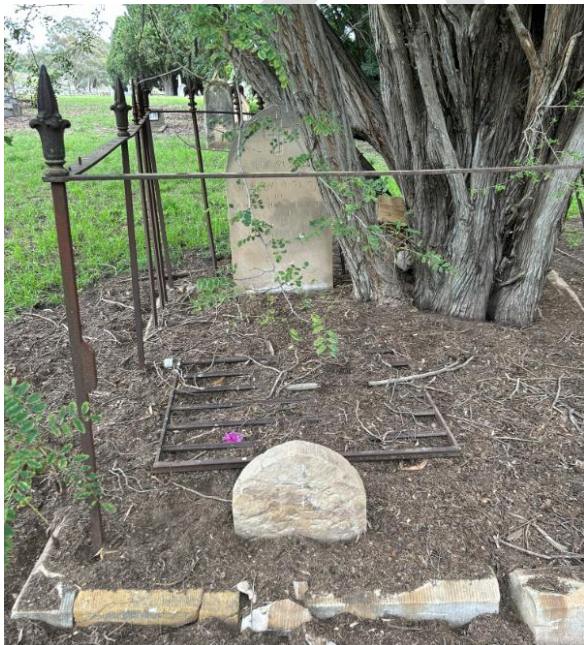
**Figure 56: A tree planted within the burial site and associated damage to fencing and monuments**

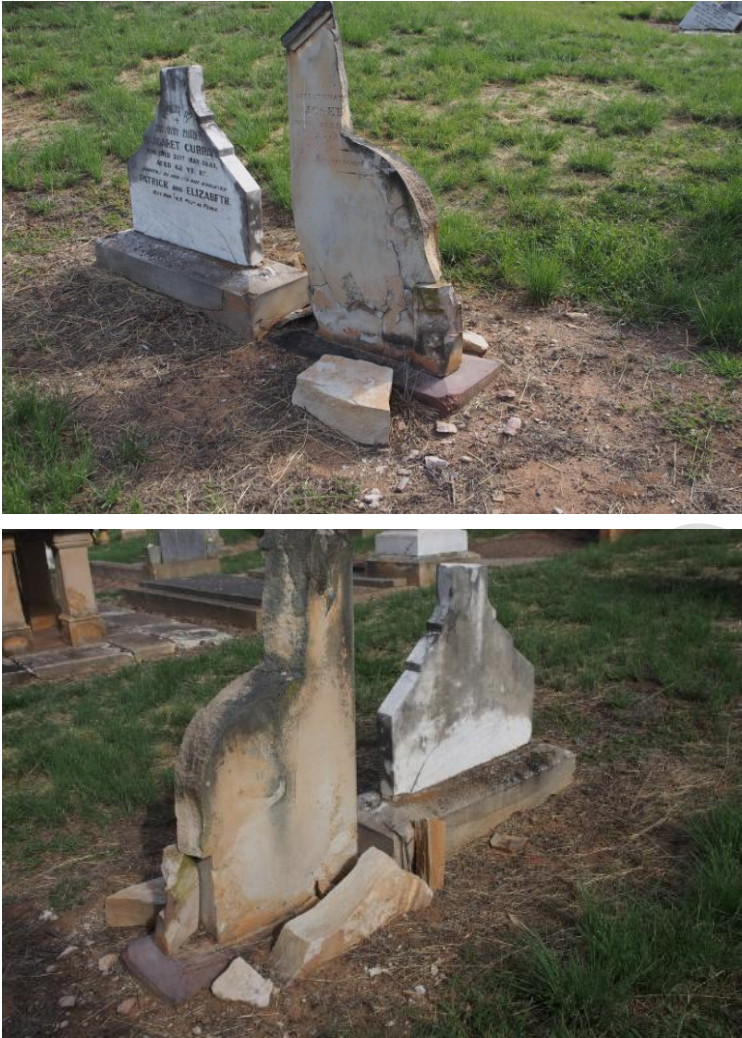
| Photograph | Description | Physical condition | Condition rating |
|---|---|---|---|
| | <p>A sandstone headstone on a low plinth of red-brown stone with inscriptions on both headstone and plinth. There is no kerbing or ledger, the plot is grassed.</p> | <p>The headstone has been broken into numerous pieces. Some broken pieces and shattered fragments remain lying next to the headstone, with remnants appearing incomplete. The portion of the headstone that remains upright is severely cracked and spalling, with more portions at risk of falling off the headstone. An incomplete first name of the deceased remains on the headstone, with family name and dates of birth and death missing. Missing inscriptions are not visible on the fallen fragments.</p> <p>There is some dark biological staining to the upper areas of the headstone.</p> <p>The dark red-brown stone shows minor wear, chiefly expressed in chipped corners but is largely intact.</p> | <p>Failed</p> |

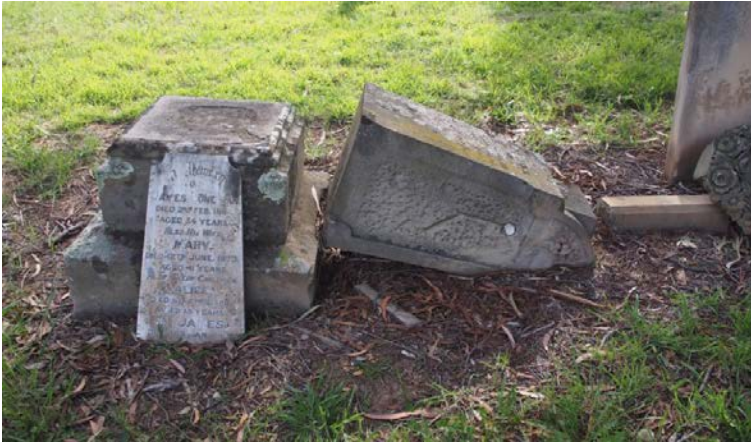
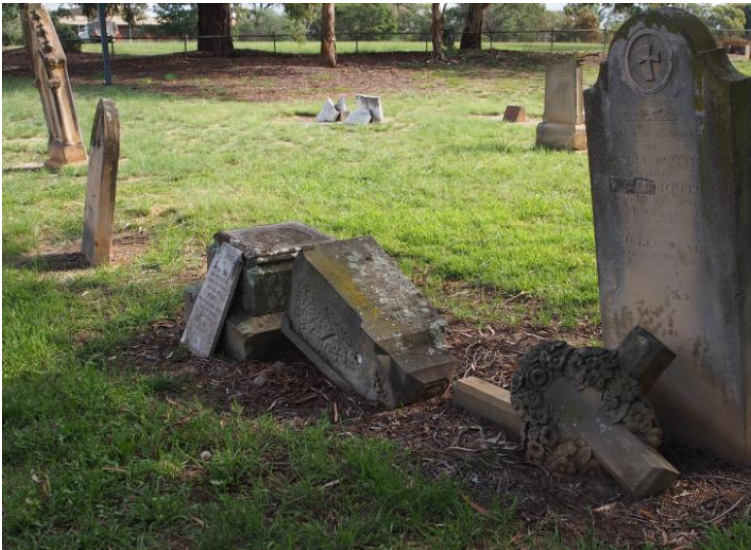
| Photograph | Description | Physical condition | Condition rating |
|---|---|---|---|
| | <p>A tall, ornate sandstone monument in the form of a cross embellished with floral wreath mounted on a tall plinth with a white marble inscription plaque. The inscription is carved into the marble with lead inserts.</p> <p>The grave is not set out with kerbing or ledger.</p> | <p>The tall plinth has detached from the base plinth and is lying on the ground to the right of the monument. The cross has broken away from the plinth and broken into several pieces which are lying in front of the headstone of the neighbouring grave. Carving of the floral wreath is clear and well-defined with minimal weathering.</p> <p>The high plinth shows weathering to inscriptions in sandstone and carved floral motifs.</p> <p>The marble plaque has been detached from the plinth and is leaning against the front of the base plinth.</p> <p>There are minor losses to lead lettering, which is complete and legible.</p> <p>The sandstone is stained with biological growth and has colonised by lichens on the base plinth</p> | <p>Overall: Failed</p> <p>Cross: Failed</p> <p>Plinth: Poor</p> <p>Plaque: Good but displaced</p> |

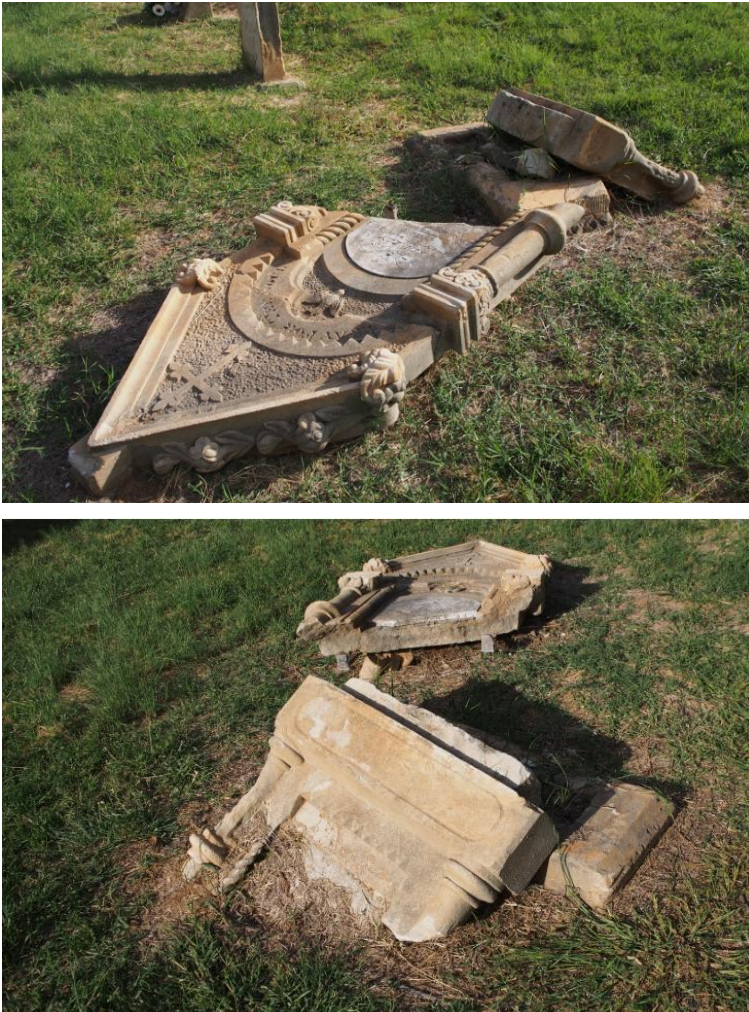
| Photograph | Description | Physical condition | Condition rating |
|---|---|---|---|
| | <p>A tall, complex sandstone monument with a marble plaque on a small stone plinth.</p> <p>Ornamental motifs include columns with ornate capitals, barley twist columns, a downwards-facing dove between two arches, floral motifs and an ornate cross</p> | <p>The headstone has fallen from its plinth and is broken into two or more pieces. A square stub at the top of the headstone suggests that the headstone may have included a cross mounted to the top.</p> <p>The upper portion of the headstone shows carving in clear, legible condition and metal bars can be seen protruding from the back of the upper headstone fragment. Inscriptions on the remaining marble plaque fragment are clear and legible.</p> <p>The lower portion of the headstone shows significant weathering, with loss of definition of the column and barley twist elements. The bottom portion of the marble plaque is missing.</p> <p>The plinth appears to be chipped but complete.</p> | <p>Failed</p> |

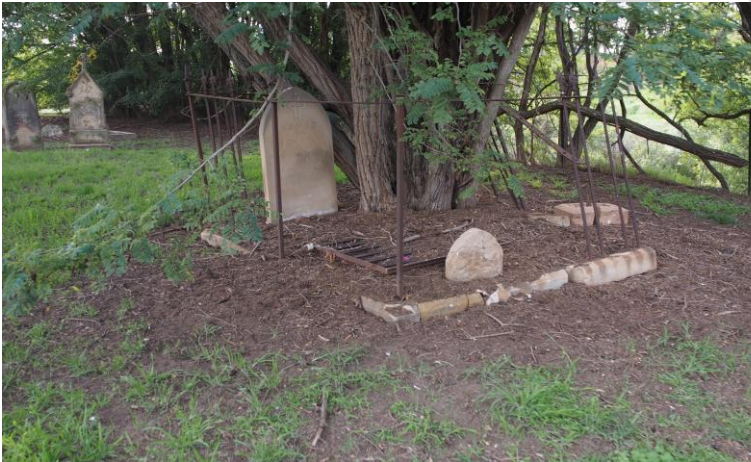
| Photograph | Description | Physical condition | Condition rating |
|---|---|---|---|
| | <p>A sandstone headstone and small foot stone with gothic arch top and no carved embellishments.</p> <p>Sandstone kerbing forms a double grave enclosure</p> <p>The monument is surrounded by a palisade styled fleur-de-lys shaped spear topped iron fence mounted into the sandstone kerbing.</p> | <p>The plot is overgrown with a large cypress tree, resulting in damage to the plot arrangement</p> <p>The headstone and footstone monuments are upright and largely intact, with inscriptions clear and legible.</p> <p>The plot is littered with a thick layer of debris from the tree but the tree has created a relatively dry environment and there is minimal biological growth on the monument.</p> <p>The palisade fence has been distorted by tree growth with most of the iron spears dislodged and many missing and support posts leaning along the right side</p> <p>Sandstone kerbing blocks are cracked and flaking in places, dislodged by the lean of the palisade fence, or obscured by vegetation litter.</p> | <p>Overall: Failed</p> <p>End stones: Good</p> <p>Kerbing: Fair</p> <p>Fence: Failed</p> |

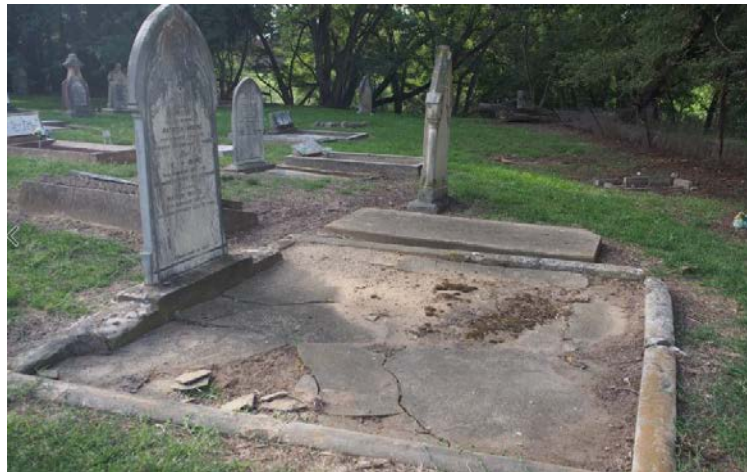
| Photograph | Description | Physical condition | Condition rating |
|---|---|---|---|
| | <p>A tall marble monument mounted on a low sandstone plinth. Sandstone kerbing forms a double grave enclosure.</p> <p>A cement or concrete infill/ ledger sits within the kerbing.</p> | <p>The marble monument is upright with a slight lean towards the back and appears to be well attached to the plinth.</p> <p>Biological staining affects the top and edges of the monument, and there is some loss of definition of carvings at the top where staining is heaviest. The inscription is clear and legible, with minor losses of lead lettering.</p> <p>Kerbing is complete, some blocks show minor wear and staining, others show cracks and losses. Lichens and orange staining are present, particularly at the foot end of the grave.</p> <p>The concrete infill/leger is cracked and slightly subsided in the middle of the grave.</p> | Fair |

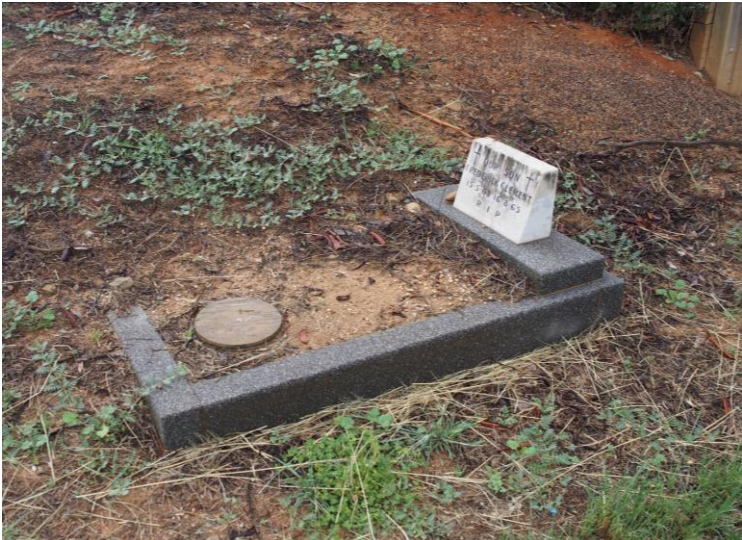
| Photograph | Description | Physical condition | Condition rating |
|---|---|---|---|
| | <p>A small white marble monument mounted on a granite or terrazzo plinth.</p> <p>Granite or terrazzo kerbing forms a small grave enclosure with no ledger evident.</p> | <p>The grave is adjacent to a steep bank where it is subject to soil being washed downhill in rains, and is partially buried by soil runoff. The left side kerb is fully buried by runoff.</p> <p>All visible elements are complete and well-aligned, with no apparent damage. Minor biological staining affects the marble block.</p> <p>There is an unpainted circular timber board approximately 15mm in thickness</p> | Fair |

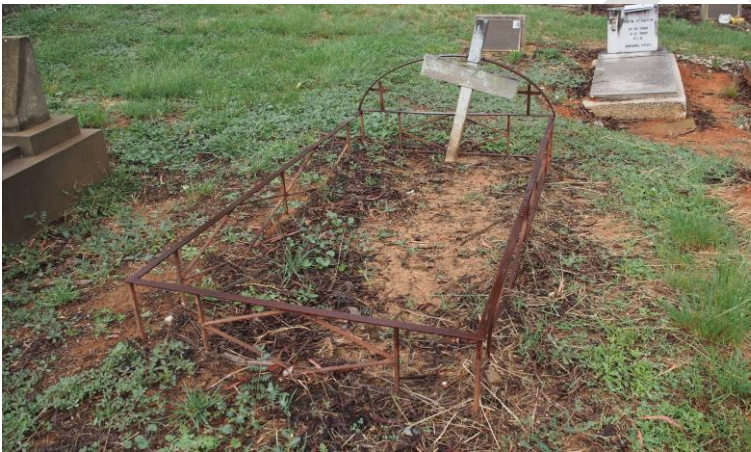
| Photograph | Description | Physical condition | Condition rating |
|---|---|---|---|
| | <p>A small, plain, white-painted wooden cross mounted directly into the ground.</p> <p>A low wrought metal fence forms a small grave enclosure appears to be mounted directly into the ground (no kerbing was evident) and there is no infill or kerb</p> | <p>The wooden cross is weathered and leaning, with some staining and lichen growth. No inscription is legible.</p> <p>The metal fence is complete, well aligned and upright. There is extensive oxidation. It is not clear whether lighter brown areas are paint or oxidation.</p> | Fair to poor |

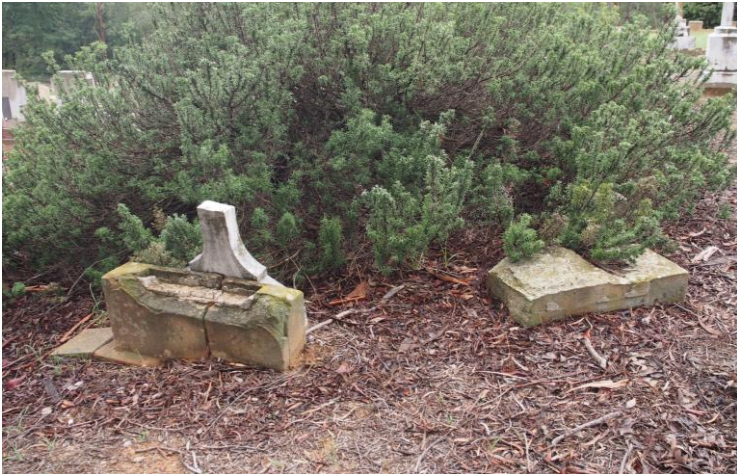
| Photograph | Description | Physical condition | Condition rating |
|---|---|---|---|
| | <p>A white marble monument, possibly in the form of a cross mounted on a small sandstone plinth.</p> <p>Sandstone blocks form low kerbing around the grave plot, in which a large rosemary bush is growing.</p> | <p>The marble monument has been dislodged from the plinth and has been placed to lean against the plinth. The top of the monument has been broken off and is missing. A small marble cross beside a neighbouring grave is possibly the missing piece but it is not clear which grave it has been displaced from.</p> <p>The rosemary bush has overgrown the grave, dislodged stone kerbing and obscured the plot from view almost completely</p> | <p>Failed</p> |

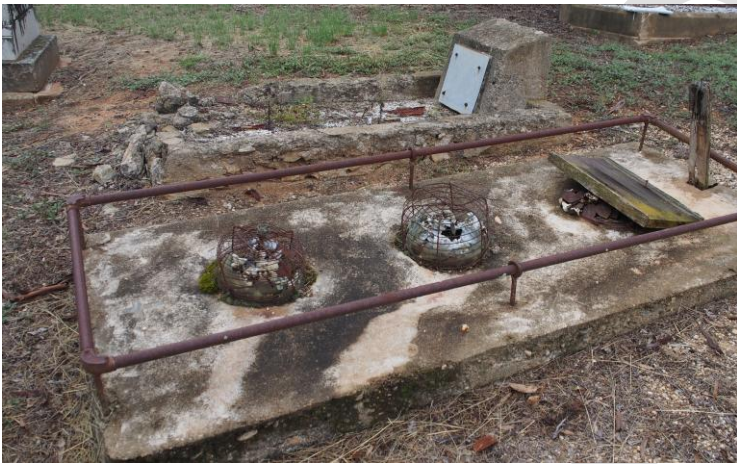
| Photograph | Description | Physical condition | Condition rating |
|---|---|---|---|
| | <p>A small timber plaque on a post mounted into concrete ledger that covers the grave plot.</p> <p>A low tubular metal rail forms a fence enclosure.</p> <p>There are three glass domes with artificial floral arrangements arranged along the ledger, these have protective metal wire covers.</p> | <p>The timber plaque is dislodged from the post. Both post and plaque show decay and the inscription is not legible as the plaque has fallen face down.</p> <p>The glass domes have been broken and floral decorations are no longer legible as such.</p> <p>Concrete infill is complete and shows staining but no damage is apparent.</p> <p>The metal rail is rusted but complete, well aligned and appears to be well attached in the ledger.</p> | <p>Fair to poor</p> |

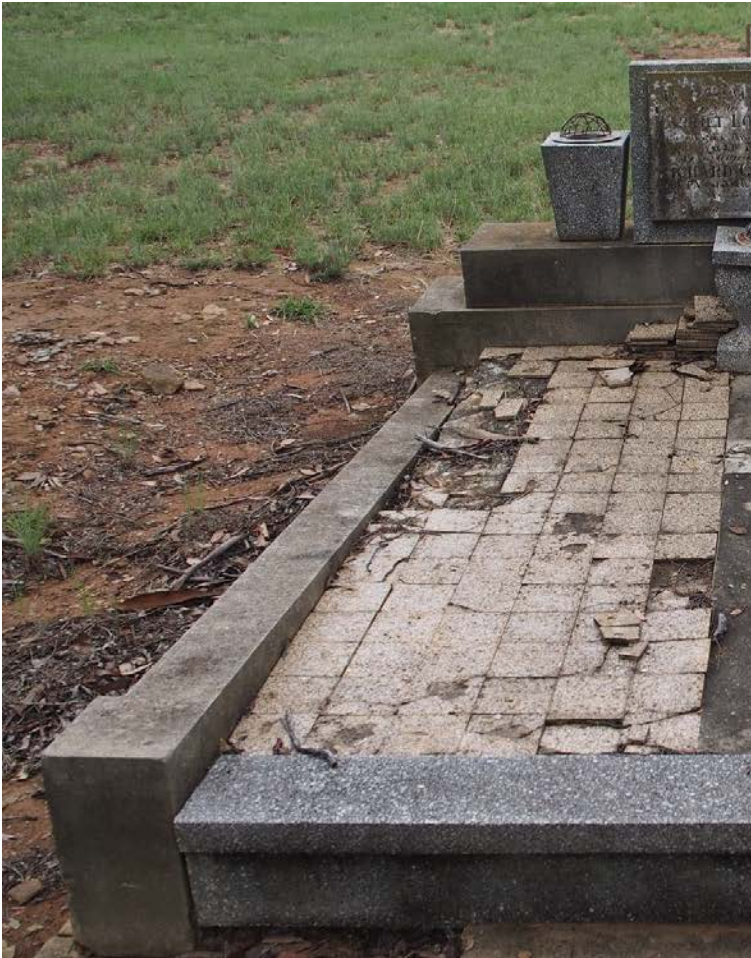
| Photograph | Description | Physical condition | Condition rating |
|---|---|---|---|
| | <p>A grey terrazzo monument with a white marble plaque mounted on a low, wide concrete or rendered brick plinth.</p> <p>Concrete kerbs along the sides and a grey terrazzo sill at the foot of the grave form a double grave enclosure.</p> <p>The concrete infill/leger has been tiled with tan-coloured square tiles.</p> <p>Two square vases are arranged on the top of the plinth on either side of the headstone and a third urn-shaped vase is in front of the headstone.</p> | <p>The structural elements of the monument are upright, well-aligned with the exception of the flower urn.</p> <p>There is generalised minor wear and biological staining which is particularly heavy on the marble plaque.</p> <p>There is some cracking apparent in the concrete at the foot end of the grave.</p> <p>Tiled surface of ledger is failing with a large number of broken and dislodged tiles. A quantity of loose tiles has been stacked at the head end of the ledger.</p> | <p>Overall: Good</p> <p>Monument: Good</p> <p>Kerbing: Good</p> <p>Ledger: Poor</p> |

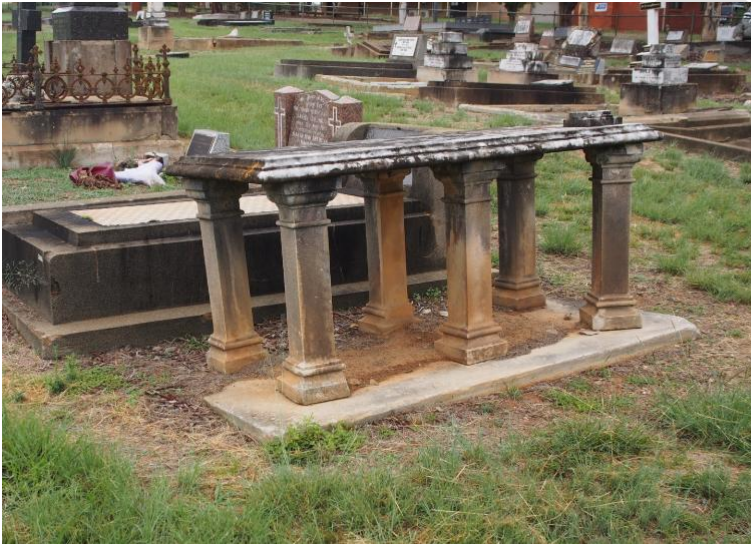
| Photograph | Description | Physical condition | Condition rating |
|---|---|---|---|
| | <p>A large sandstone monument in the form of an altar or tabernacle, comprising 6 square columns which support a rectangular slab.</p> <p>The structure is built on a plain concrete ledger forming a single grave plot.</p> | <p>The ledger has subsided on the left (uphill) side and is partially buried by soil washed downhill. The columns are upright and in position but some have come out of alignment and the whole structure leans due to the subsided ledger slab, posing a risk of collapse.</p> <p>The columns and top are heavily stained with dark biological stains and lichens.</p> | Fair to poor |

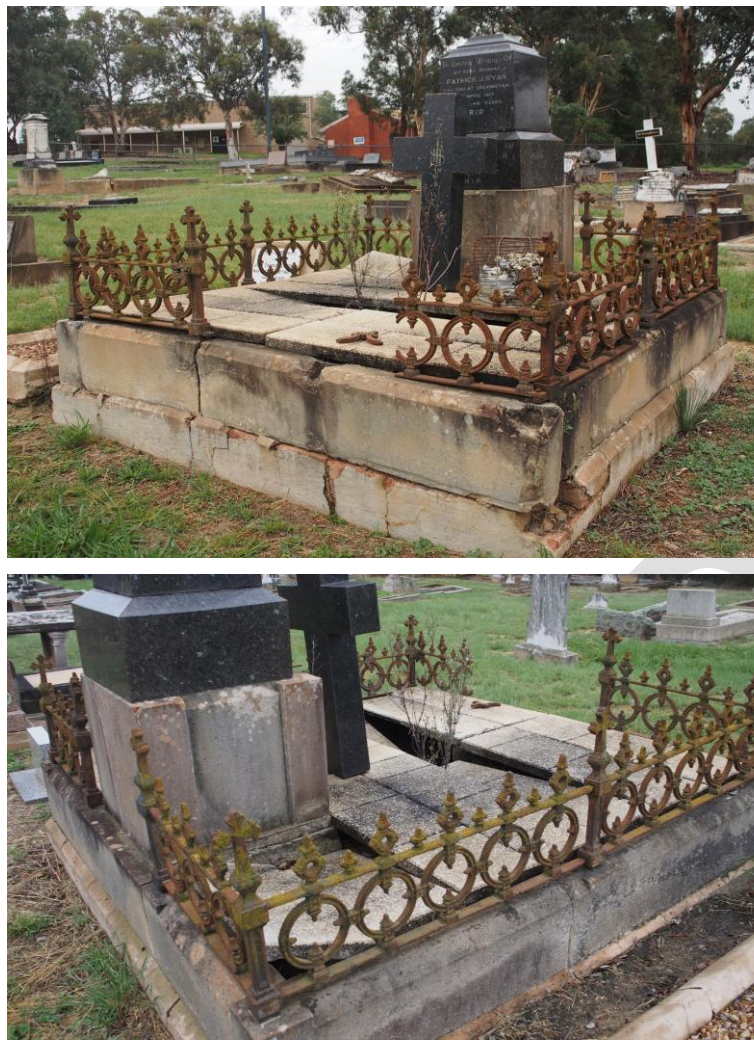
| Photograph | Description | Physical condition | Condition rating |
|---|---|---|---|
| | <p>A large, complex monument comprising a large black granite cross on a tall granite and concrete plinth mounted on a high square podium built of sandstone blocks assembled on a rendered brick base. The podium is topped with an ornate wrought-iron fence and large square terrazzo tiles.</p> | <p>The cross has been dislodged from the plinth and is standing within the grave enclosure in an upright position leaning against the plinth.</p> <p>The granite cross and plinth appear in good condition with no visible cracks or breaks aside from dislodgement of the cross.</p> <p>The sandstone plinth is complete and in alignment, with minor wear apparent.</p> <p>The wrought iron fence is mostly upright and appears secure, with portions broken, one upright missing and there is generalised oxidation to the metal.</p> <p>The terrazzo tile ledger is extensively displaced, with individual tiles collapsing and a cavity visible underneath.</p> <p>Sandstone blocks of the podium are generally sound, however the foot end block is broken and the right corner has subsided. Biological staining affects the sandstone in sections, particularly on the downhill side.</p> <p>The rendered brick base of the podium is generally complete sound with some cracking. The base shows significant subsidence, breakage and sagging at the right (downhill) foot end of the monument.</p> | <p>Overall: Poor</p> <p>Monument and plinth: Good but cross is dislodged</p> <p>Fence: Fair to poor</p> <p>Ledger: Failed</p> <p>Stone podium: Generally good</p> <p>Brick podium: Generally fair with failed portion</p> |

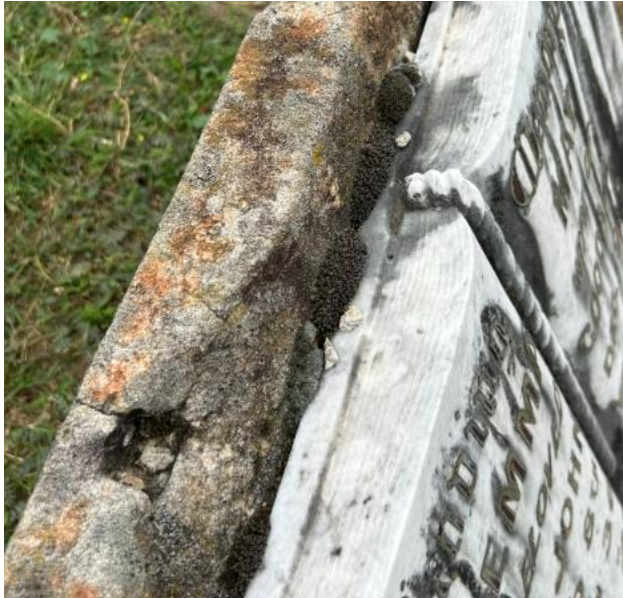
**Figure 66:** An example showing biological growths including lichen and moss causing discoloration of the sandstone

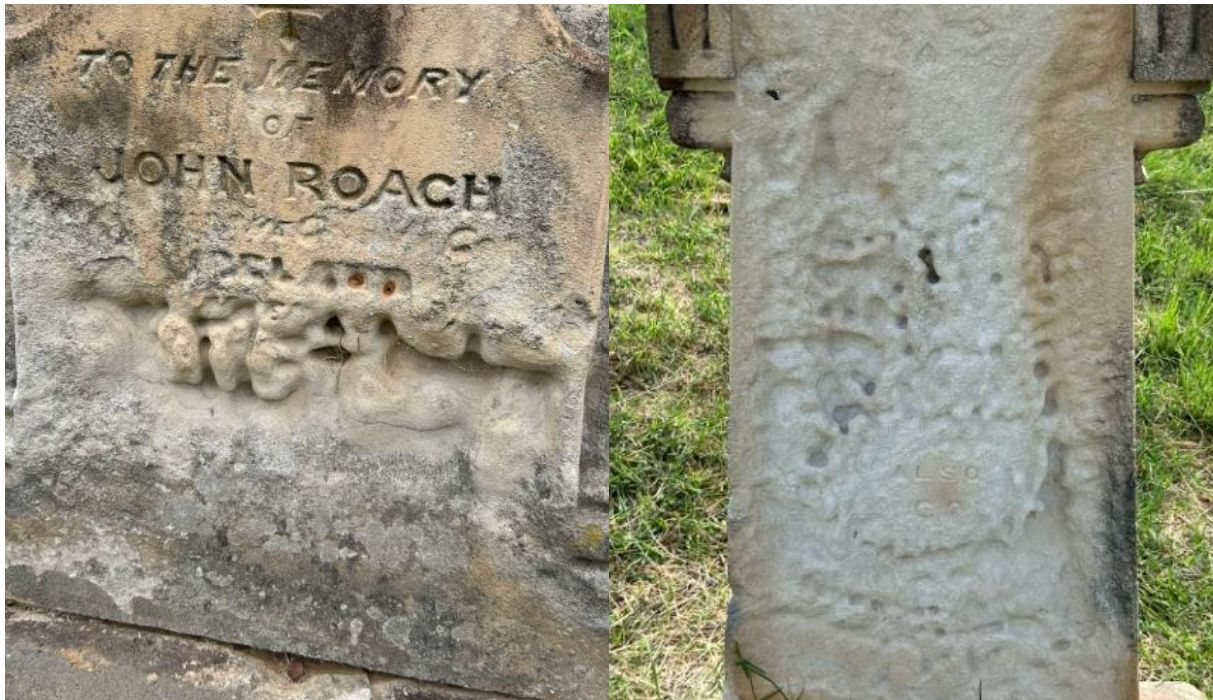
**Figure 70: Weathering of sandstone (also known as honeycombing)**

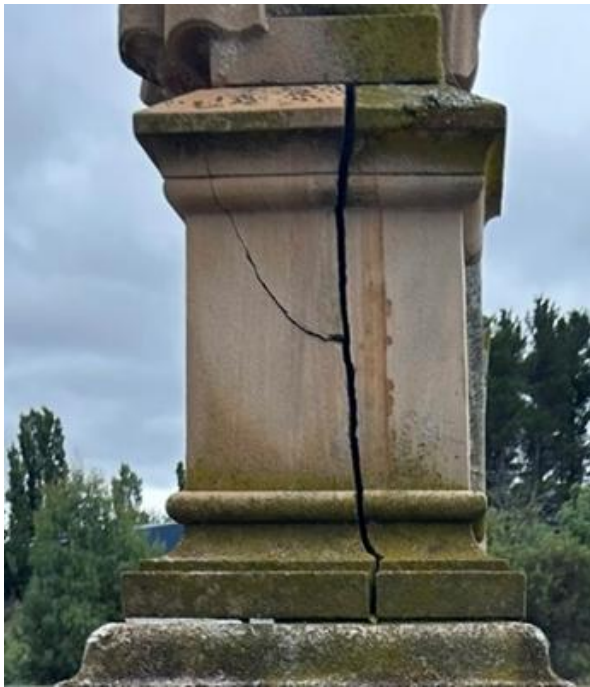
**Figure 72: A sandstone element displaying a significant fracture**

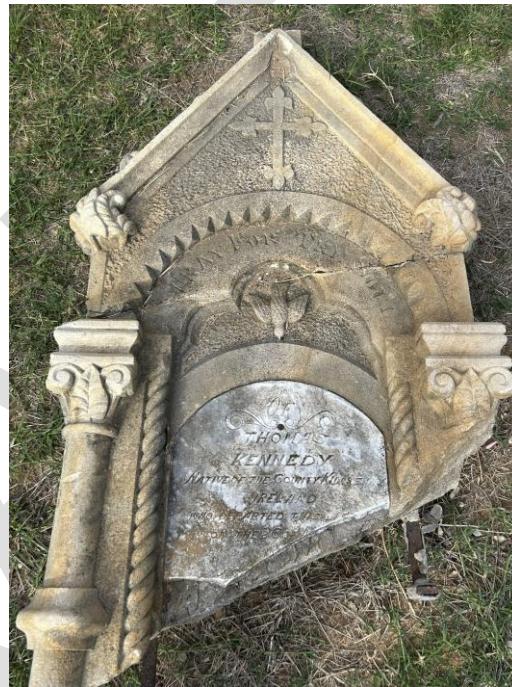
**Figure 73: An example where the stone has fractured, leaving the monument in pieces**

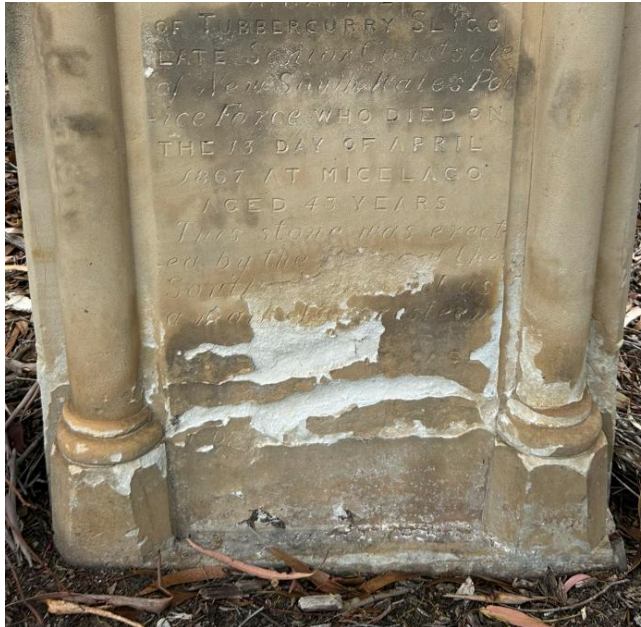
**Figure 74: An example of spalling which has resulted in the loss of the stone surface**

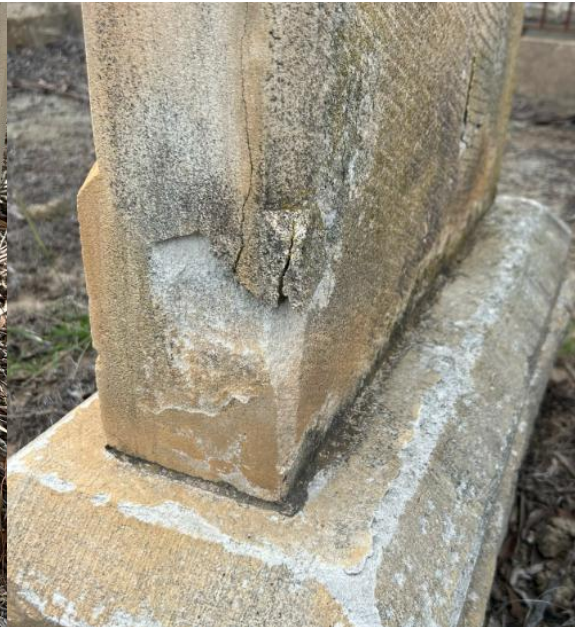
**Figure 75: An example where blistering has resulted in parts of the stone becoming loose and breaking off**

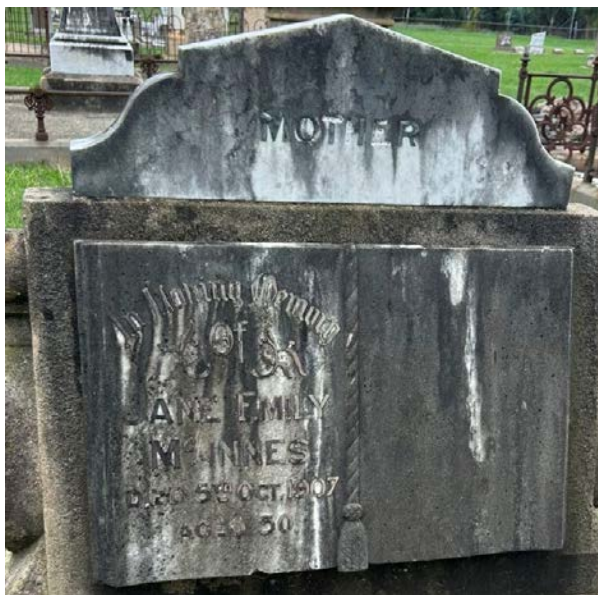
**Figure 76:** An example of the significant discolouration of a marble element

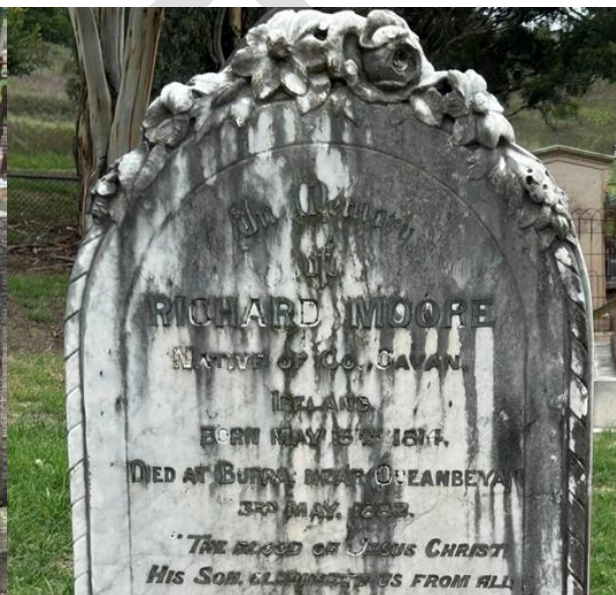
**Figure 77:** An example of marble discolouration and soiling

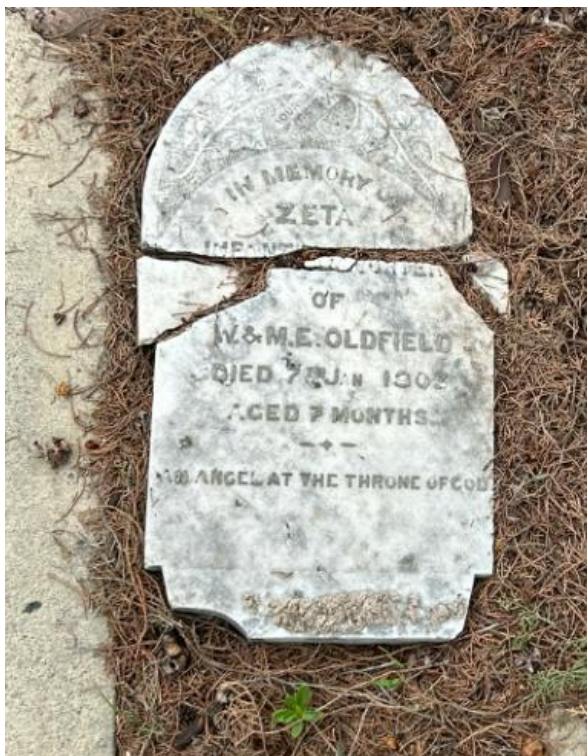
**Figure 78: Example where a marble monument has fractured but been reassembled on the grave floor**

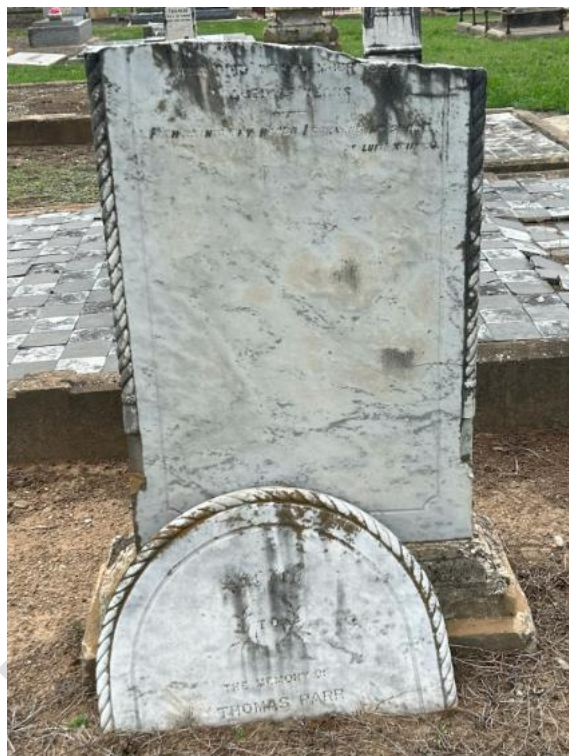
**Figure 79: Example of a marble monument that has fractured resulting in the top portion breaking off**

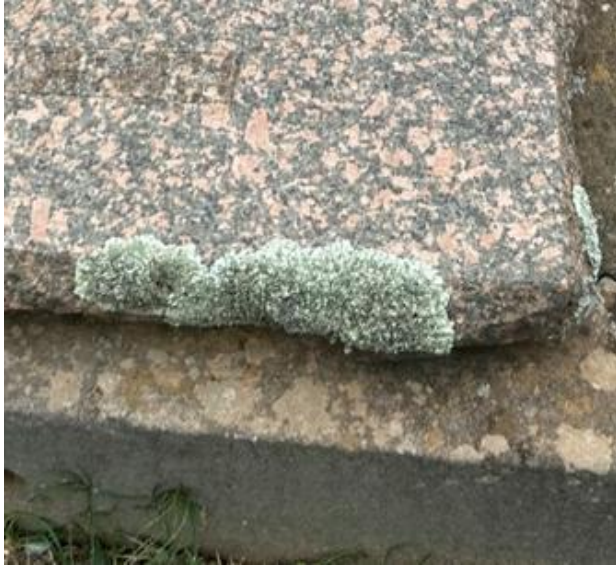
**Figure 80: Example of a granite ledger displaying lichen growth**

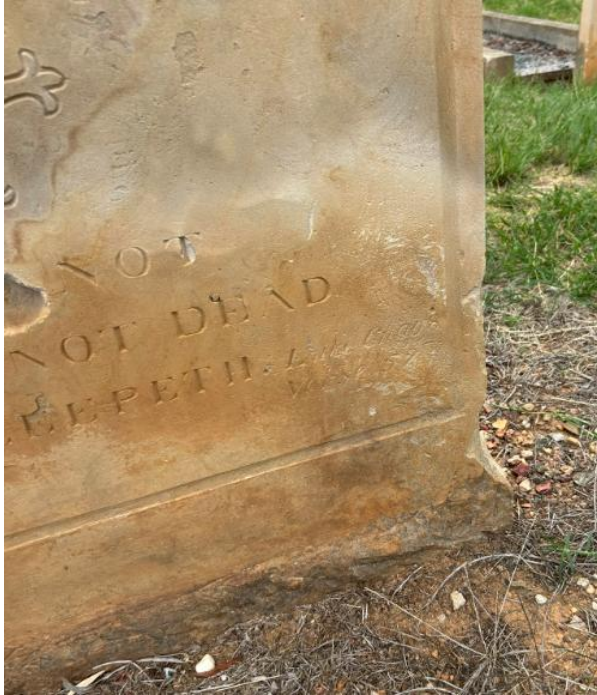
**Figure 82: Example of rising damp in sandstone**

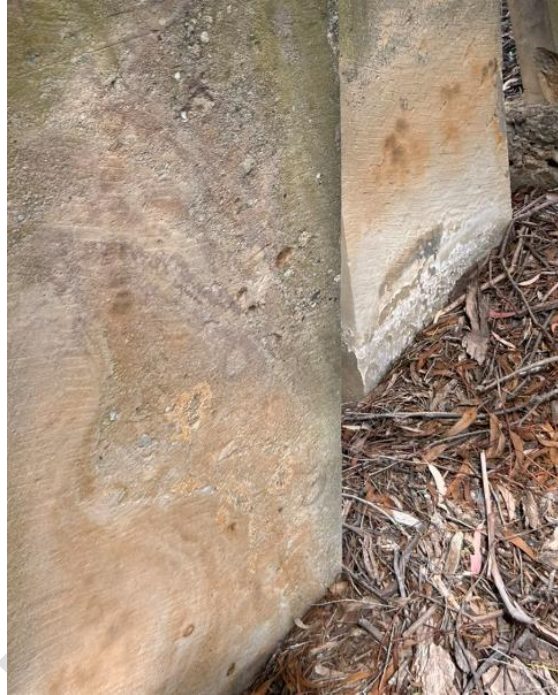
**Figure 83: Examples of rising damp causing damage to the rear of sandstone monuments**

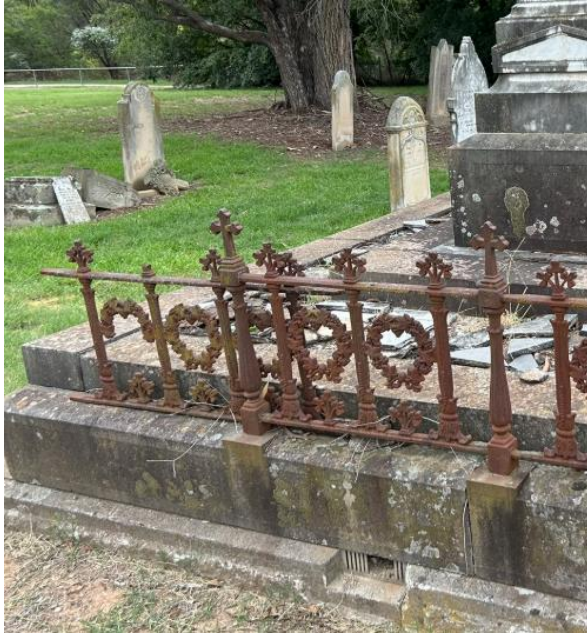
**Figure 84: Example of ornate ironwork, some of which has been displaced**

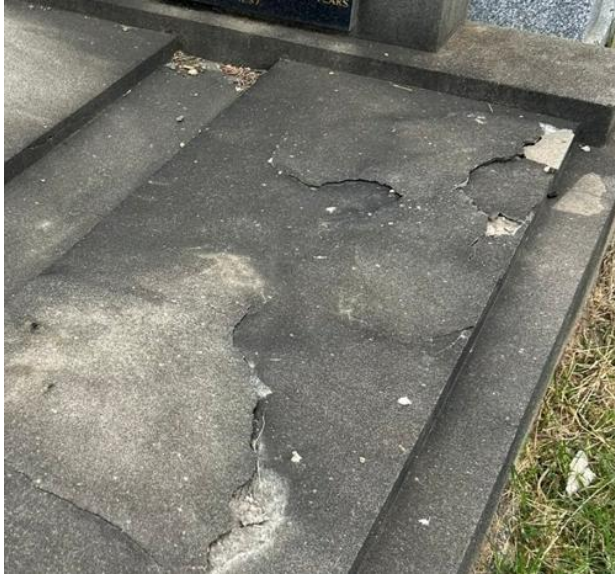
**Figure 86: Cracking and discoloration of the concrete ledger**

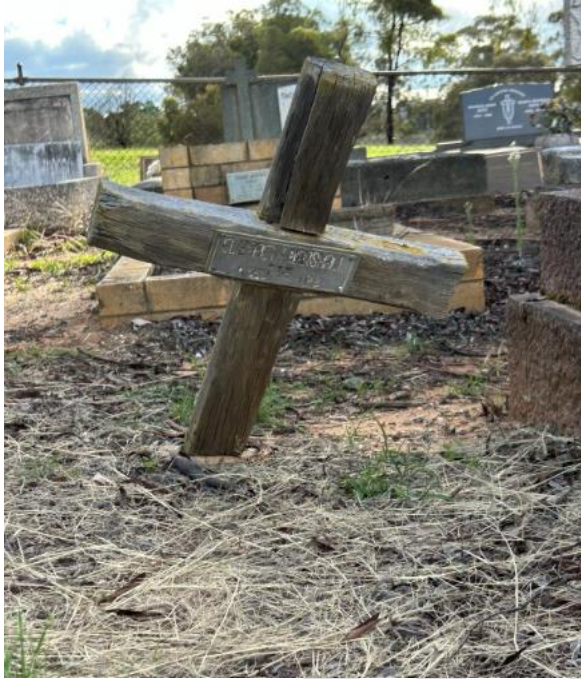
**Figure 88: Small timber cross showing signs of biological growth and deterioration**

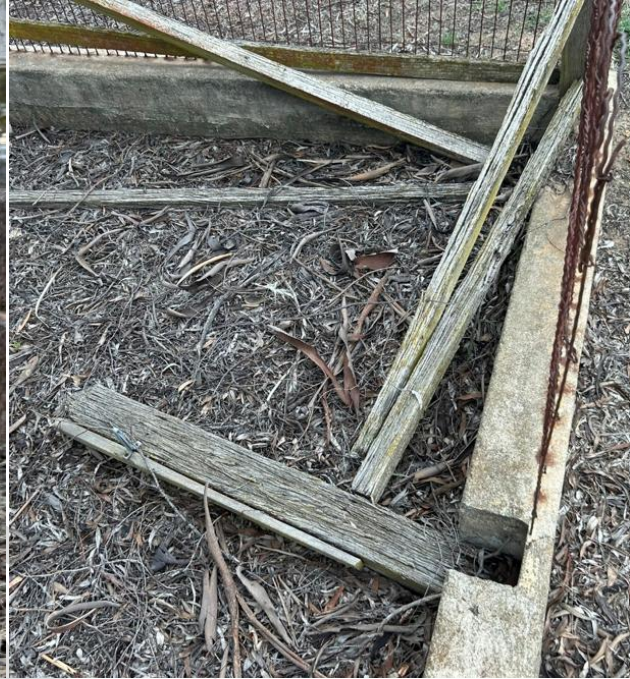
**Figure 89: parts of a timber fence that has failed showing signs of biological growth and decay**

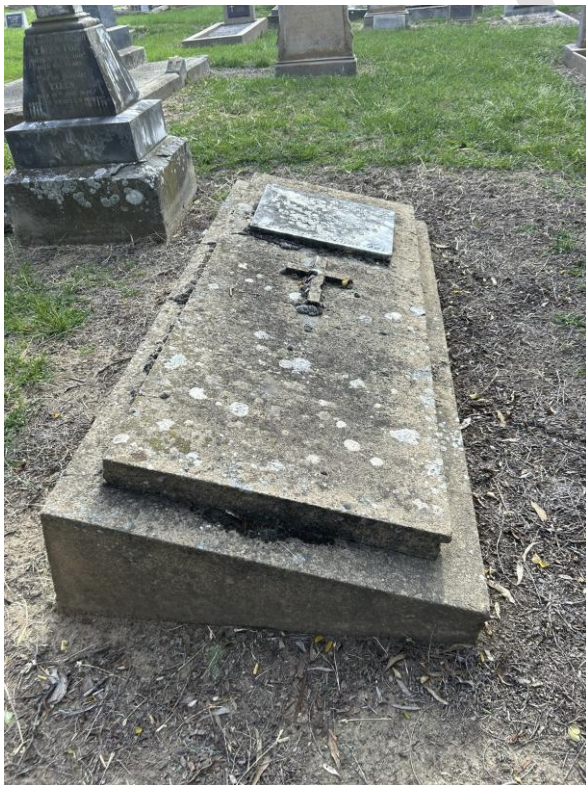
**Figure 92:** Example where subsidence is causing the grave to sink

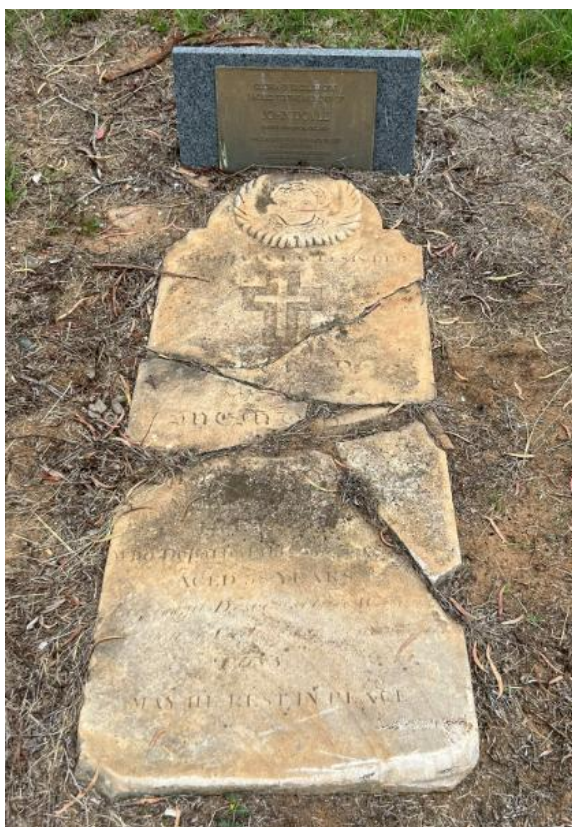
**Figure 94: Example where a headstone has failed and been reassembled with a contemporary plaque**

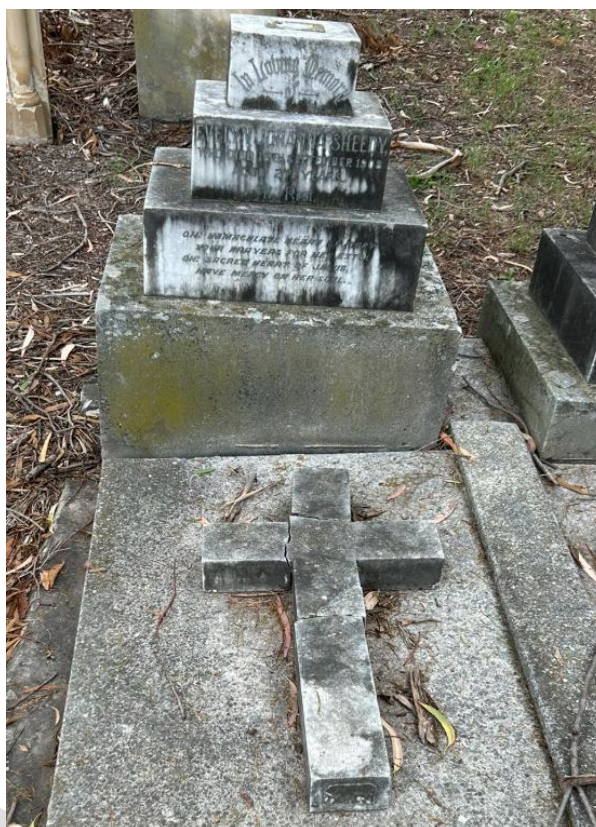
**Figure 95: Example where a marble cross has come free from the monument and fractured but has been reassembled on the grave ledger**

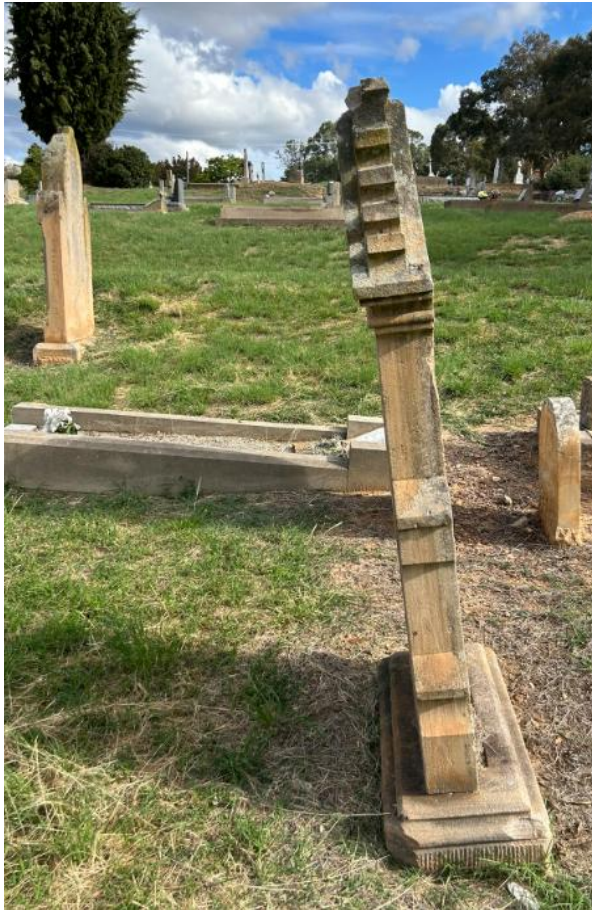
**Figure 96: A sandstone monument leaning**

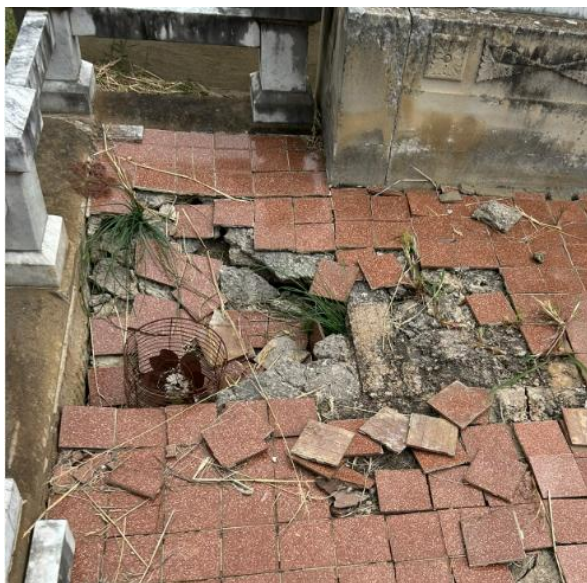
**Figure 100: Example of a tiled floor where tiles are dislodged and the floor is damaged**

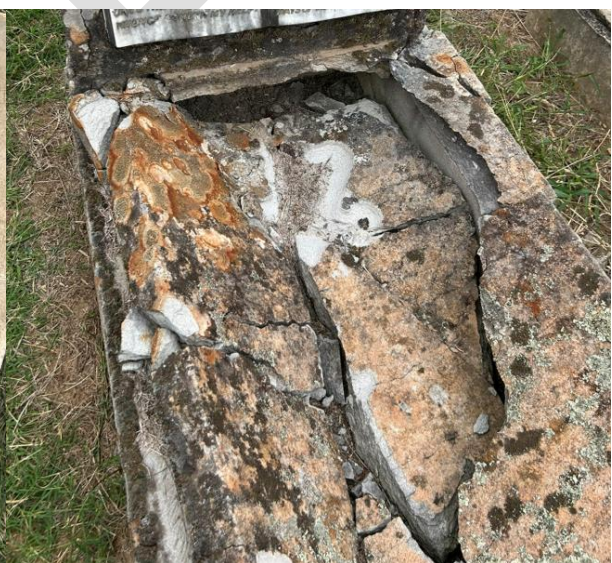
**Figure 103: Example of a fractured stone ledger**

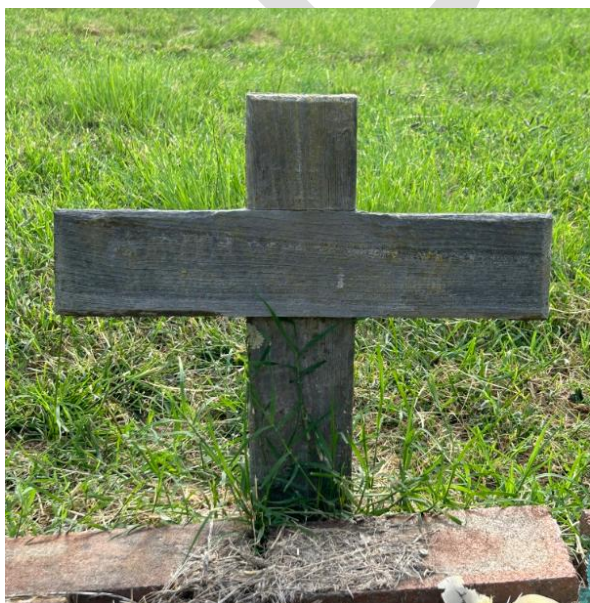
**Figure 106:** An example of a small timber cross with evidence of decay

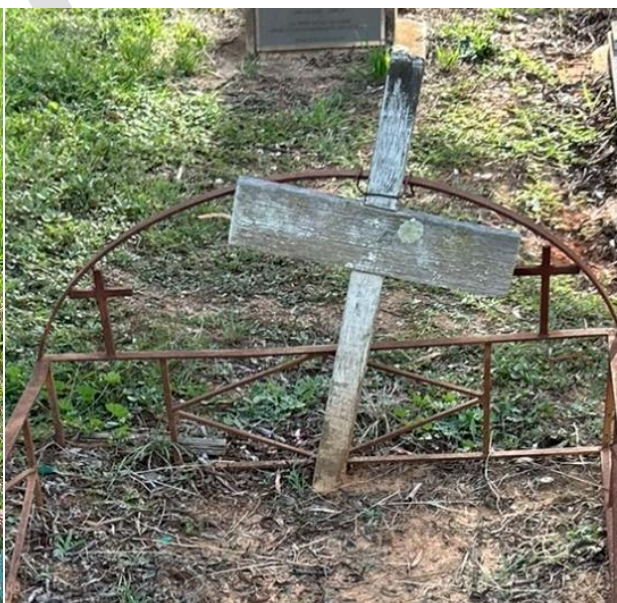
**Figure 107:** An example of a small timber cross with evidence of decay and biological growth
