Report on  
Preliminary Site Investigation

Proposed Residential Development  
Lot 1 DP 798111, Bungendore

Prepared for  
Queanbeyan-Palerang Council

Project 88336.00  
December 2016

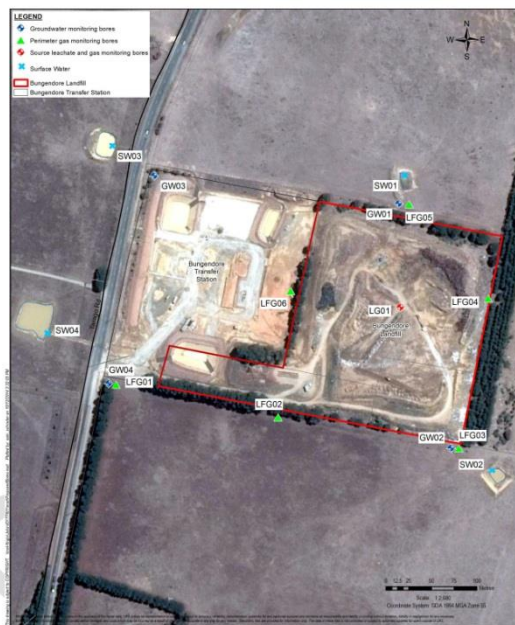
**Figure 1: Location of samples (from ENRS, 2015)**

Four groundwater monitoring bores (GW01 to GW04), one leachate bore (LG01) and six landfill gas bores (LFG01 to LFG06) were constructed around the landfill. Four surface water samples were collected from dams (SW02 to SW04) outside the boundary of the landfill including one sample from the dam within the north western portion of the site. The figure below shows the sample locations in relation to the landfill. The location of the landfill is shown on Drawings 1 and 2, Appendix B.

ENRS noted that the results of sampling for landfill gas, surface and groundwater indicated the landfill was suitably contained. ENRS considered that the existing monitoring locations and sampling (specified by the EMP) generally provided suitable assessment of surface water, leachate and groundwater conditions. However, ENRS recommended subsequent monitoring results continue to be reviewed to assess for potential seasonal or temporal changes. In particular, review should be conducted for levels of methane in LFG02 and groundwater chemistry in GW01 which presents similar geochemistry to leachate composition. Minor detections of selected analytes such as trace metals should also continue to be reviewed to establish if levels are associated with background concentrations and the site geology.

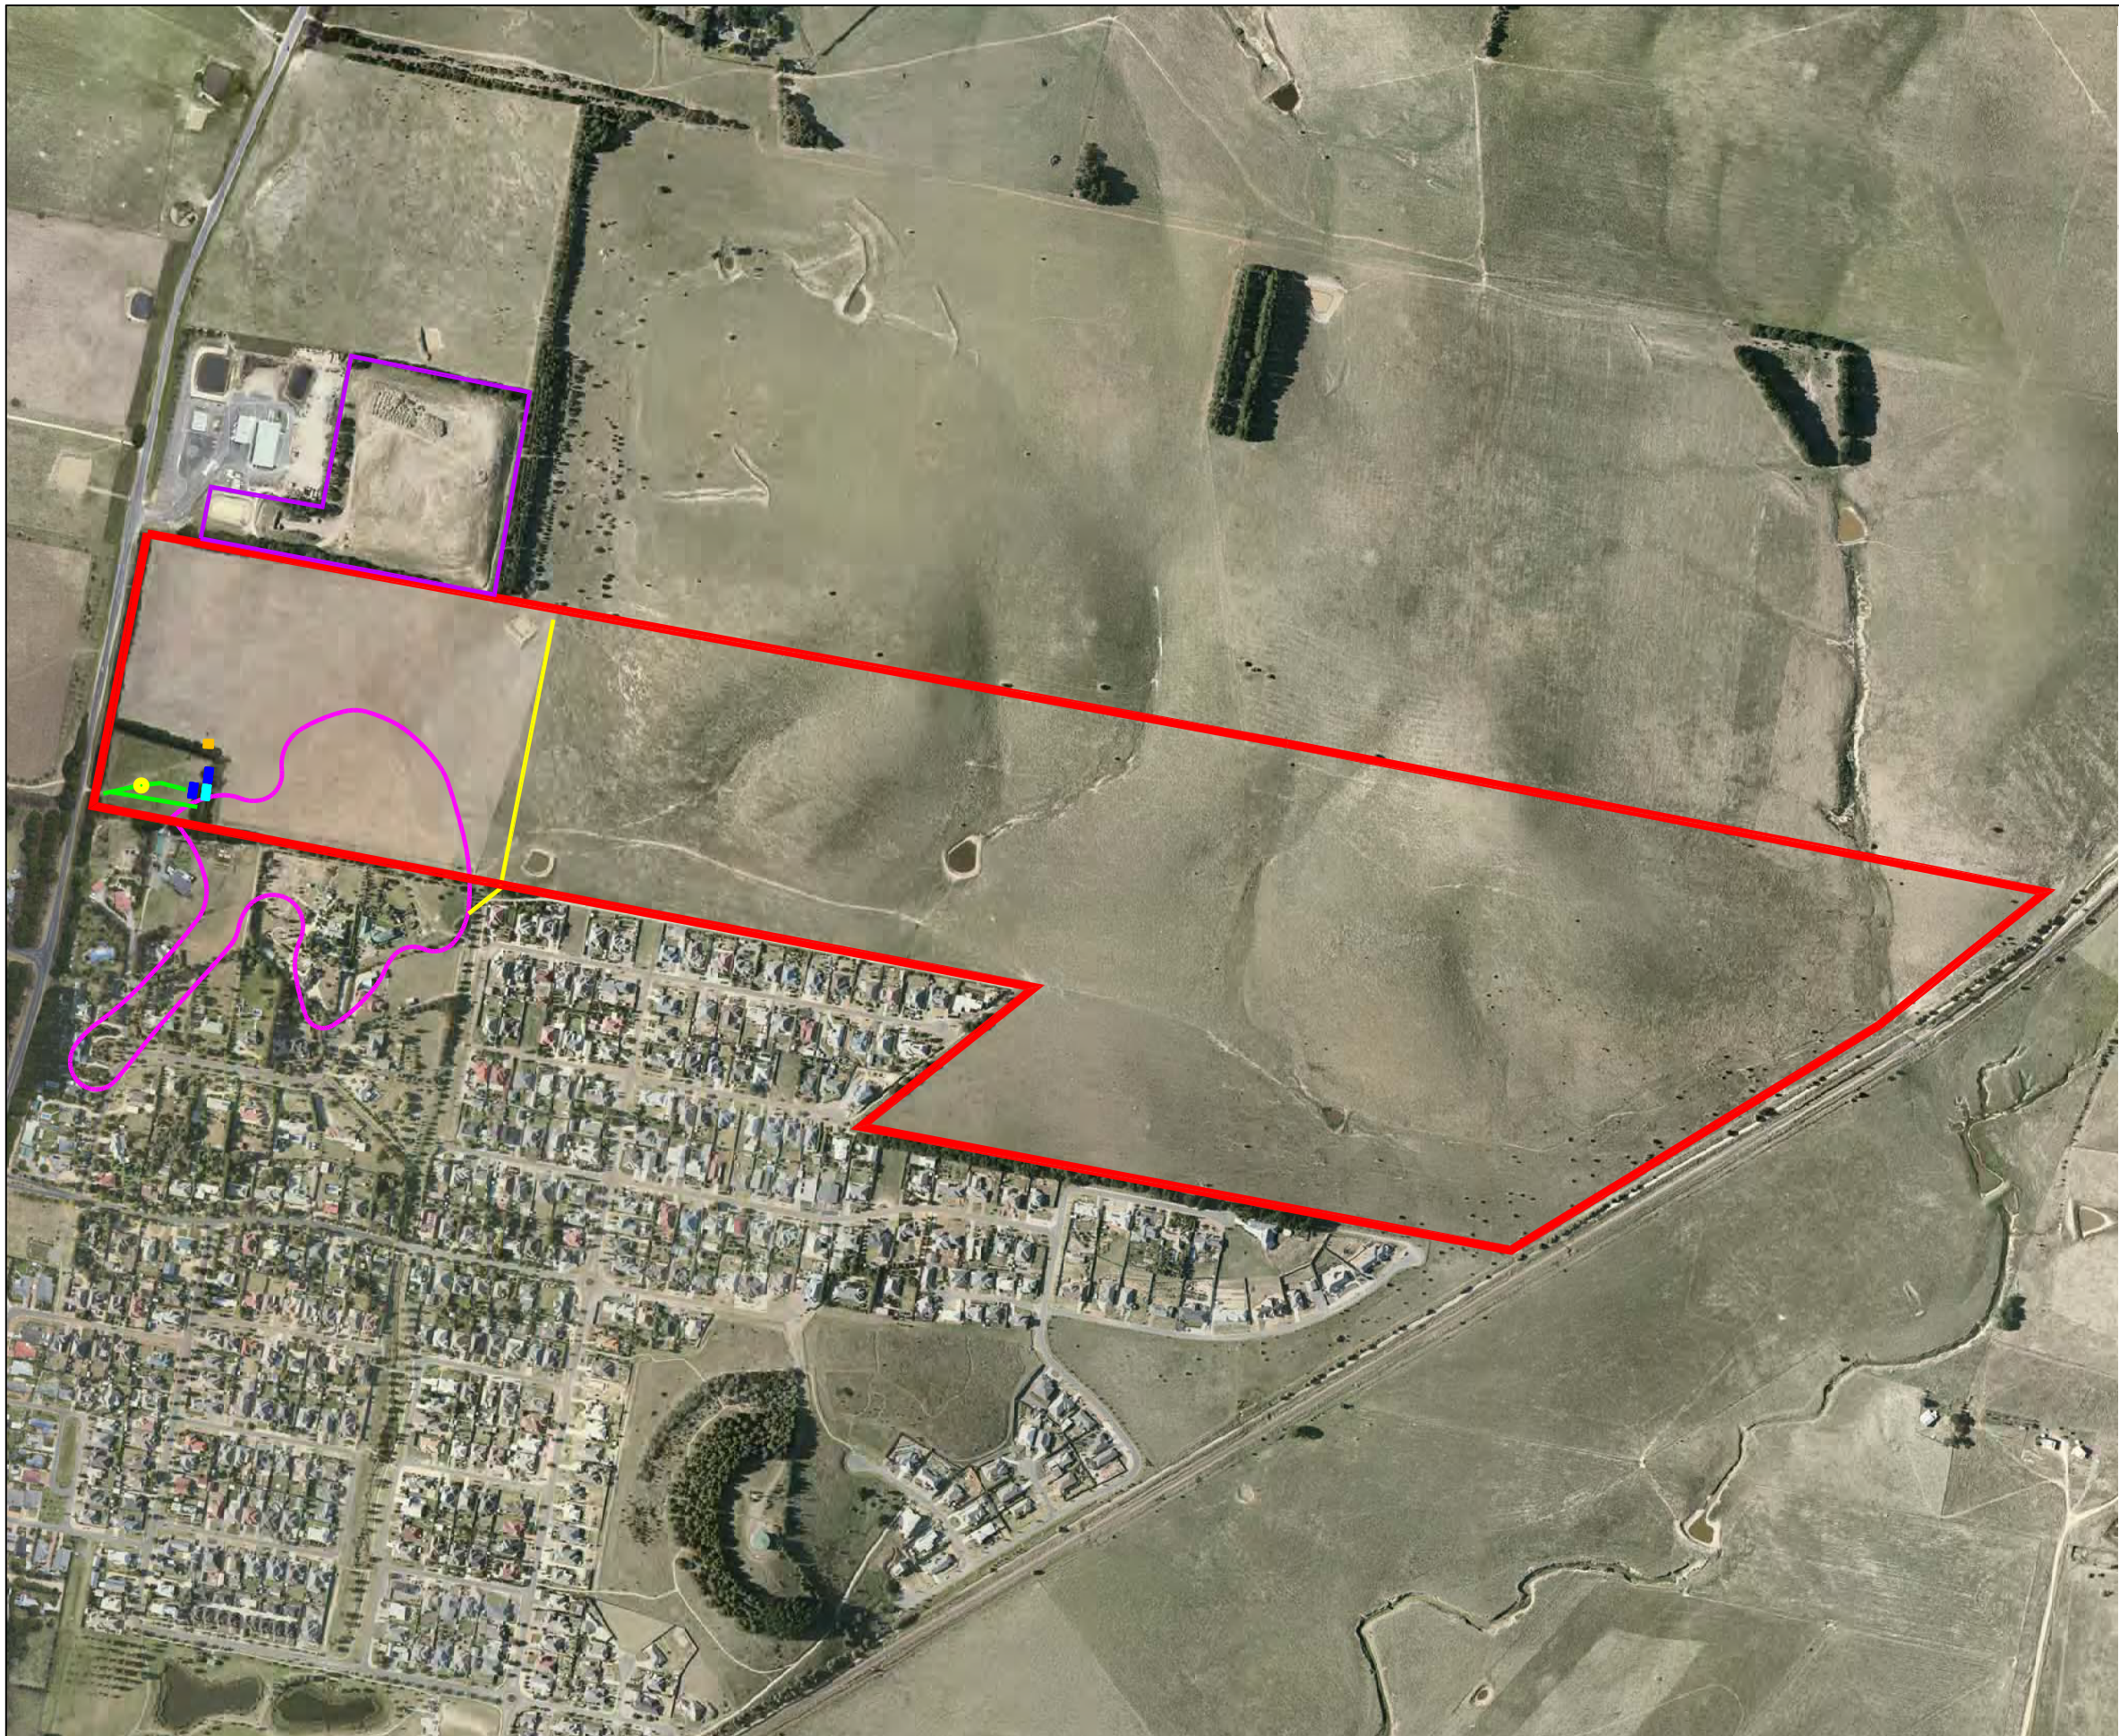
- Approximate Site Boundary
- Disturbed ground noted in the 1985 Aerial Photograph and slightly visible in the 1992 Aerial Photograph
- Dirt track noted in the 1992 Aerial Photograph
- Disturbed ground noted in the 1992 Aerial Photograph
- Buildings noted in the 1992 Aerial Photograph
- Building noted in the 1992 and 2002 Aerial Photographs
- Building noted in the 2002 Aerial Photographs
- Entrance driveways to the buildings noted in the 1992 and 2002 Aerial Photographs
- Bungendore Landfill Facility noted from the 1967 to 2002 Aerial Photograph

Potential sources of contamination observed on site are shown on Drawings 1 and 2, Appendix B. However, it should be noted that other fill areas not identifiable on aerial photographs or via surface walkover, could be present.

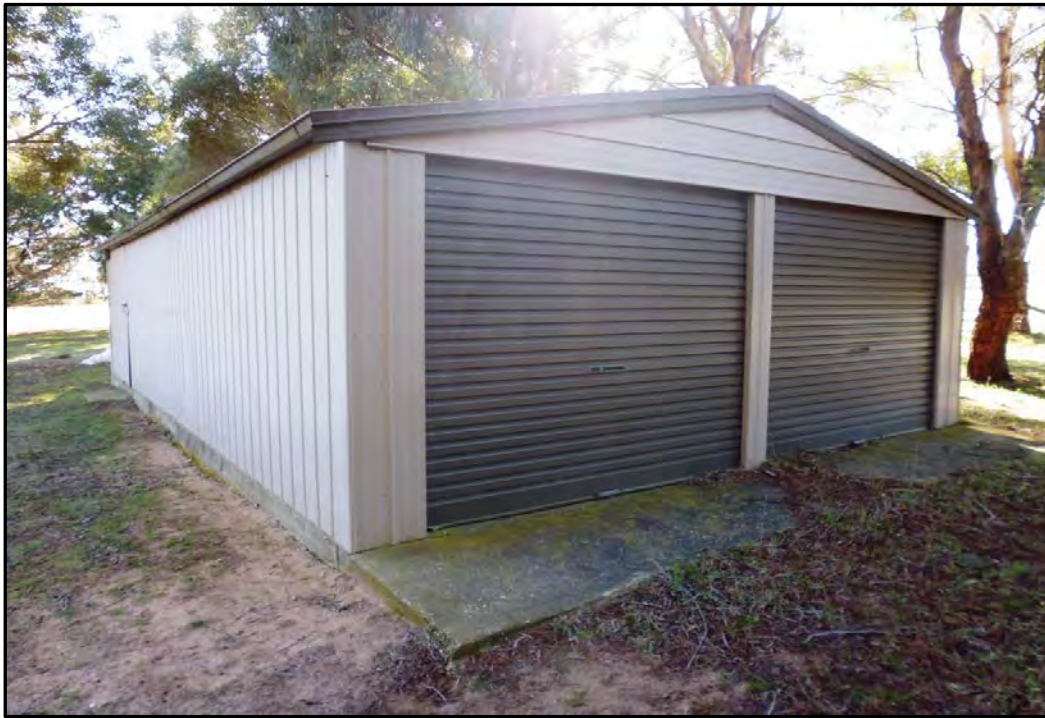
The locked shed was constructed on a concrete hardstand surface and therefore any minor storage of chemical such as pesticides, herbicides, insecticides or fuel would be unlikely to migrate into the surrounding environment. However, the shed would need to be accessed to determine the extent of any storage. It is also noted that the Queanbeyan-Palerang Council and Mr Brinkmeyer indicated that weed control has been undertaken across the site annually. Mr Brinkmeyer noted that there was no storage of chemicals or fuel at the site and there had not been a sheep or cattle dip at the site.

**Photo 3: Locked shed**

We would also recommend that the locked shed be accessed to determine if there is any storage of chemicals or fuel, and as noted above in Section 9, on-going monitoring of the Bungendore Landfill Facility to the north of the site should be undertaken. Confirmation should be sought that the landfill is not considered to be impacting the current site and that the 250 m buffer applied for any proposed development is appropriate. Further investigation may be required if this cannot be confirmed.

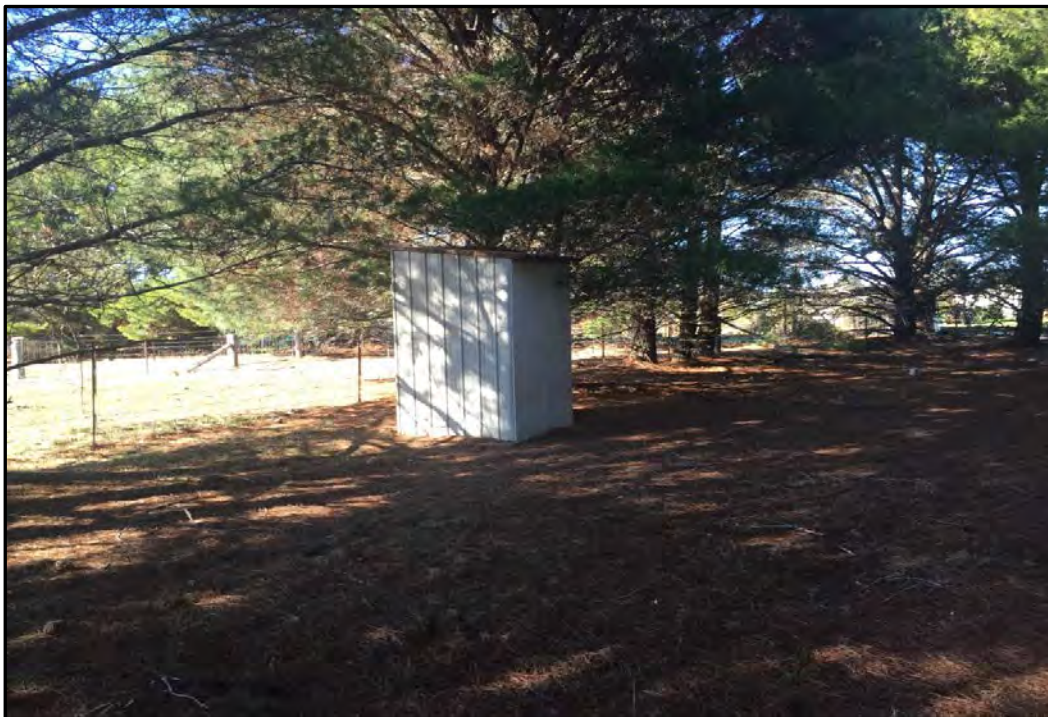
**Photo 6: Toilet with hole dug beneath for septic tank**

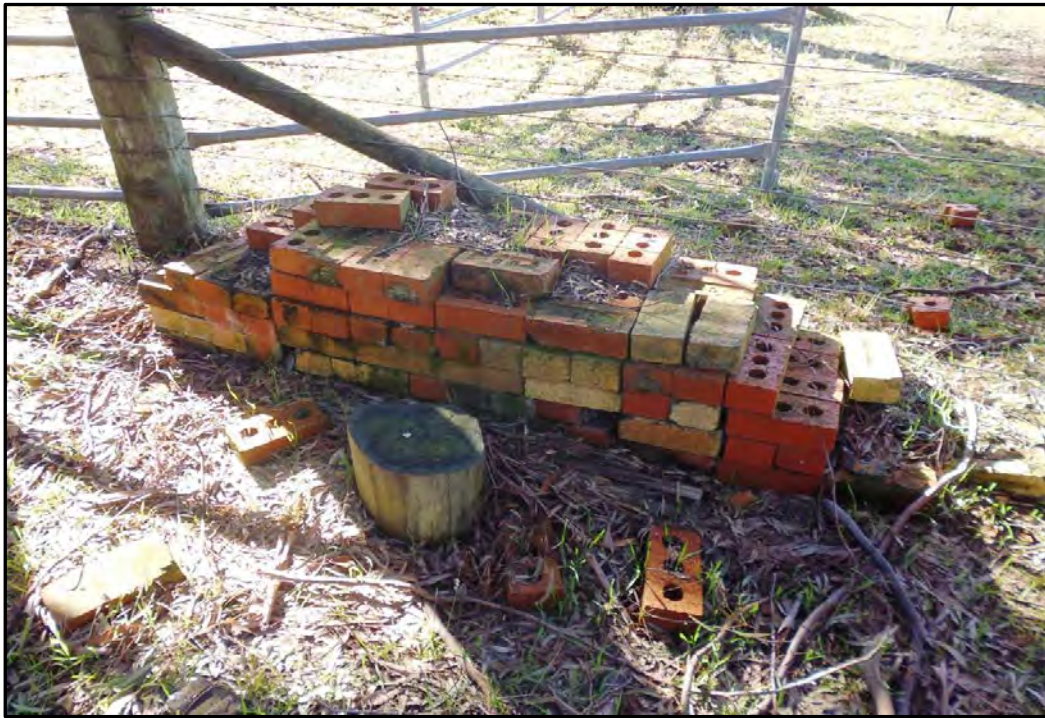
Some scattered items such as bricks, wood planks and wire were noted around the buildings. An old 20 L drum labelled kerosene was noted near to the locked shed, however, this was empty and appeared to be disused. The locked shed was not able to be accessed at the time of the site walkover and was built on a concrete hardstand foundation. The toilet appeared to be above a hole dug in the ground and no evidence of a pipe to a tank elsewhere was noted; see Photographs 7 to 9, Appendix E.

Photo 7: Scattered rubbish - bricks

In regards to the scattered rubbish across the site, there is unlikely to be any impacts to the site considering the inert pieces identified however there is an aesthetic impact. Therefore we would recommend that a more secure barrier be placed between the landfill and the site to minimise the rubbish migrating into the site. The rubbish could also periodically be collected by hand across the site and should be done just prior to site preparation and earthworks commencing for the development.

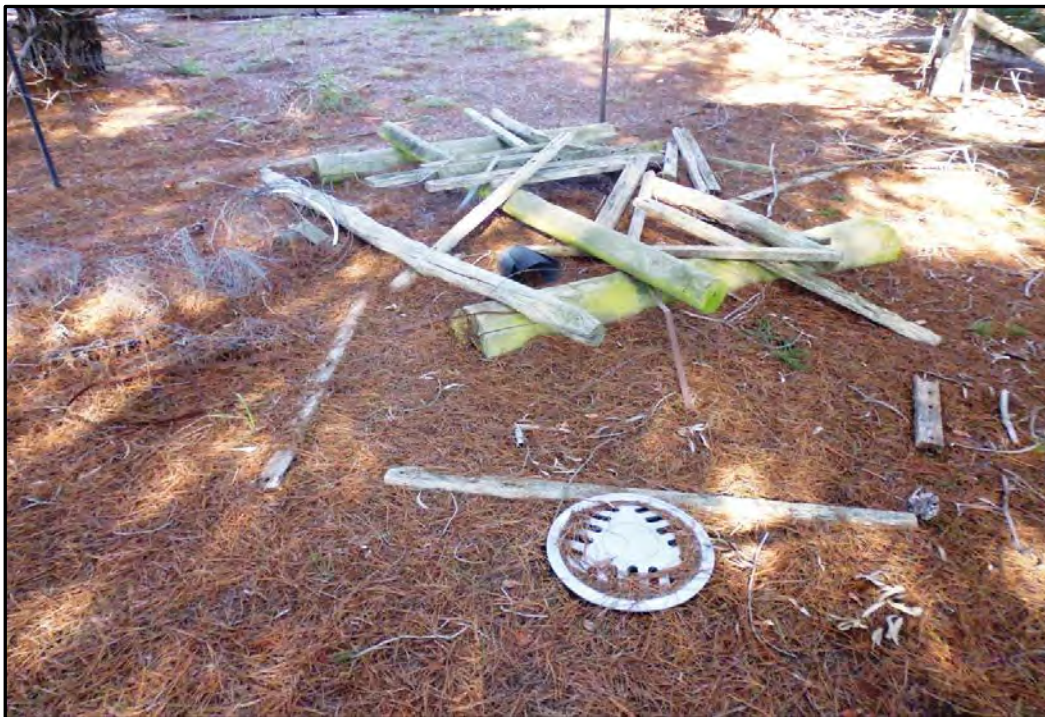
Photo 8: Scattered rubbish - wood planks

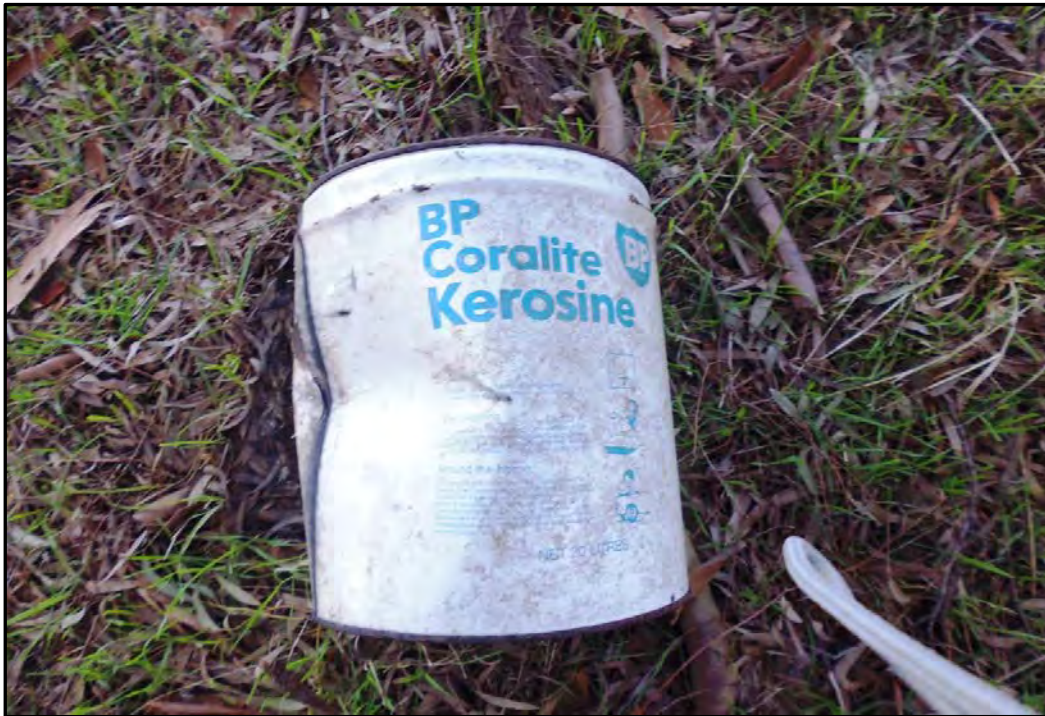
Photo 9: Scattered rubbish - old empty 20 L drum

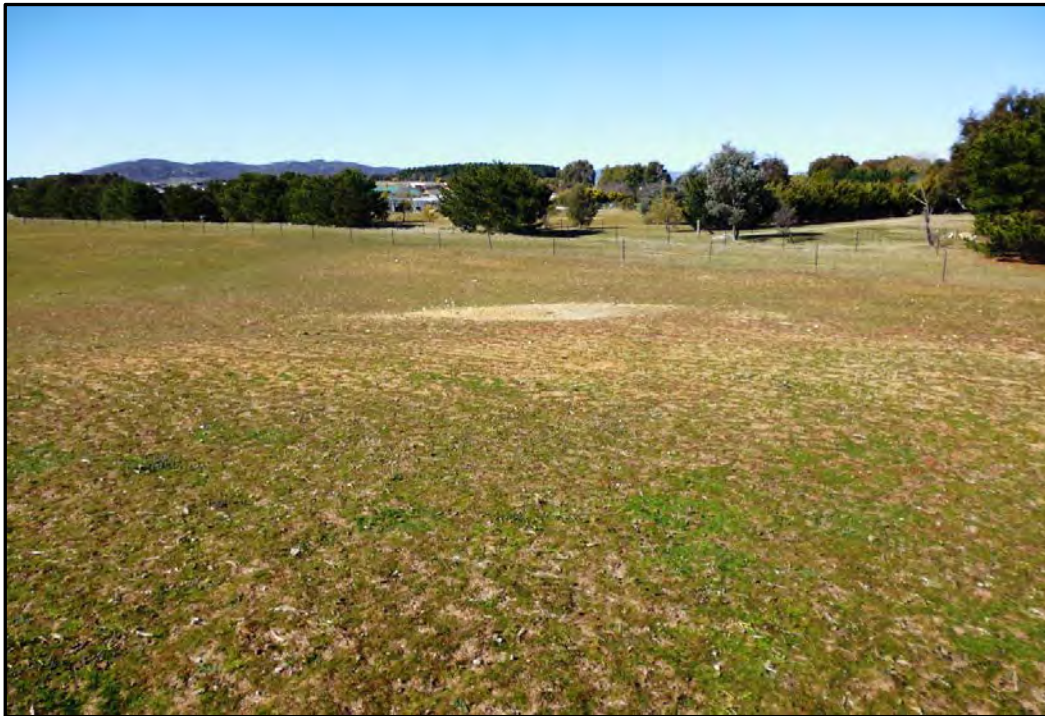
Photo 15: Small area of disturbed ground

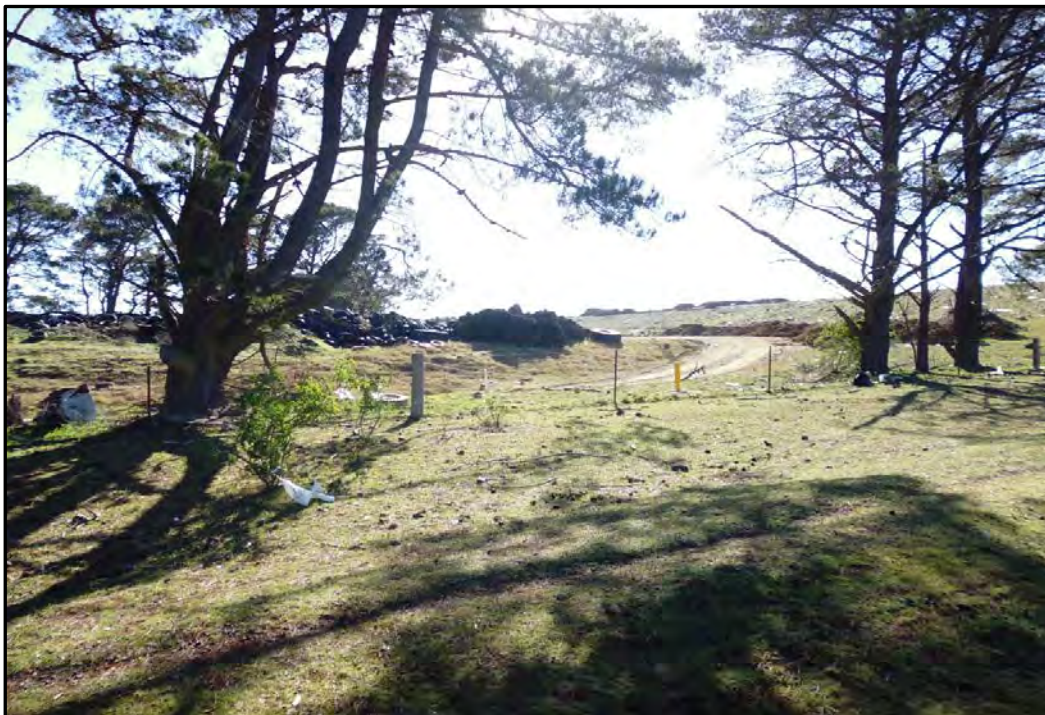
The Bungendore Landfill Facility has been subject to assessment and monitoring as part of the planned closure. The environmental monitoring assessment by ENRS (2015) considered that the landfill was suitably contained and recommended continued monitoring. Groundwater has also been noted by URS (2014) to flow to the north from the landfill, away from the current site. DP would consider the recommendations of ENRS for the on-going monitoring of the landfills impacts on the surrounding area to be sufficient at this point in time. Should any information become available that the landfill has an unacceptable impact on the current site this would need to be reviewed and possible additional investigation undertaken on the boundary of the landfill with the site. DP would recommend confirmation be sought that the landfill is not considered to be impacting the current site and that the 250 m buffer applied for any proposed development is appropriate.

Photo 16: Landfill to the north

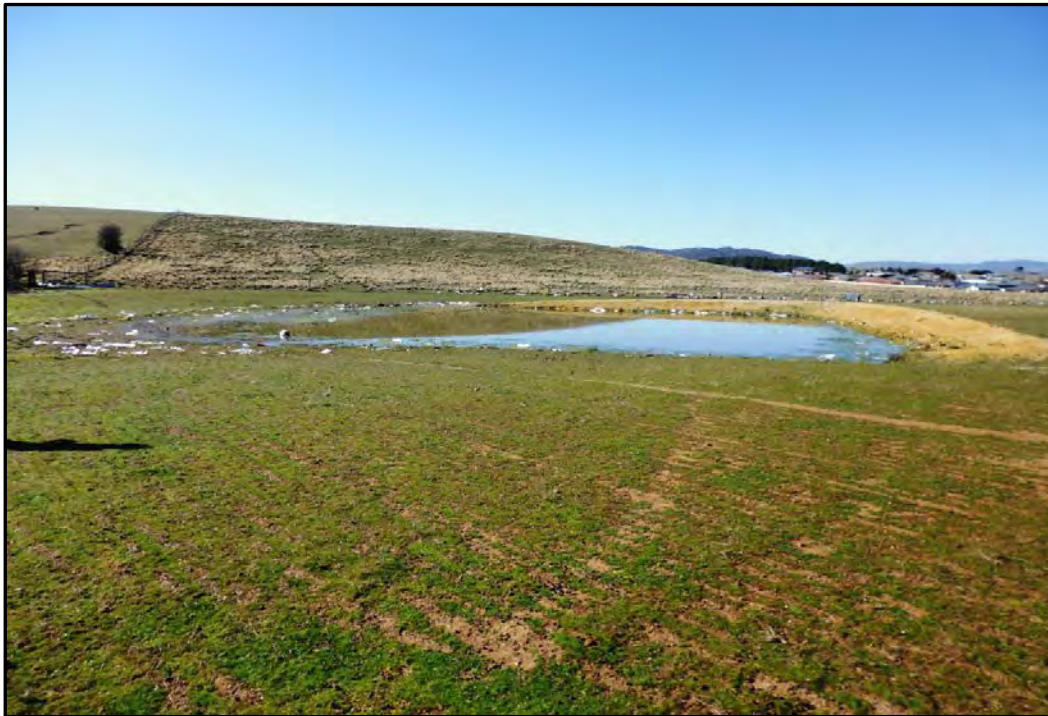
Scattered rubbish, mostly pieces of plastic and cardboard such as food wrappers, bags and boxes, were noted particularly near to the landfill to the north of the site. Three old 200 L fuel drums and an old 20 L kerosene drum were noted within the site, however, were empty and disused.

Photo 17: Dam in the north western portion - scattered rubbish from landfill

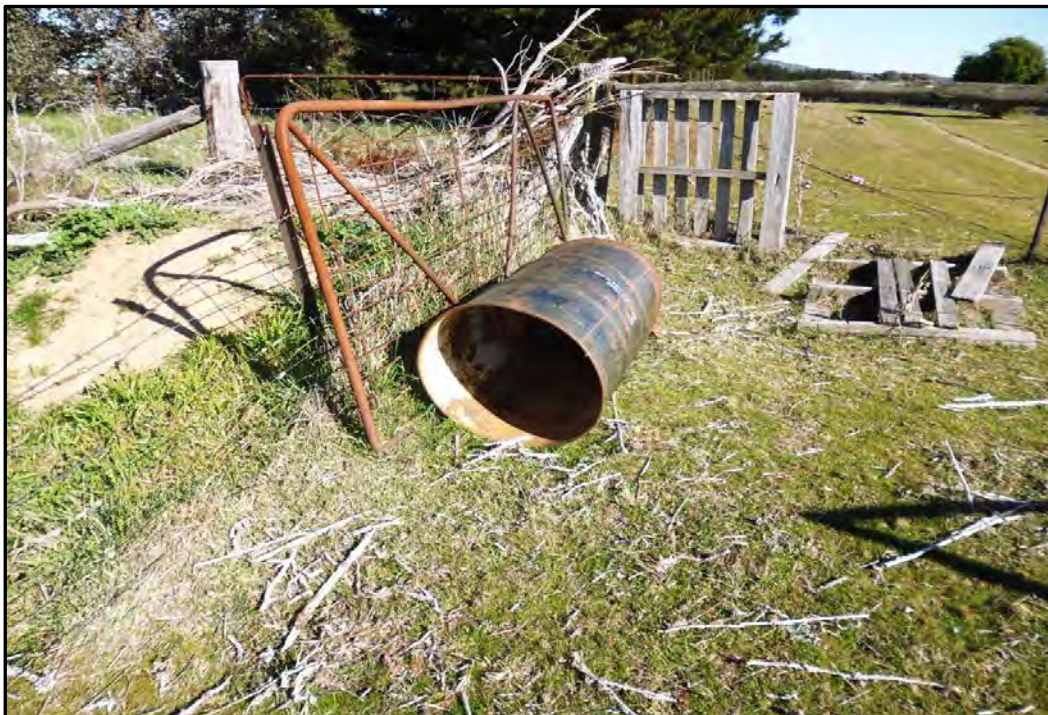
One old 200 L fuel drum was noted in the south central portion and two old 200 L fuel drums were noted in the south eastern portion of the site. These all appeared to be empty and disused. A PVC pipe was sticking out of the ground in the central portion of the site. The depth was not visible, however, it appeared to have water at the bottom. It was possibly a disused underground water tank / water supply or an old groundwater bore; see Photographs 18 to 20, Appendix E.

Photo 18: Old empty 200 L drum

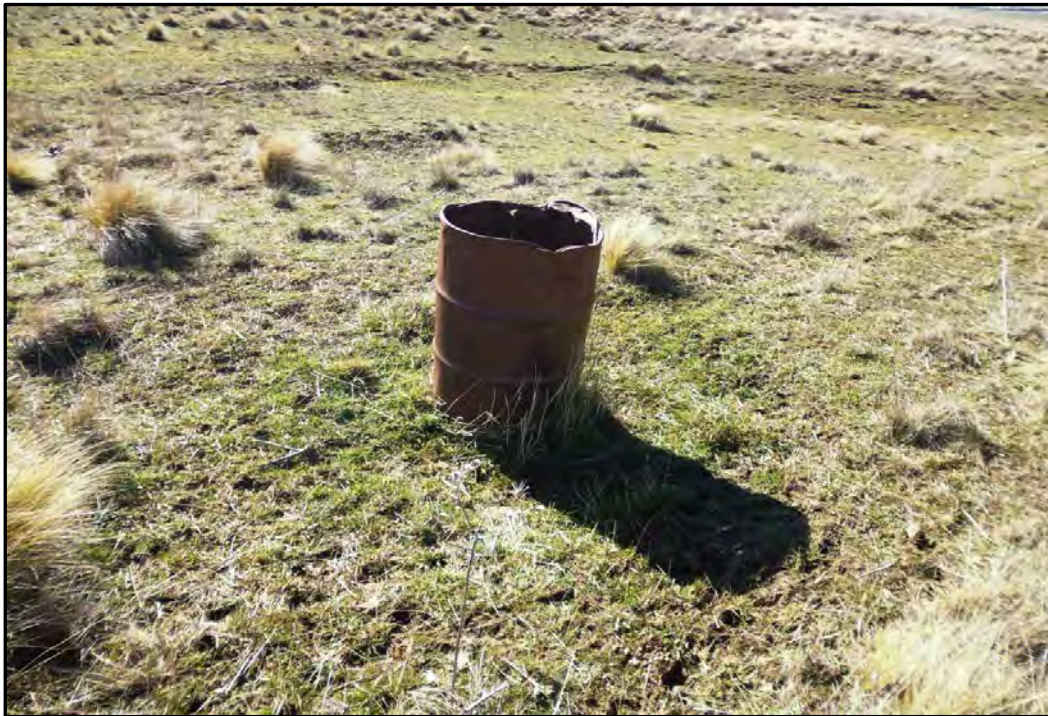
Photo 19: Old empty 200 L drum

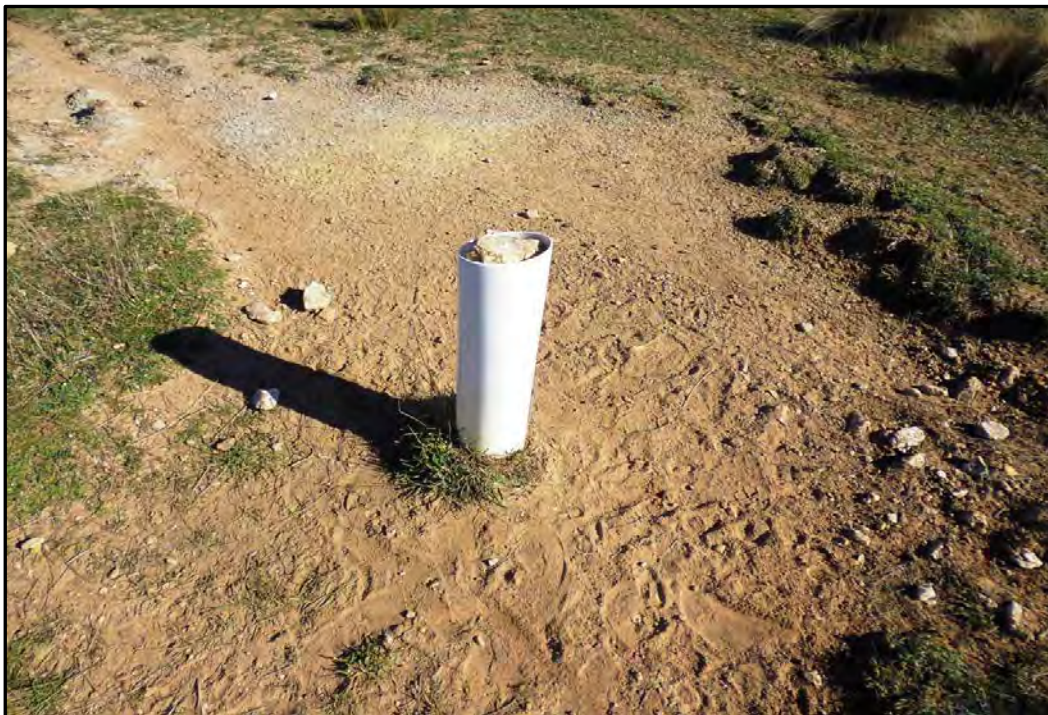
Photo 20: Possible underground water tank or groundwater bore
