Report on  
Preliminary Geotechnical Investigation

Proposed Residential Development  
Lot 1 DP 798111, North Bungendore

Prepared for  
Queanbeyan - Palerang Regional Council

Project 88336.01  
March 2018

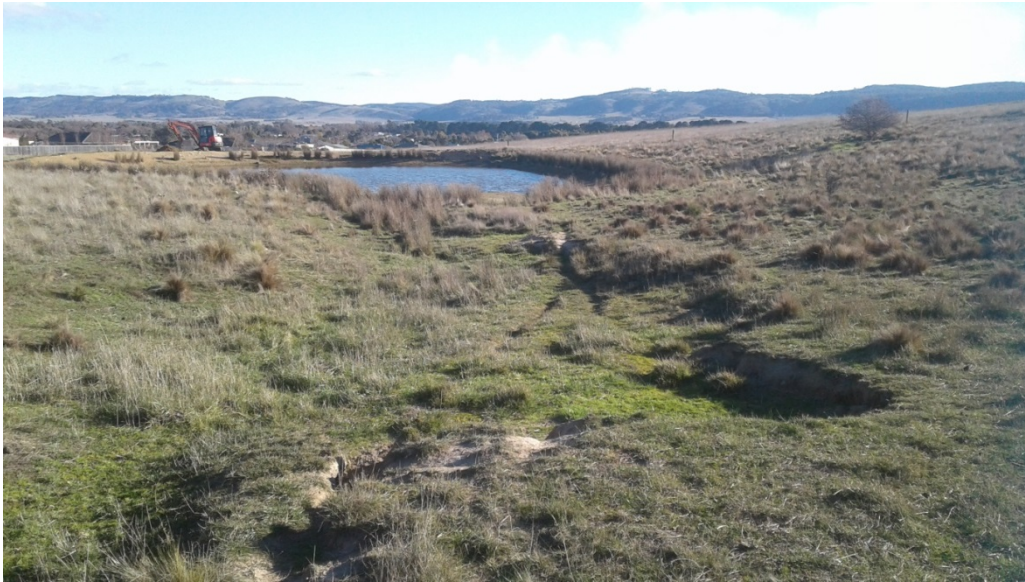
**Figure 1: View south of some erosion evident at the base of an intermittent creek entering one of the farm dams.**

these creeks pass through dams, with some erosion at their location is evident (See Figure 1). A fourth creek line crosses through the site in the north eastern corner.

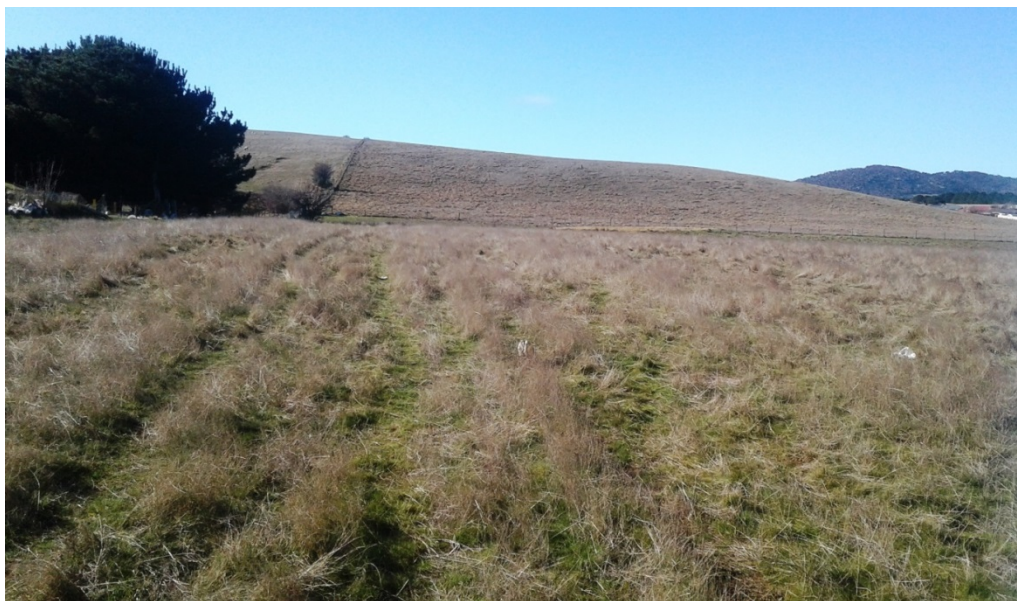
**Figure 2: View east of the north-western corner of the westernmost paddock with a hilltop in the adjacent paddock visible in the background.**

With the exception of the westernmost paddock which is relatively flat, the site comprises a number of hill tops along the northern boundary with wide gullies in between (see Figure 2). A local topographical high point is located immediately to the north of the central portion of the site. The site slopes generally to the south to southwest, and to the west in the western portion of the site, from 750 mAHD to 700 mAHD.
