# Riverside Cemetery

## Condition Assessment

Report to Queanbeyan-Palerang  
Regional Council

May 2026

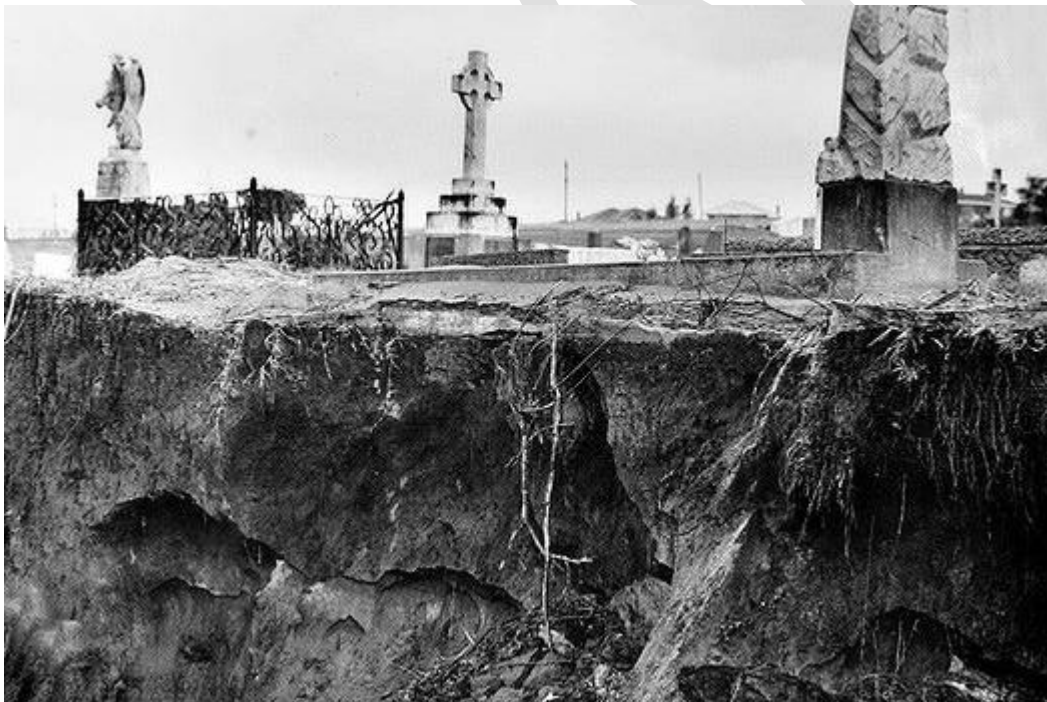
Figure 19: Northern section of Anglican section washed away after floods of 1974, grooves exposed where coffins had once lain (Source: ABC News, 17 July 2017)

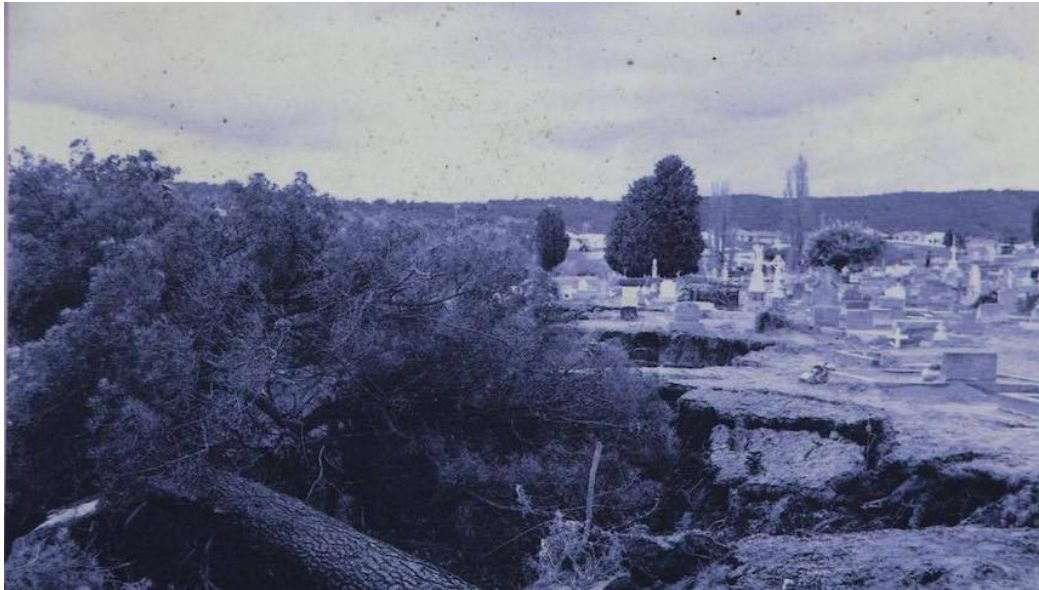
**Figure 20: Damage to Riverside Cemetery after 1974 flood (Source: ABC News, 2017)**

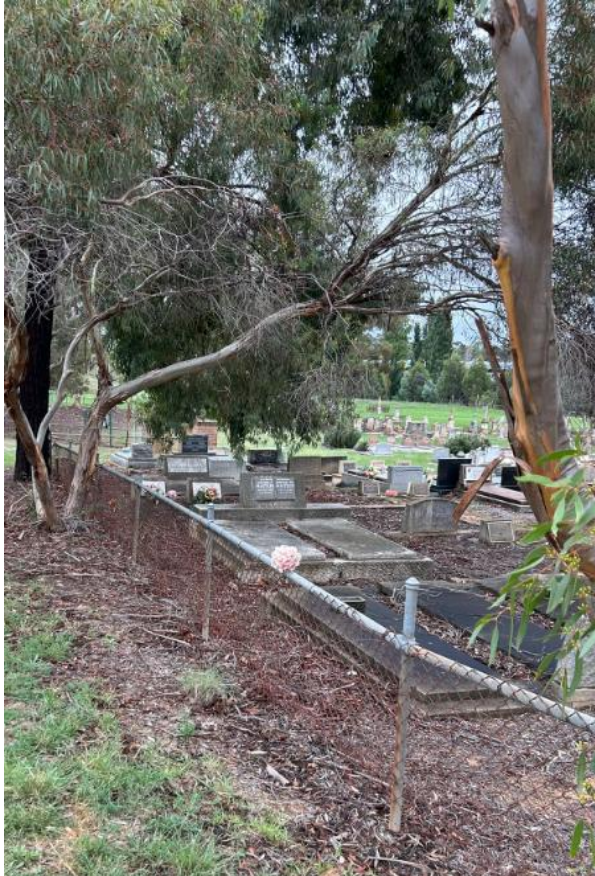
**Figure 30: View of a section of the post and wire perimeter fencing looking into the Anglican section**

There is evidence of corrosion and surface weathering, a loss of protective coatings and slight misalignment in places. The fencing remains legible and largely intact. There are some areas around the perimeter where the lower portion of the wire mesh is misshapen and there are gaps between the mesh and the ground. There is some variability in the condition of the fencing which is likely to be the result of flooding and ground movement, damage from falling branches and general wear and tear.

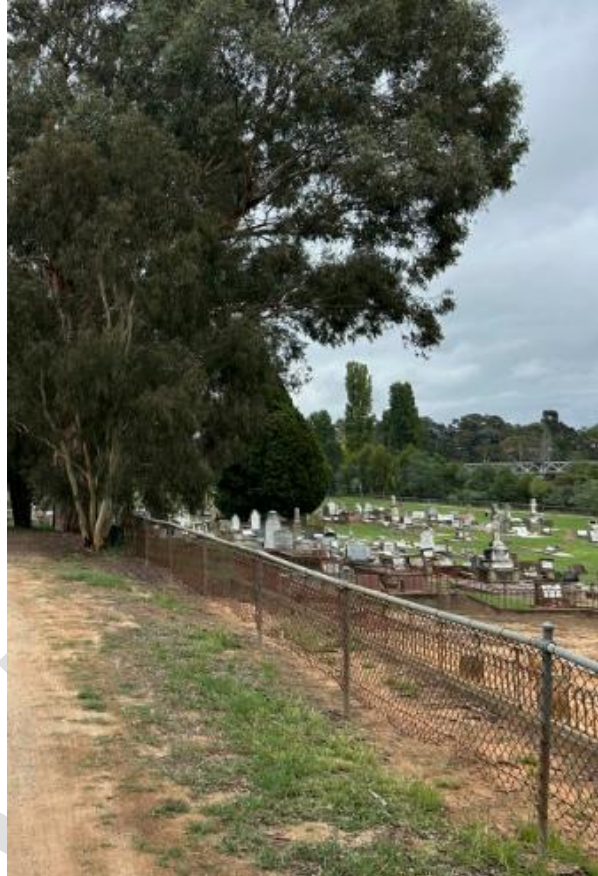
**Figure 31: View of a section of the post and wire perimeter fencing looking into the Catholic section**

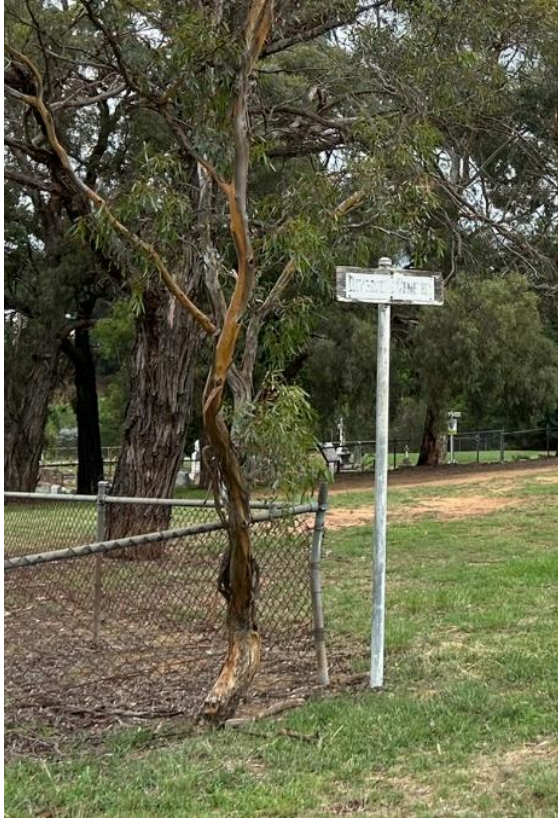
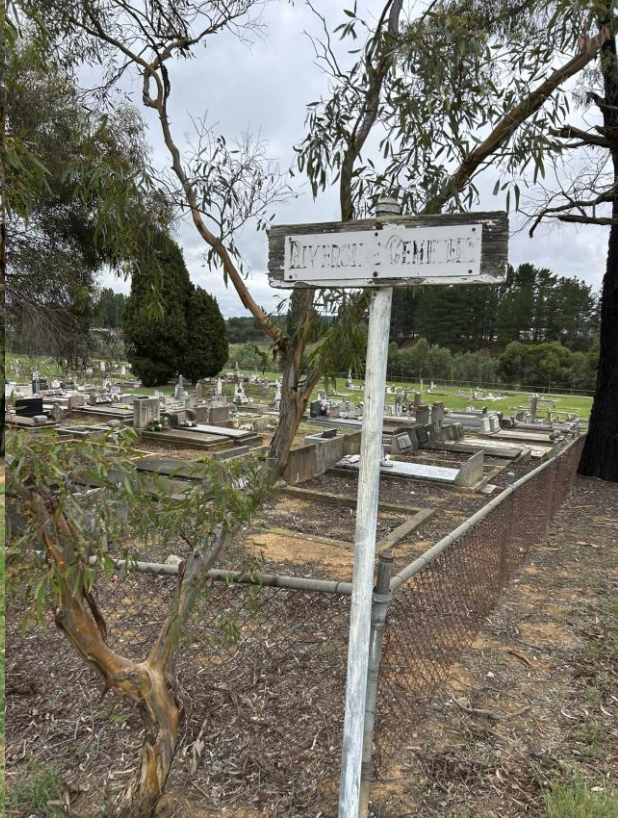
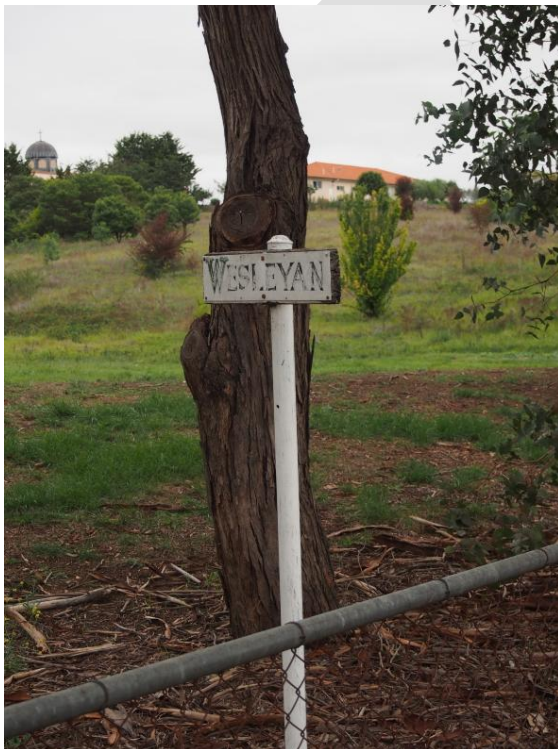
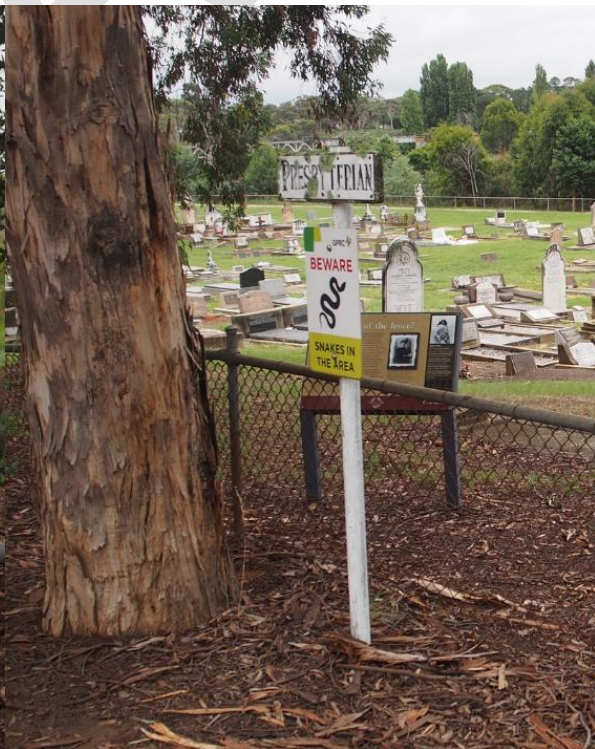
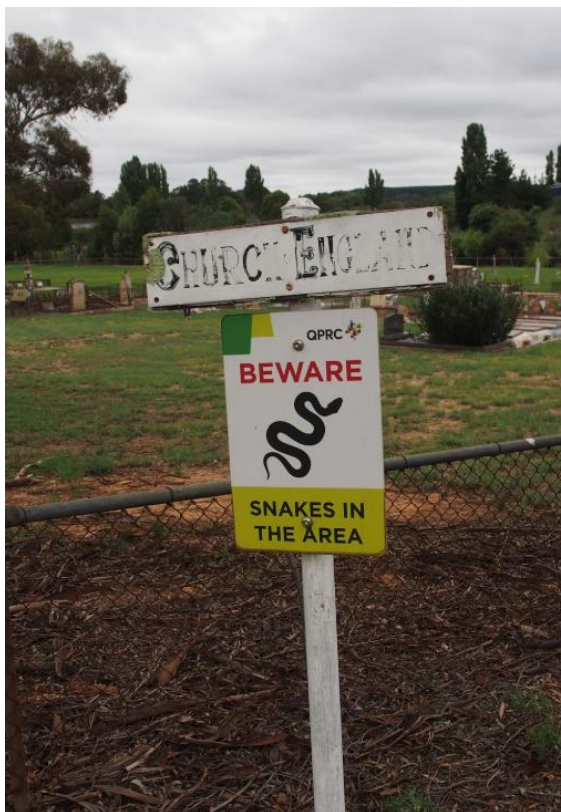
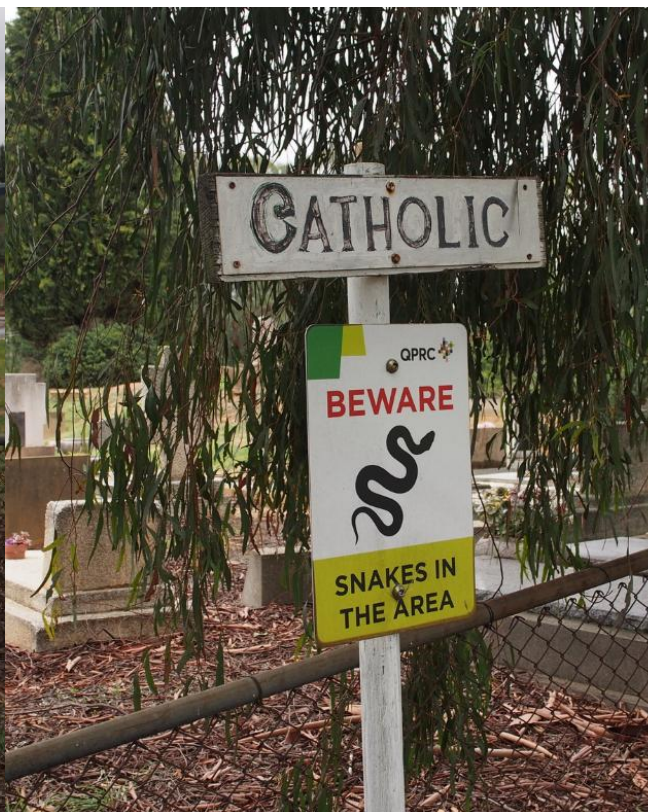
Figure 32: Riverside Cemetery signage

Figure 33: Riverside Cemetery signage

Figure 34: Wesleyan signage

Figure 35: Presbyterian signage

**Figure 36: Church of England signage**

**Figure 37: Catholic signage**

Each sign appears to be painted lettering on tin which is screwed to a timber plank backing, mounted on tall steel posts, which is also painted. The steel posts are in fair condition but require new painting. The timber panel is in poor condition with evidence of biological growth and deterioration. The original white paint is peeling off, and the lettering remains just legible on most signs.

**The overall condition of the denominational section markers is fair to poor.**

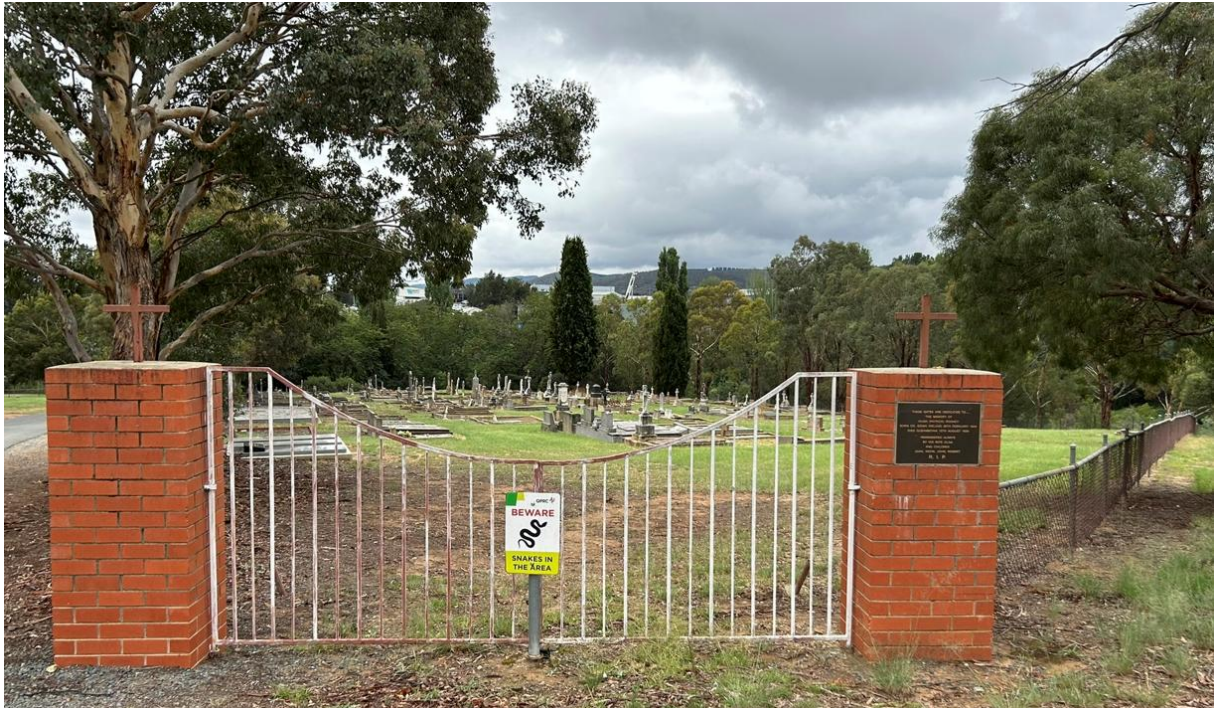
The entrance gates to the Catholic section of the cemetery (Figure 38) consist of a pair of white painted metal swing gates between two brick piers. Each brick pier has a metal cross mounted on top sitting on a slightly domed concrete capping.

The metal gates are a simple vertical bar configuration, painted white. The paint finish is heavily weathered with visible chips, flaking, corrosion which has meant there are areas of exposed metal. The hinges and fixings appear intact and in working order although the Council erected beware of snakes sign indicates that the gates are no longer operational or provide vehicular access.

**Figure 38: Brick piers and white painted metal gates marking the formal entrance to the Catholic section of the cemetery**

The brick piers appear to be structurally sound with some weathering of the mortar, particularly to the top half of the left-hand side pier. The metal crosses on top of each pier are weathered and slightly discoloured but overall in fair condition.

Overall the gates and associated elements are in a fair condition.

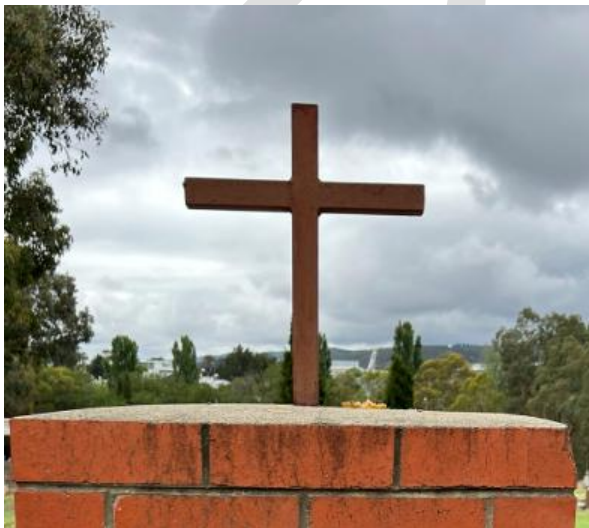
**Figure 39: Close up image of the cross embedded in the top of the piers**

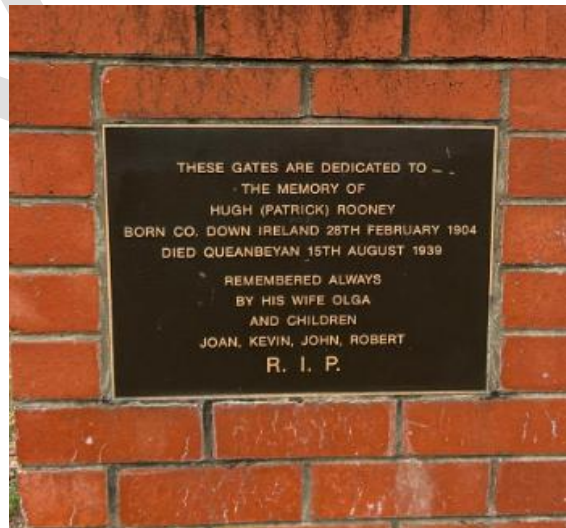
**Figure 40: Plaque attached to the right hand side pier**

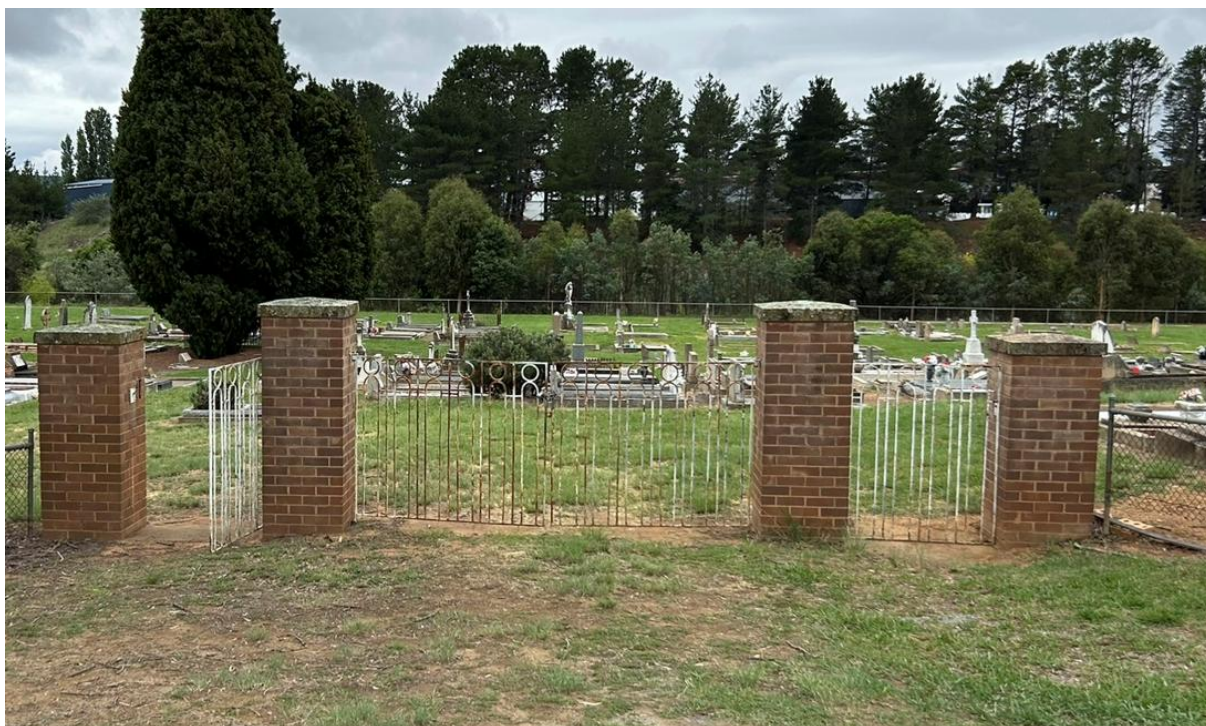
**Figure 41: Formal gate configuration providing access to the Anglican section of the cemetery**

The pedestrian and vehicular gates all display evidence of corrosion particularly along the lower sections. This is likely exacerbated by prolonged exposure to moisture and ground contact. The paint coating the metal is significantly weathered and completely missing in some parts leaving the metal exposed. The hinges appear to be operational.

The brickwork is largely intact with no obvious cracking or structural failure visible. There is evidence of minor weathering and staining and the mortar appears to be in good condition. A concrete cap sits on top of each gate post which is slightly domed. There is evidence of biological growth on all the capping.

**The metal gates are in a poor to fair condition and the brick piers remain in a fair condition.**

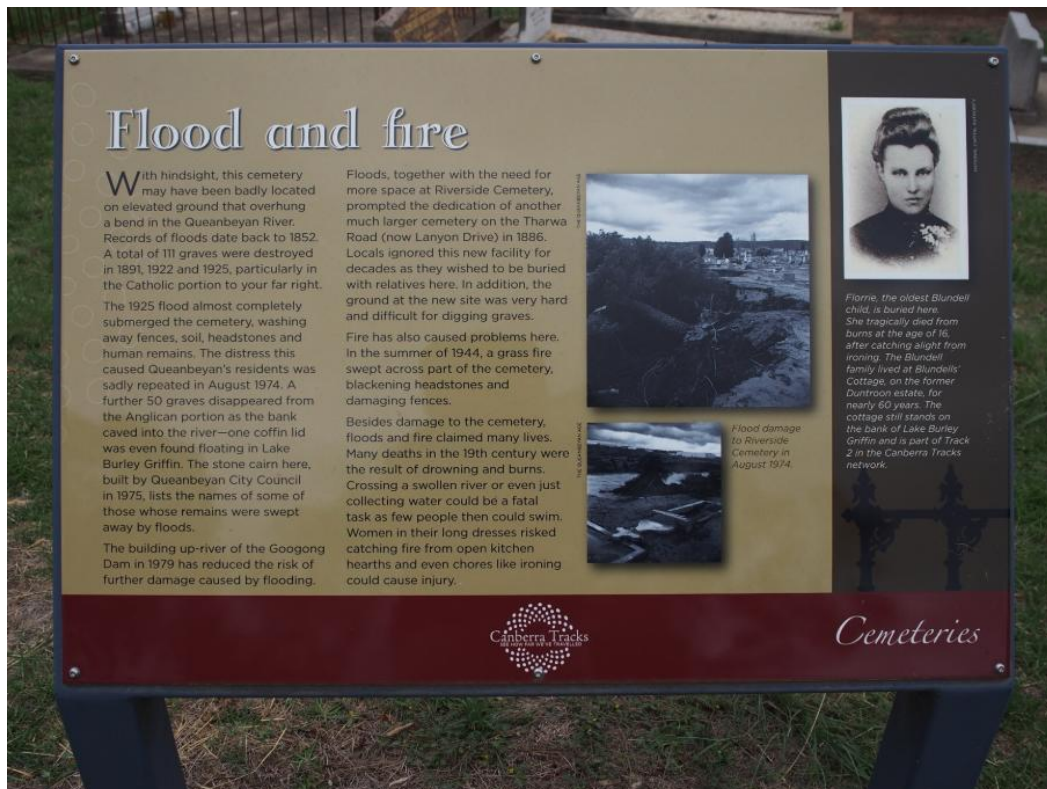
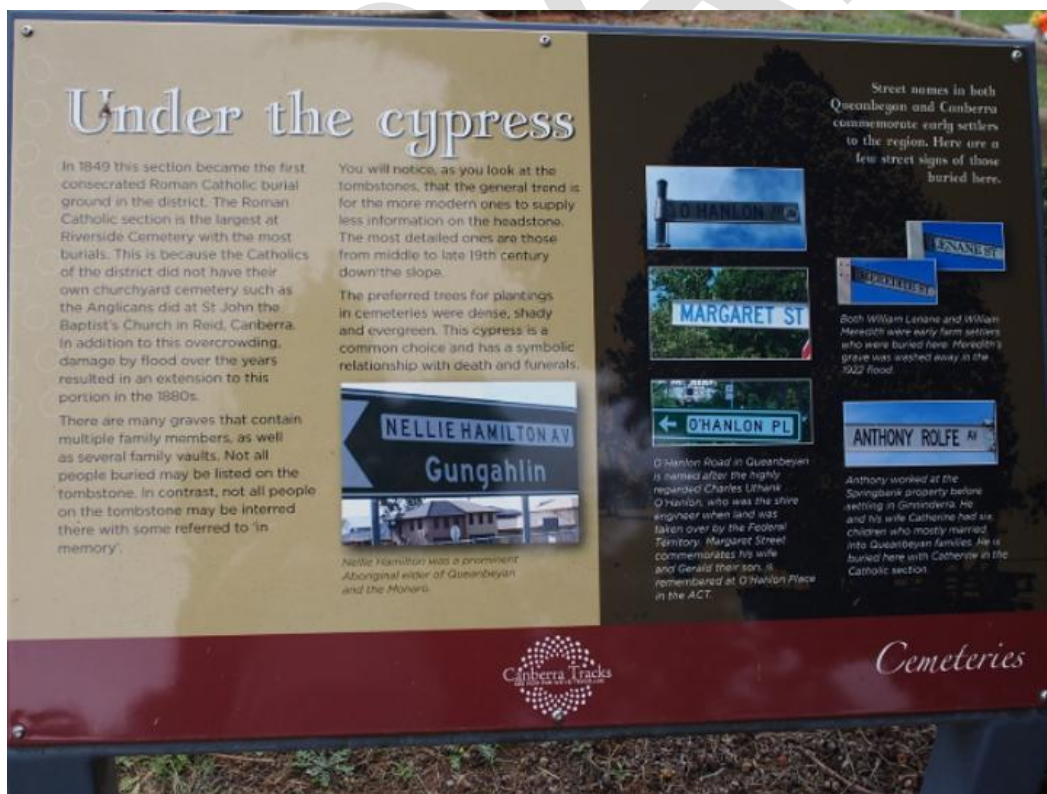
**The contemporary signage is in good condition.**

Figure 42: Contemporary signage providing historical information about the cemetery

Figure 43: A contemporary sign providing historical information about the cemetery

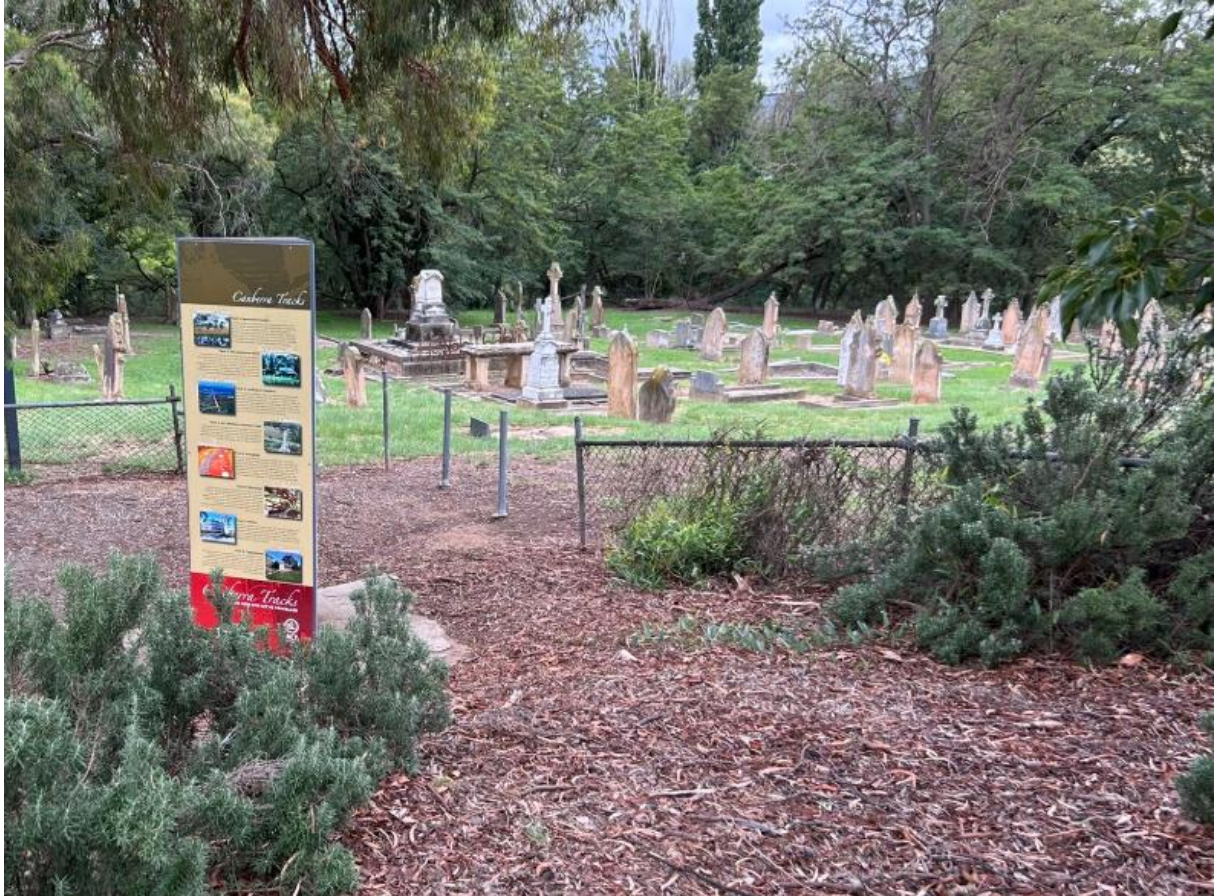
**Figure 44: Pedestrian access into the Catholic section of the cemetery**

In an attempt to prevent unauthorised vehicles entering the cemetery each pedestrian access point has additional steel posts, which act as bollards (Figure 44) or a smaller portion of the fencing construction (Figure 45). At the Presbyterian section there is a gate (Figure 46), which is currently closed and doesn't appear to have been operational for some time.

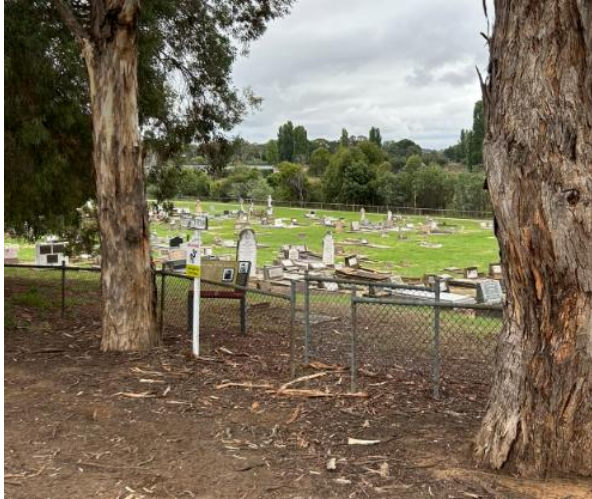
**Figure 45: Pedestrian access to the Presbyterian section of the cemetery**

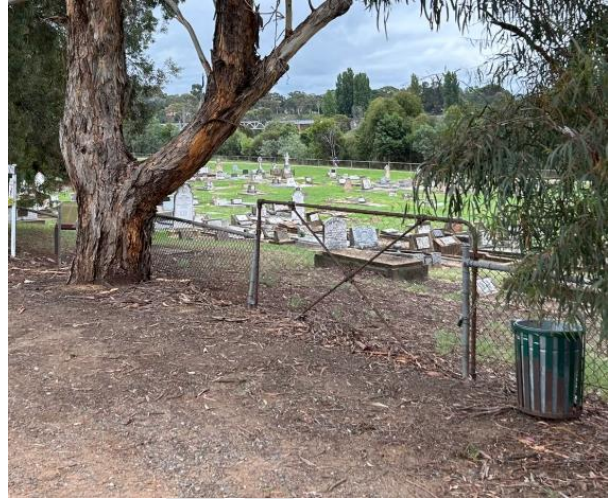
**Figure 46: Locked vehicular gate to the Presbyterian section of the cemetery**

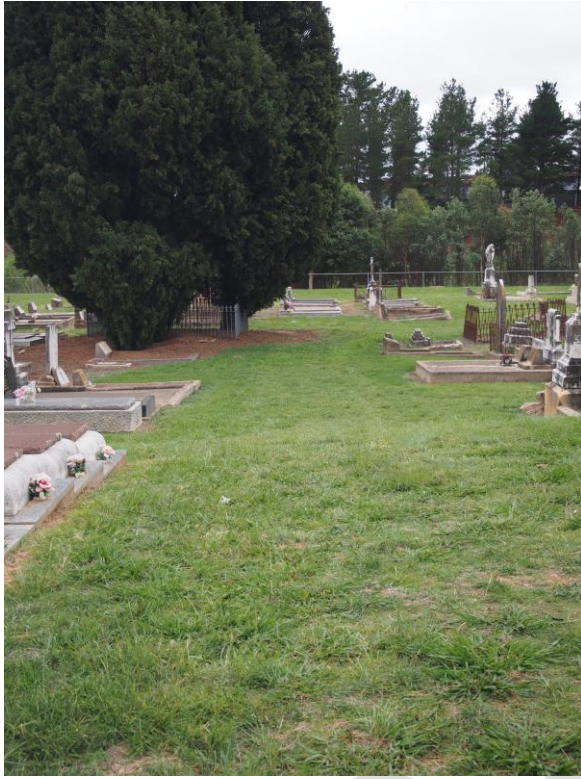
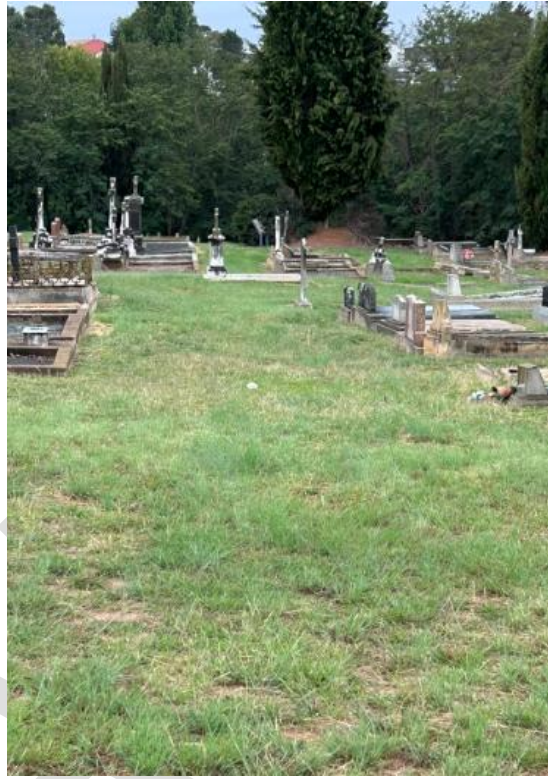
The informal paths through the cemetery are grassed and appear to be well maintained. As can be seen in Figure 49 the paths are not defined but are wider than normal spacing between sections of the cemetery.

**Figure 49: Informal grassed path providing pedestrian access**

**Figure 50: Informal grassed path providing pedestrian access**

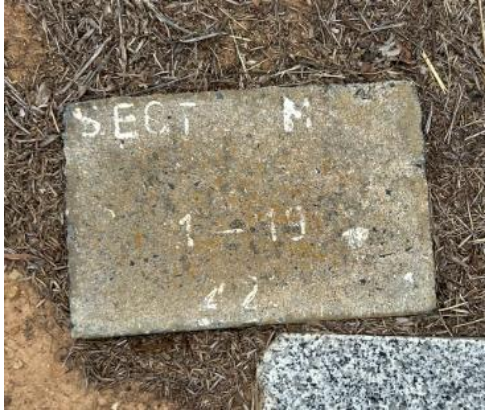
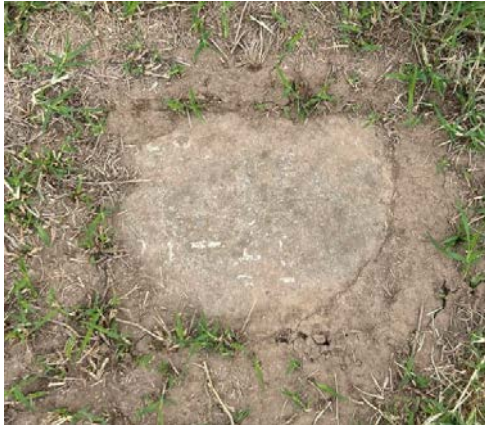
There is evidence of some early markers in the ground (Figure 51). There is evidence of white paint on some of these concrete pavers which appear to be wayfinding signage. These are very weathered and worn and the writing is indecipherable on the majority of the markers.

**Figure 51: Image showing two markers between rows**

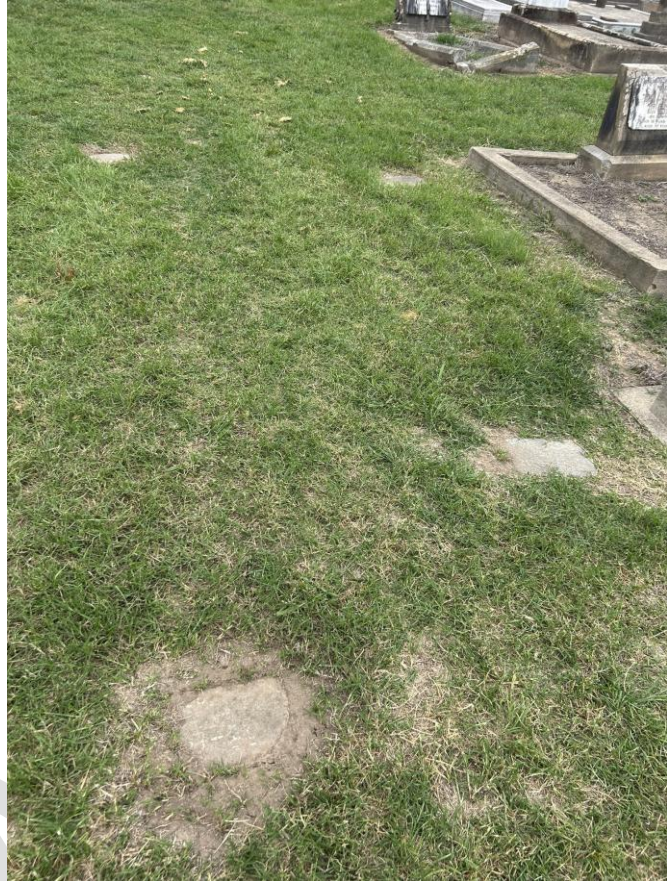
**Figure 52: Section markers between rows within the cemetery**

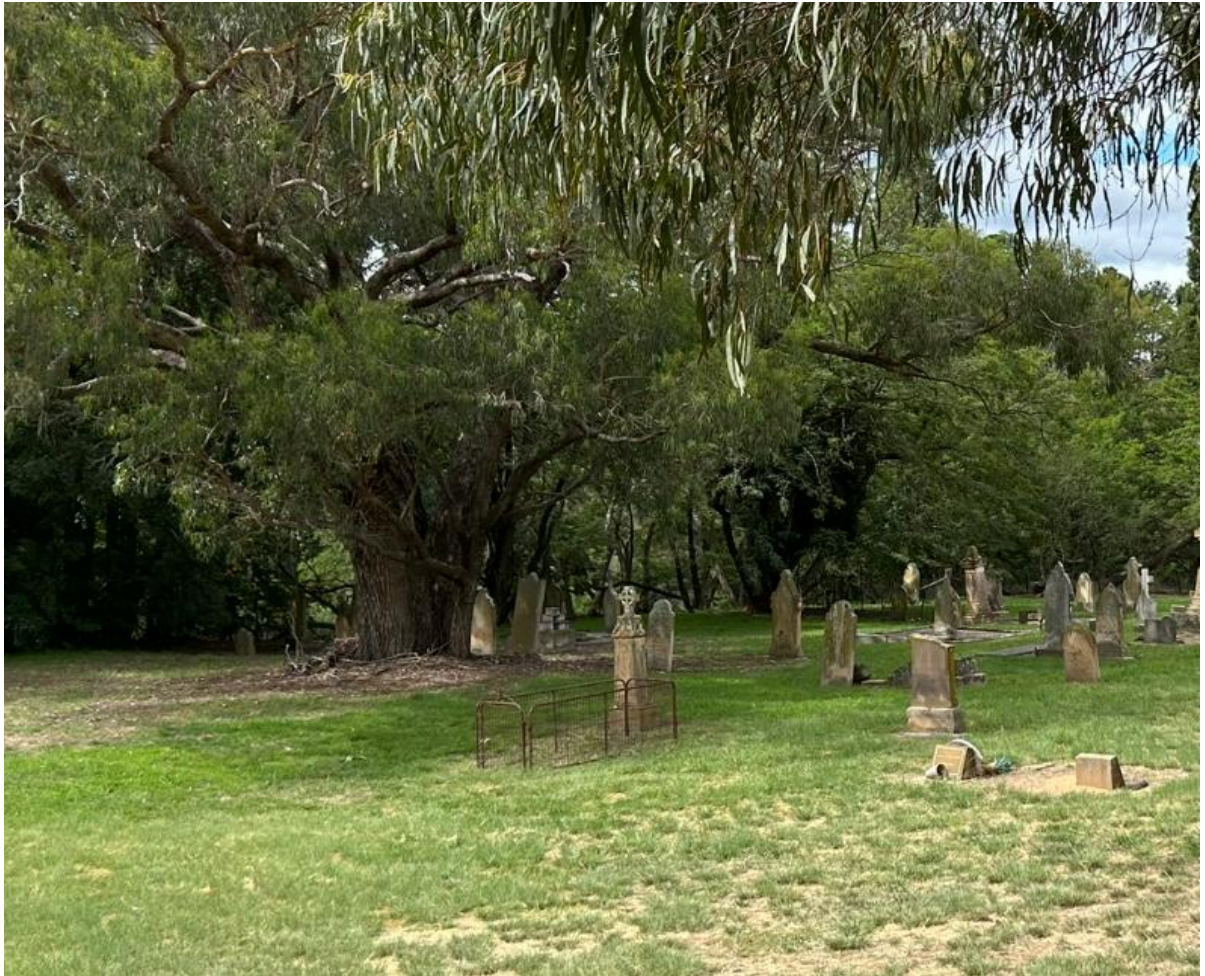
The majority of trees within the cemetery are in the northern corner of the Catholic section. These trees are causing damage to the monuments in this section. The roots are adding to the existing variability of soil in this area, leaf litter and debris is collecting on graves and the area is generally damper than other more exposed sections of the cemetery. The increase in moisture is having an increase impact on the amounts of biological growth, rising damp and salt attack in these areas.

**Figure 53: View across to the Catholic section of the cemetery where there are numerous mature trees and burial sites below them**

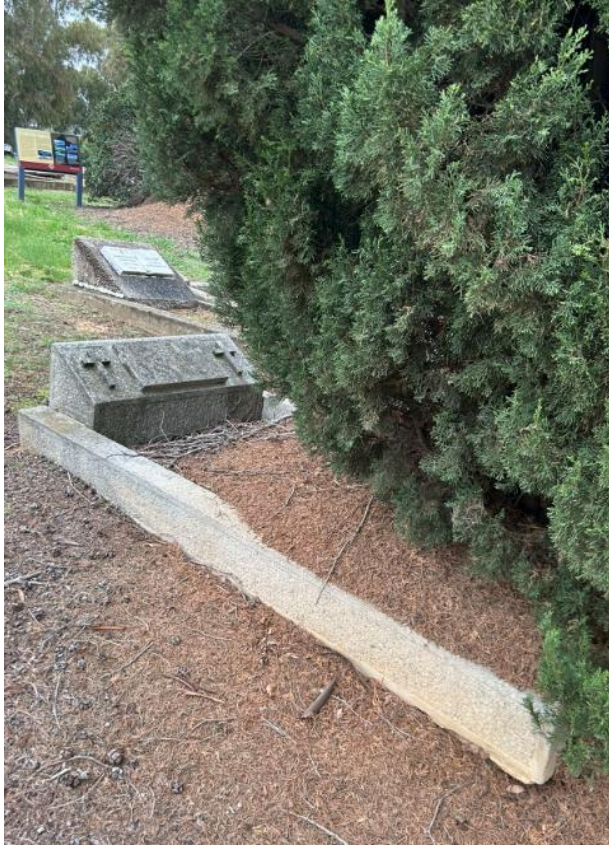
There are a number of burial sites throughout the cemetery where trees and vegetation have been planted in close proximity to, or as part of, the burial site (Figure 54 to Figure 57). In some cases, what is now mature vegetation, is having a detrimental impact on the condition the burial sites.

**Figure 54: Planting within a burial site and leaf litter from the planting on the kerbing**

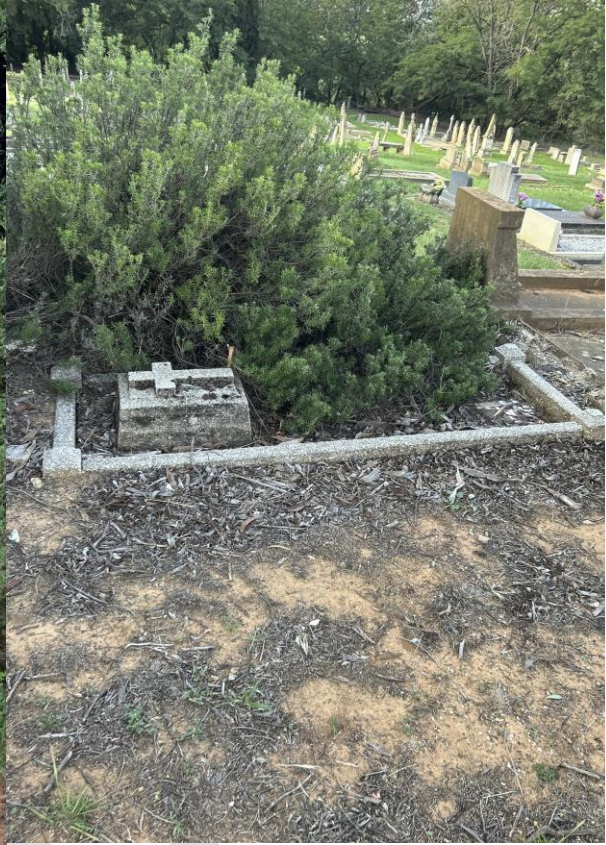
**Figure 55: Planting within a burial site extending across neighbouring plots**

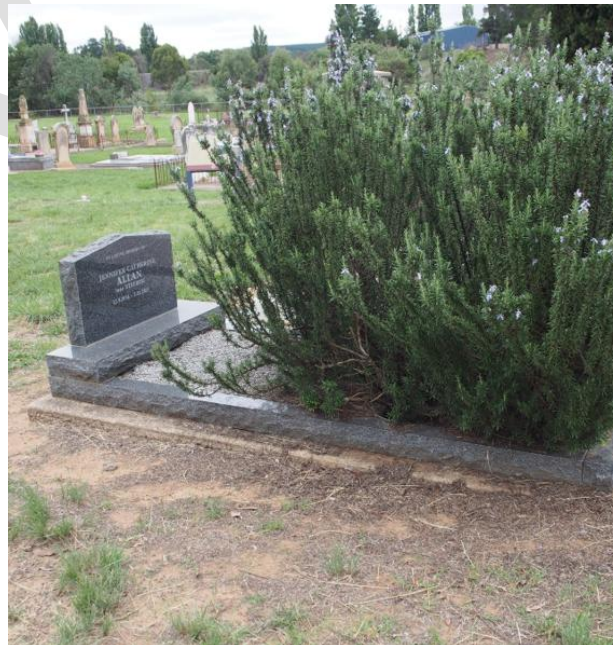
**Figure 57: A large rosemary bush planted within the grave floor**

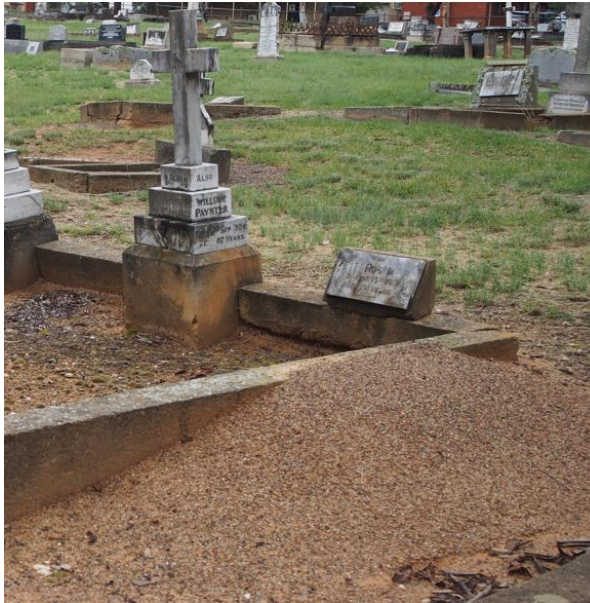
There is also evidence of significant ant mounds around the cemetery, with a heavy build-up of soil against the stone kerbing as shown in Figure 58 and Figure 59.

**Figure 58: An ant mound adjacent to the kerbing of a burial site**

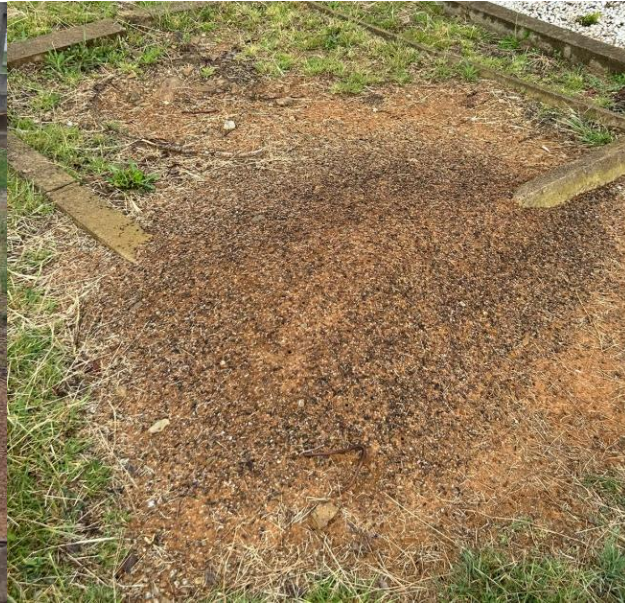
**Figure 59: An ant mound over the kerbing of a burial site**

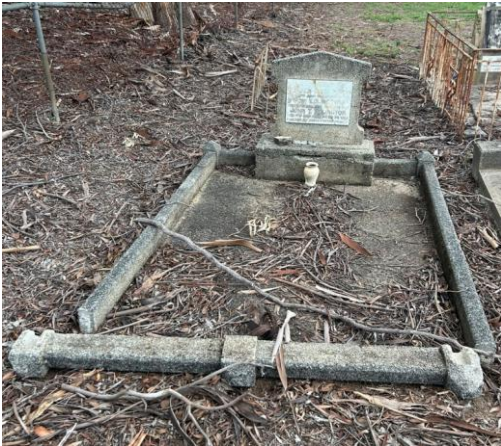
| Photograph | Description | Physical condition | Condition rating |
|---|---|---|---|
| | <p>Concrete/ pebblecrete rendered headstone with a marble plaque sitting on top of a small concrete plinth.</p> <p>Low concrete kerbing surround forming a rectangular grave enclosure.</p> <p>A cement or concrete infill/ ledger sits within the kerbing.</p> | <p>The small headstone is structurally stable but has some cracking to the base. The marble plaque has a crack running through it with a small missing piece to the top. It appears to remain well adhered to the headstone.</p> <p>The inscription has been engraved. There is some evidence of weathering and staining but the inscription remains legible.</p> <p>The ledger appears to have subsided and the kerbing at the foot of the grave is completely dislodged.</p> | Fair |

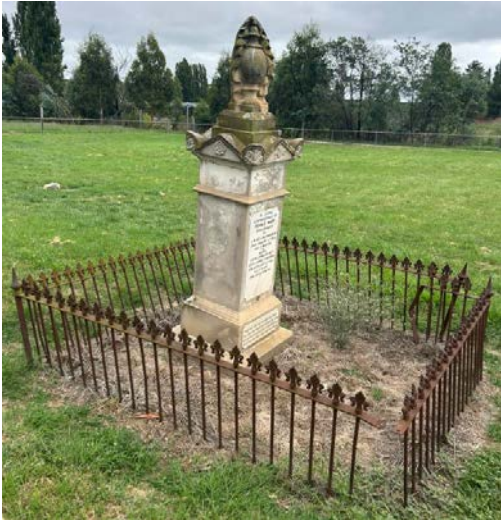
| Photograph | Description | Physical condition | Condition rating |
|---|---|---|---|
| | <p>A sandstone monument with a draped urn sitting on top of a tall decorative plinth with two marble plaques. The monument is surrounded by a palisade styled spear topped iron fence.</p> | <p>The urn monument and plinth are complete but exhibit a lean. There is significant staining to the top of the urn element section, with the plinth moderately leaning. Carved details retain shape and clarity, particularly where there is no staining. The marble plaques are clean and inscriptions are legible.</p> <p>There are some losses to the iron fence, with corners not connecting and portions of the fence lean outwards. The base of the fence is obscured by overgrowth of grasses.</p> | Fair |

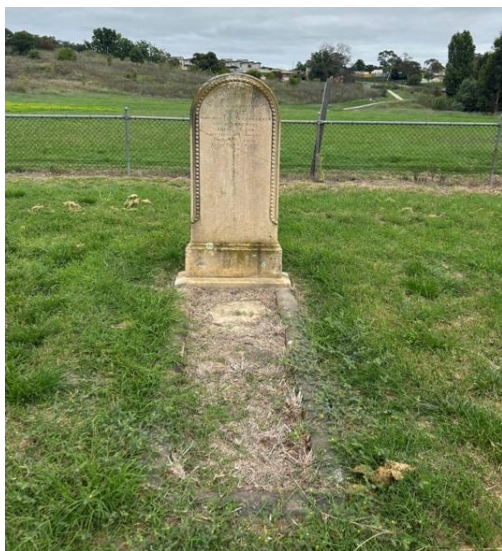
The ledger and kerbing are overgrown with grass but appear to be in good repair and position

Good

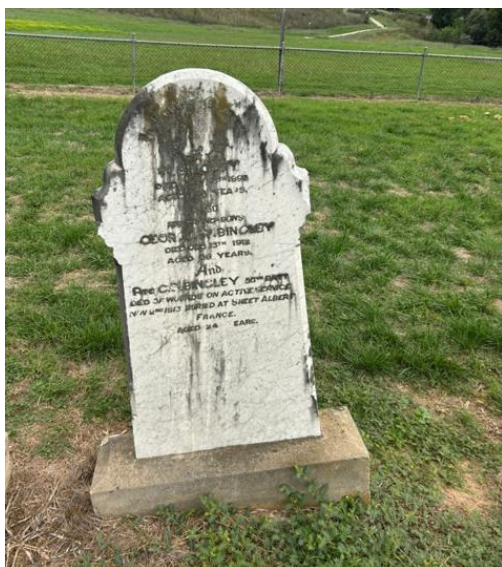
The headstone is structurally stable but leans to the left.

The inscription has been engraved with metal lettering inserted, most likely lead, with minor losses to letters. There is some evidence of weathering and staining but the inscription remains legible.

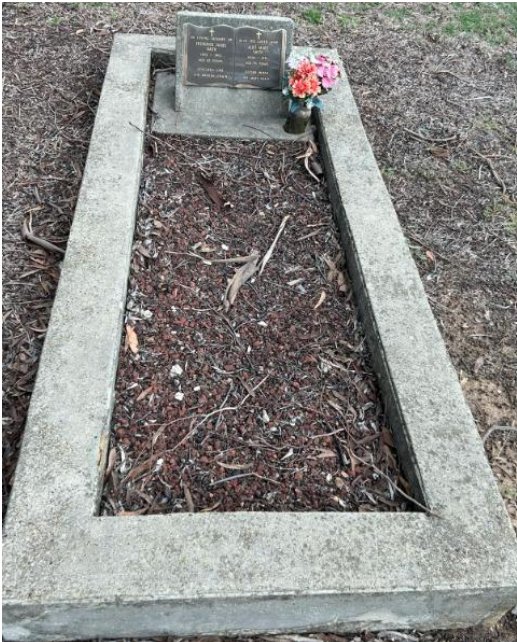
| Photograph | Description | Physical condition | Condition rating |
|---|---|---|---|
| | <p>A small cast concrete headstone with a bronze plaque sitting on a low plinth.</p> <p>Low concrete kerbing surround forming a rectangular single grave enclosure with red-brown gravel fill.</p> | <p>The small headstone is structurally stable and appears complete. The bronze plaque is complete, is clearly legible and appears to remain well adhered to the headstone.</p> <p>The kerbing is complete with no visible losses or damage.</p> | <p>Good</p> |

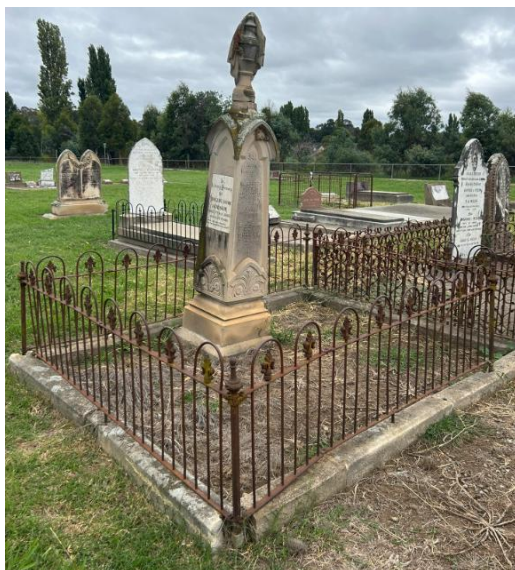
The urn monument and plinth are complete but exhibit a lean. There is significant staining to the top of the urn element section, with the plinth lean by comparison. Carved details retain shape and clarity, particularly where there is no staining. The marble plaques are clean and inscriptions are legible.

Overall: Fair  
Monument: Good  
Fence: Poor

There are some losses to the iron fence, with corners not connecting and portions of the fence lean outwards. The base of the fence is obscured by overgrowth of grasses.

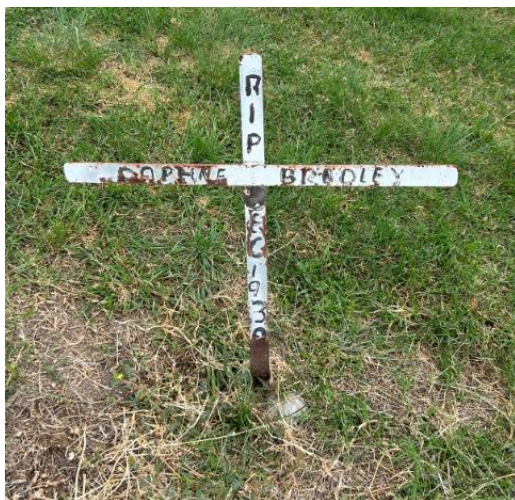
The metal strips show oxidisation where paint losses have occurred, particularly at ground level. The hand painted inscription is mostly legible with the last digit of the date of passing unclear.

Fair

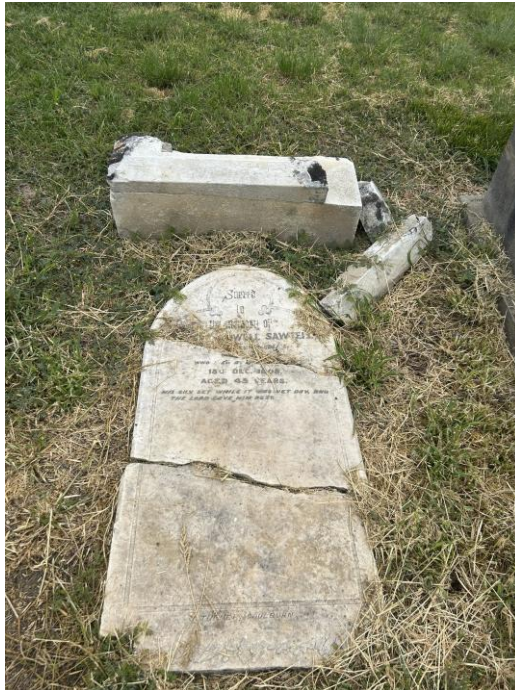
The headstone appears complete but is detached from the plinth and has been lain flat on the ground. It is broken into at least three pieces but the inscription and ornamentation are legible. Portions of the plinth are detached and come away.

Previously failed but does not pose a safety risk due to lying flat on the ground

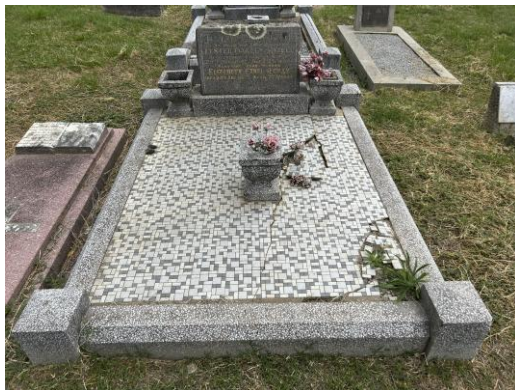
The headstone and kerbing are generally in good condition with some weathering of terrazzo apparent and minor lichen infestation on the headstone. The flower vase to the left of the headstone has cracked on the front edge. The ledger has cracked and appears to have subsided a small amount on the right half, with fractured mosaic surface associated with ledger break. Weeds are growing in cracks in the lower right corner of the ledger, with potential to cause further damage

Tiled ledger: Poor

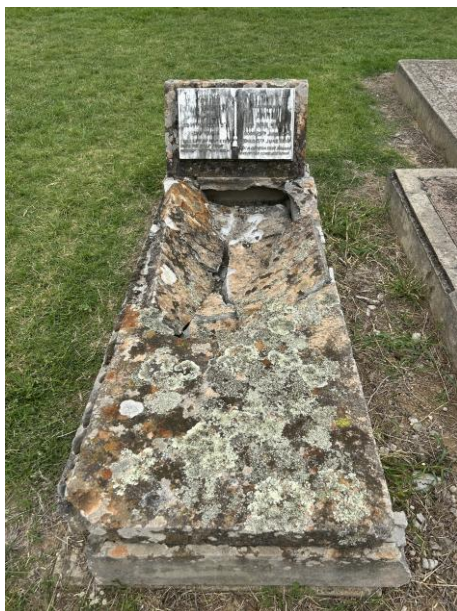
(Anglican Section 4 Row 13)

The marble plaque shows black biological growth but the inscription is legible. Sandstone components are densely colonised by lichens. Portions of the stone kerbing have broken away and are missing. The stone ledger is broken and approximately half has collapsed into the grave.

Overall: Poor  
Headstone: Fair  
Kerbing: Poor  
Ledger: Failed

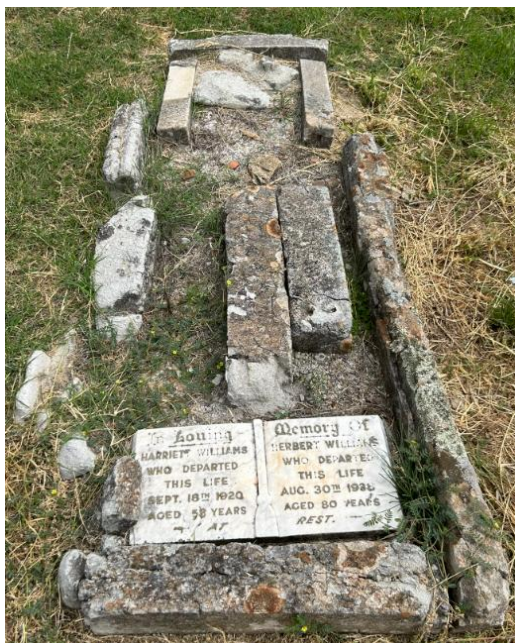
The original form of the monument is no longer legible as the stone sections have suffered extensive dislocations, breakage and some losses. Lichens have colonised sections of the monument. What appears to have been a composition of posts and plinth which may have been a headstone has collapsed and is no longer legible in its form relative to the rest of the grave. The marble plaque is detached and there is no apparent evidence of where it had been affixed. The lead lettering inscription is legible, with some losses to lead lettering.

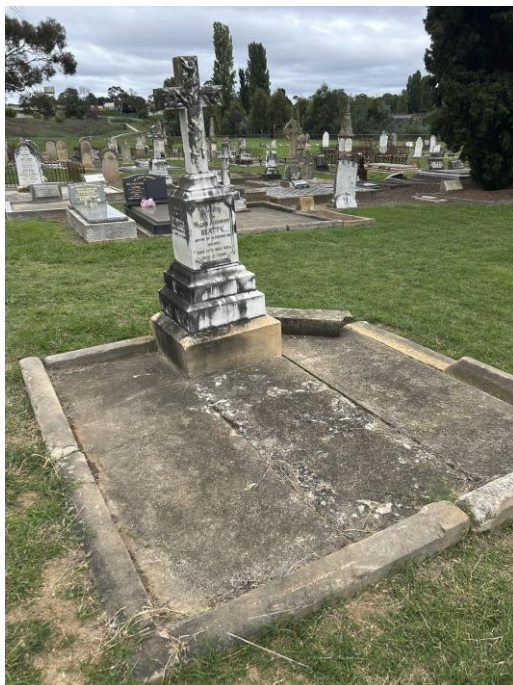
(Anglican section 4 Row 12)

White marble exhibits extensive black biological growth with particularly heavy staining on the cross faces and the southern side of the marble monument, where partial losses of inscription legibility have occurred.

The downhill section of the stone kerbing is broken approximately in half with the portion at the foot of the grave leaning away from the ledger and the portion at the head of the grave completely dislodged. One portion of the kerbing that flanks the monument plinth is broken and is completely dislodged from the kerb, lying loose on top of the ledger and clay soil infill is spilling out from under the ledger.
