# Riverside Cemetery

## Condition Assessment

Report to Queanbeyan-Palerang  
Regional Council

May 2026

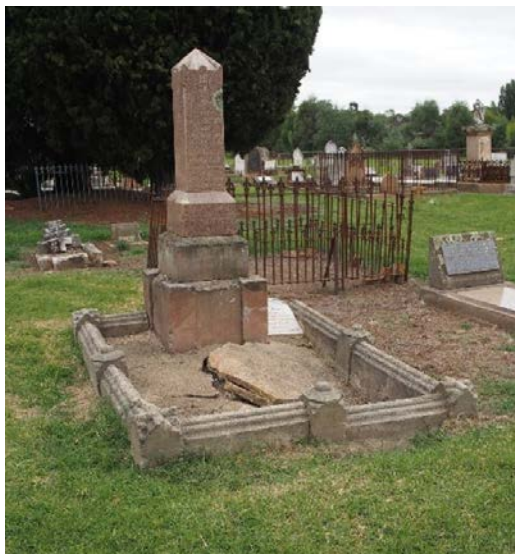
The infill ledger is broken and a significant portion has subsided. A portion of the kerbing at the foot end of the grave has subsided and shows evidence of repair but kerbing generally remains in place.

Kerbing: Fair

Infill/ledger:  
Failed/unsafe

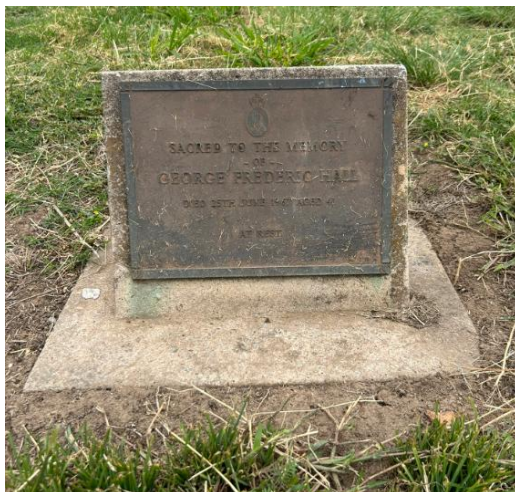
The concrete shows minor weathering but appears complete and sound. The bronze plaque is oxidised but is legible

Good

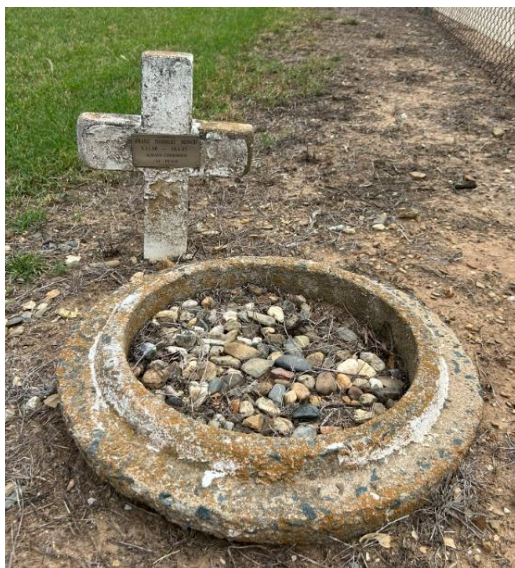
(Anglican Section 3 Row 19)

The concrete of the cross and kerbing ring show weathering but appear sound. Both show staining. Paint on the cross is discoloured and flaking. The kerbing ring appears to have been painted but most paint has weathered away with small remnants in place.

Good

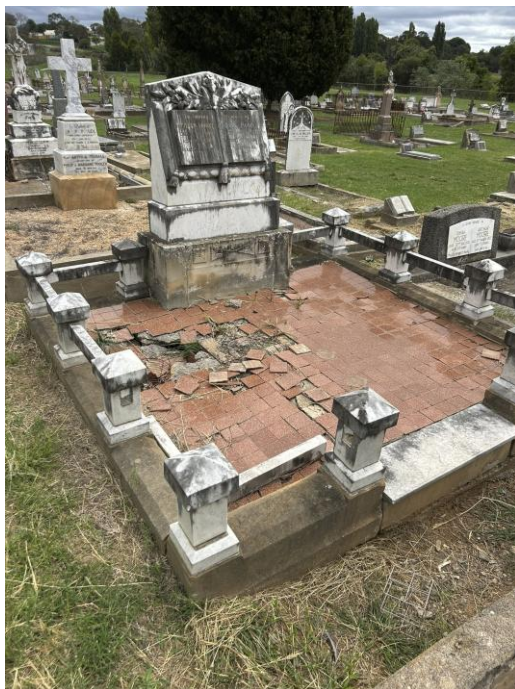
The headstone is complete and fixings to the plinth appear solid. The marble is generally clean on vertical surfaces but there is heavy black biological staining to the "book face" inscription panel. Smaller areas of staining occur around the marble plinth and fence elements.

The infill/ledger has broken and subsided, with loose and broken tiles resulting. There is a cavity beneath the ledger where soil has subsided and weeds are growing in areas exposed by cracking

Fence: Fair

Ledger: Failed/unsafe

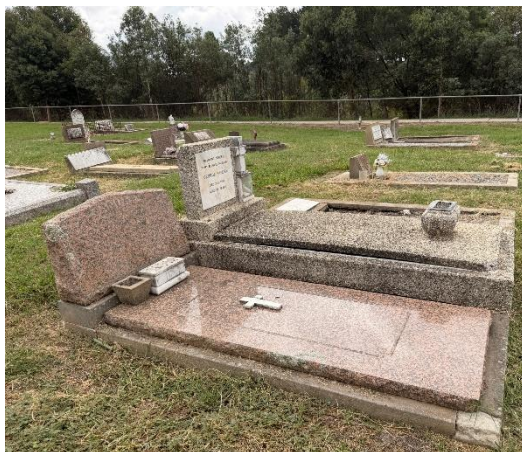
There is minor lichen growth on the granite headstone and ledger and black biological staining to white marble decorative elements. The left foot kerbing corner shows some minor weathering.

All visible monument elements are all in alignment and good repair.

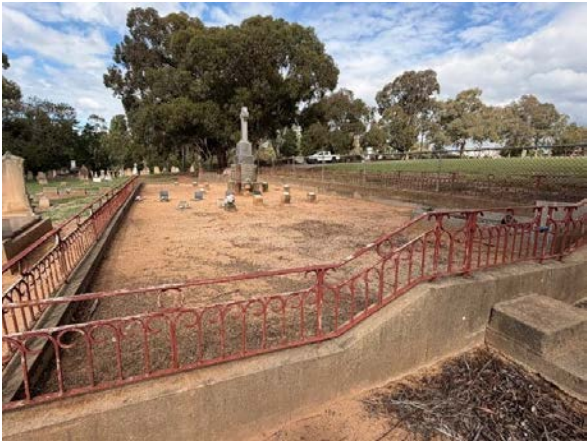
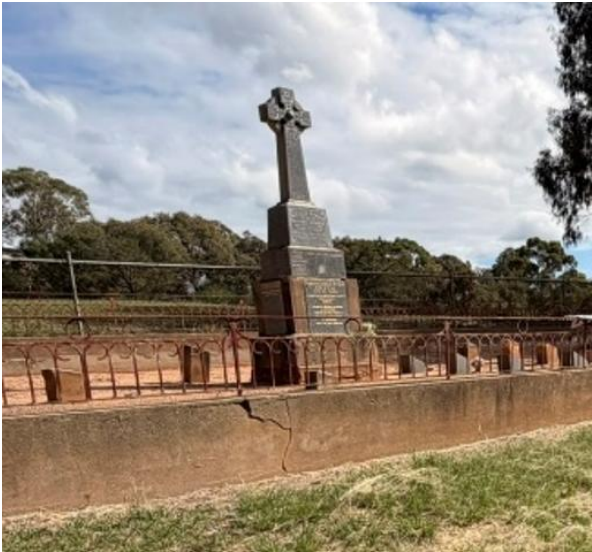
| Photograph | Description | Physical condition | Condition rating |
|---|---|---|---|
| | <p>A fenced rectangular family plot at the southern boundary of the Presbyterian section. The plot has been levelled and enclosed with concrete or rendered brick retaining wall topped with a low wrought iron fence previously painted.</p> <p>There is a tall black granite monument in the centre of the plot that is a large Celtic style cross on a tall concrete or rendered brick plinth, with granite plaques with inscriptions on all sides of the plinth.</p> <p>There is one individual grave plot demarcated with grey granite in the south-western corner of the plot and approximately 20 small plinths within the enclosure</p> | <p>The monument and individual headstones are in good repair, with legible inscriptions.</p> <p>The wrought-iron fence has either been painted white and has rusted through paint that has not been maintained, or has been painted a red oxide colour over earlier white paint</p> <p>The retaining wall shows cracking in the approximate middle of the northern side, but this does not appear to be resulting in subsidence or collapse.</p> | Good |

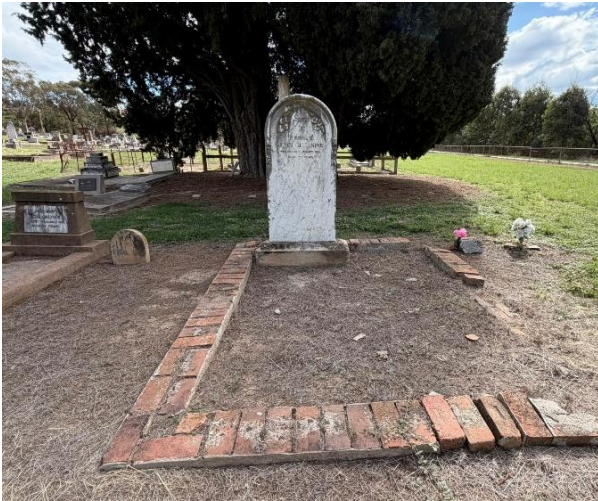
| Photograph | Description | Physical condition | Condition rating |
|---|---|---|---|
| | <p>A white marble headstone with simple semicircular arched top and floral carved detail. The headstone sits on top of a small bevelled sandstone plinth towards the left half of a grave enclosure.</p> <p>A single row of red brick kerbing surround forms a rectangular double grave enclosure.</p> <p>There does not appear to be any infill or ledger.</p> | <p>The headstone is upright and appears well affixed to the plinth. Dark biological growth on upper sections of the marble has caused staining. There is minor wear to the top of the headstone, and some losses of lead lettering.</p> <p>The stone plinth is complete and in good repair with some biological staining.</p> <p>Brick kerbing condition is variable. Bricks are complete and in position along the left edge with complete mortar. Head and foot sides of the grave are generally complete with losses to mortar and loose or missing bricks towards the north (right side). The right side is in poor repair with partial brick kerbing remaining in place at the head end, subsided, loose or missing bricks for the remainder of the perimeter kerb. Some bricks show evidence of past rendered finish, with small remnants in place</p> | <p>Overall: Fair</p> <p>Headstone: Good</p> <p>Kerbing: Poor to fair</p> |

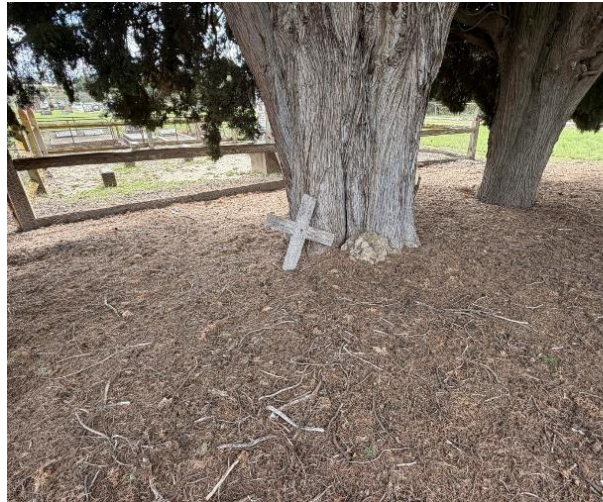
| Photograph | Description | Physical condition | Condition rating |
|---|---|---|---|
| | <p>A small plain wooden cross leaning against a tree trunk</p> | <p>The wooden cross shows extensive weathering and any inscription it may have carried has been weathered to illegibility. The cross is not affixed to any other grave marker or monument and there is no indication that it relates to a grave at this location.</p> | <p>Poor.</p> <p>The wooden grave marker has failed but does not pose a safety risk.</p> |

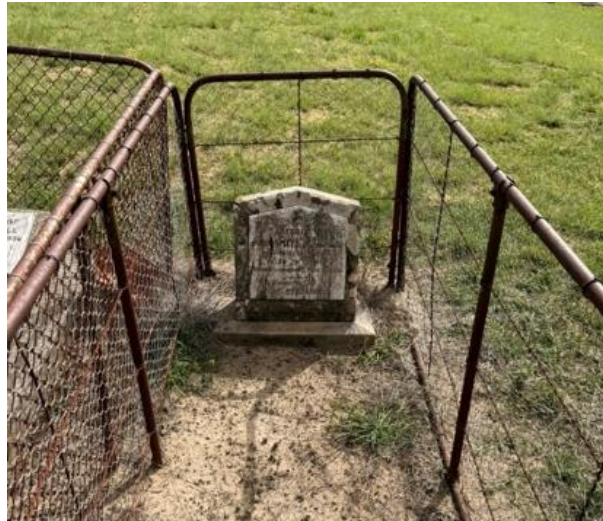
| Photograph | Description | Physical condition | Condition rating |
|---|---|---|---|
| | <p>A small sandstone headstone with a white marble plaque on a small low plinth.</p> <p>A fence of tubular steel and chicken wire forms an enclosure around a single grave.</p> | <p>There is significant staining from biological growth to the monument and plaque, with losses of inscription legibility.</p> <p>The headstone is upright and appears well attached to its plinth.</p> <p>The tubular steel and rod frame of the fence enclosure is complete and appears sound but is stained with oxidation. Chicken wire infill is in good repair.</p> | |

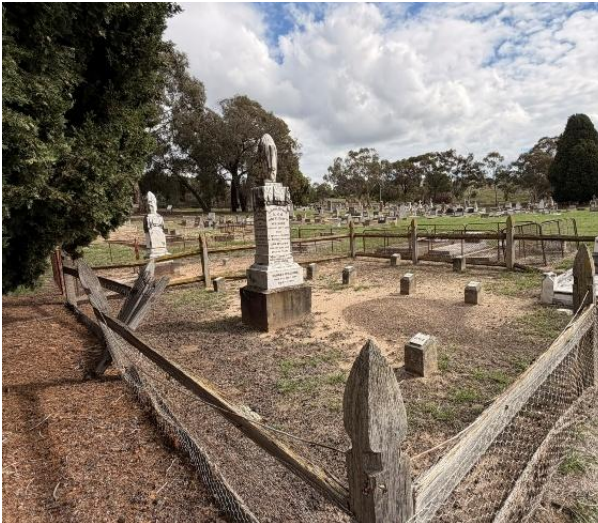
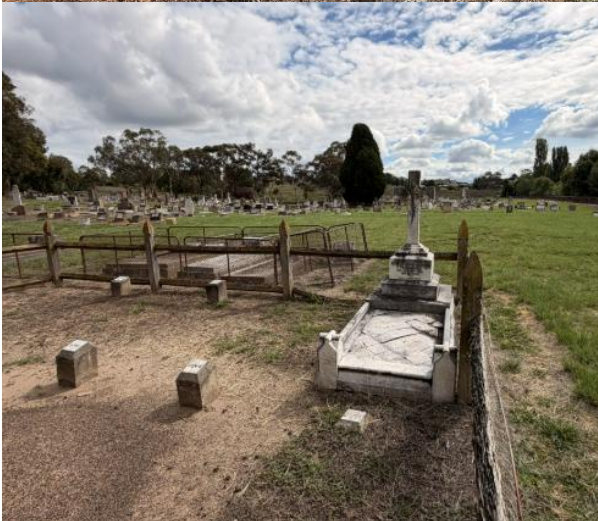
| Photograph | Description | Physical condition | Condition rating |
|---|---|---|---|
| | <p>A large fenced square family plot in close proximity to a mature cypress tree, containing a variety of grave marker types. The plot is enclosed with a timber post and rail fence with chicken wire fencing.</p> <p>There is a white marble monument with a draped urn sitting on top of a tall decorative draped plinth inscriptions on all four sides. The monument sits on top of a stone or rendered brick plinth. The monument is surrounded by a timber spear shaped post and rail fence with a picket type gate in the eastern side of the enclosure.</p> <p>There is one individual grave plot with a tall white marble cross with floral motif on top of a white marble plinth with inscriptions. White marble kerbing forms a grave enclosure within the family plot. A ledger of unknown composition is topped with square white marble tiles in a diagonal grid pattern.</p> <p>There are 9 small plain stone or concrete plinths with white marble plaques arranged in rows within the grave enclosure.</p> | <p>The family monument is upright and appears well mounted to its plinth. There is dark biological staining to the upper sections of the monument, particularly the draped decorative elements. There is minor wear and chipping of plinth and monument edges. Monument inscriptions are clear and legible.</p> <p>Small individual monuments are upright and in good repair.</p> <p>Timber fence is weathered and the timber shows splitting and biological growth on top surfaces of some sections. Most fence posts are upright and in place, with falling posts adjacent to the gate, which is collapsing. Most fence rails are in place, with a few dislodged. Chicken wire appears sound but sags in places where timber fence is sagging or loose.</p> <p>The enclosure is generally free of vegetation, with some grassed patches.</p> <p>There is a large anthill within the enclosure.</p> | <p>Overall: Fair</p> <p>Urn on plinth monument: Good</p> <p>Marble grave with cross: Fair</p> <p>Fence: Poor</p> <p>Gate: Failed</p> |

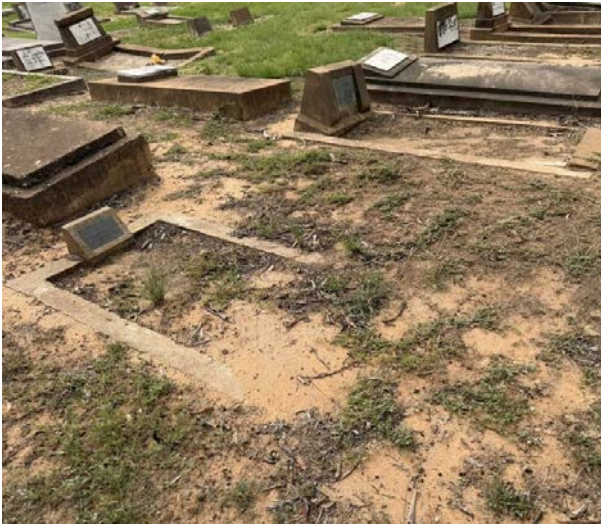
| Photograph | Description | Physical condition | Condition rating |
|---|---|---|---|
| | <p>A small plain cast concrete plinth with bronze plaque.</p> <p>Concrete kerbing with no infill or ledger forms a single rectangular grave enclosure.</p> | <p>The plinth is complete, in good repair. It appears well attached to kerbing and the plaque is legible and appears well attached to the plinth.</p> <p>The head end half of the kerbing is in good order with no visible breaks or cracks. There is minor weathering to both plinth and kerbing.</p> <p>Approximately half of the grave at the foot end is buried in soil that appears to have been eroded and washed down in stormwater runoff.</p> | <p>Visible sections:<br/>Good</p> <p>Buried sections:<br/>unknown condition of fabric, requires removal of soil deposits</p> |

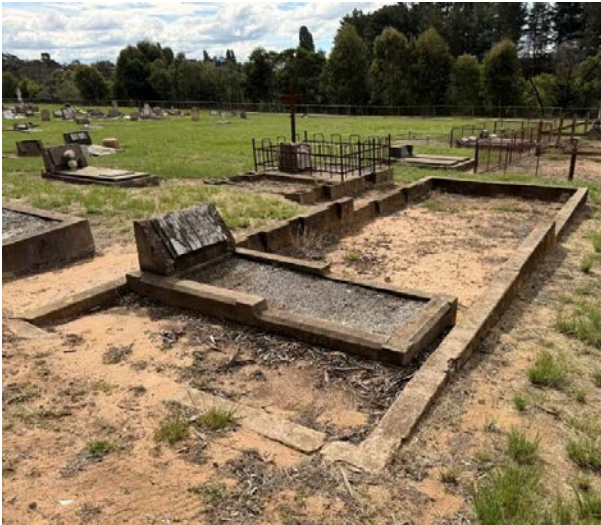
| Photograph | Description | Physical condition | Condition rating |
|---|---|---|---|
| | <p>A large plot to accommodate 7-8 single graves enclosed by a low split- level kerb of rendered brick with niches in kerb at head end.</p> | <p>The plinth and plaque show staining from biological growth and some minor weathering. The single grave is complete, with some staining and weathering but no visible breakages or losses.</p> | Fair |
| | <p>The enclosure contains one low plinth of sandstone or cast concrete with a white marble plaque in the form of an open book. The remainder of the plot is bare earth and does not contain any other monuments.</p> | <p>The enclosure kerbing is cracked and broken in several places, with minor losses of render in the vicinity of the single grave.</p> | |
| | <p>There is one bronze plaque on kerbing at the head end at the northern-most end of the plot.</p> | <p>The bronze plaque is complete and appears well attached to the top of the kerbing.</p> | |
| | <p>A low concrete or rendered brick bevelled kerb encloses a single grave plot with gravel infill. It is not apparent whether a ledger is present under gravel infill.</p> | <p>It cannot be determined if the remainder of the individual plots remain vacant or if burials have occurred and monuments or plaques have been lost.</p> | |

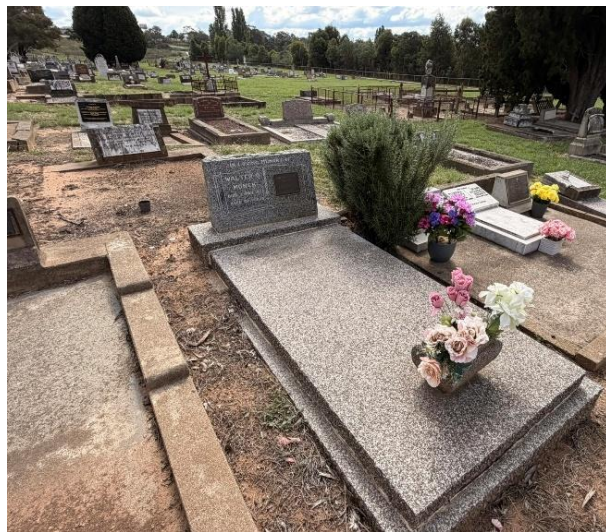
| Photograph | Description | Physical condition | Condition rating |
|---|---|---|---|
| | <p>A small simple headstone of grey granite with a bronze plaque mounted on a low rectangular plinth.</p> <p>Low granite kerbing is topped with a plain granite ledger and a fluted rectangular granite flower urn.</p> | <p>All elements of the monument are in alignment and appear securely attached together.</p> <p>There is some deterioration of white sealant at the foot end of the joint between the kerbing and the ledger.</p> | Good |

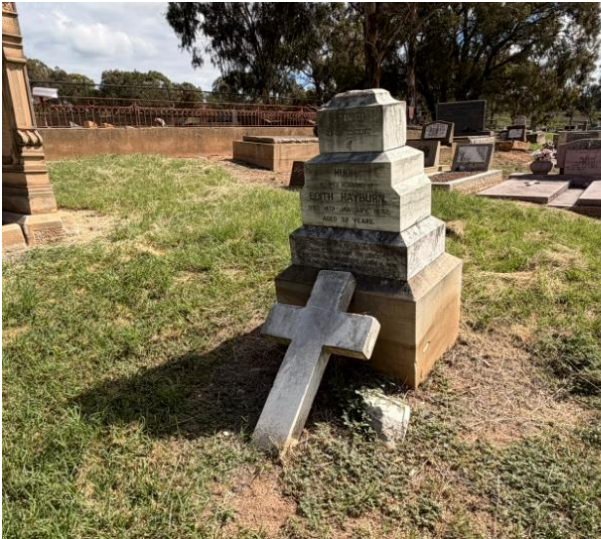
| Photograph | Description | Physical condition | Condition rating |
|---|---|---|---|
| | <p>A white marble monument comprising a plain cross, tiered square plinth in 3 sections mounted on a square sandstone plinth. The plinth is inscribed on one side. The grave plot is grassed plot with no kerbing or ledger.</p> <p>There is a stone fragment on the grave that appears unrelated to the monument.</p> | <p>The cross is detached from the plinth but is complete and has been placed on the ground leaning against the plinth. The cross shows scratching, some weathering and biological staining.</p> <p>The marble plinth shows biological staining but is in good repair and alignment. There is some minor spalling of the sandstone plinth.</p> | <p>Overall: Fair</p> <p>Individual elements of monument: Good</p> <p>Connection between cross and plinth: Failed.</p> |

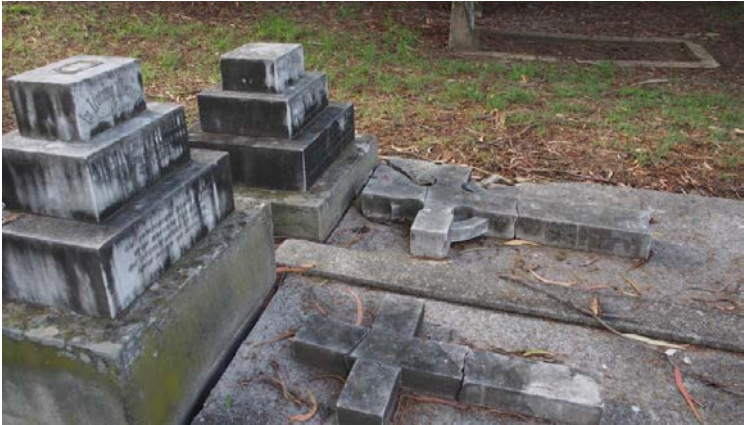
| Photograph | Description | Physical condition | Condition rating |
|---|---|---|---|
| | <p>A pair of white marble monuments in the form of crosses on rectangular plinths of 3 stacked rectangular marble blocks with face inscriptions on all three blocks, sitting on top of concrete or rendered brick rectangular plinths.</p> <p>Terrazzo or coarse concrete kerbing forms the grave plots which have terrazzo or coarse grain concrete ledgers.</p> | <p>Both crosses have been broken at the base, detached and broken. The broken pieces have been lain on top of the ledgers, arranging the pieces in cross alignment. The remnant pieces of the plain cross from the grave on the left are complete, there are losses to the cross from the grave on the right.</p> <p>Marble plinths have extensive dark biological staining. Lead inset lettering is complete and legible.</p> <p>There is some weathering and biological staining to the concrete plinths, kerbing and ledgers, with minor lichen growth. The ledger of the grave on the right is cracked along the outer (right) edge towards the head end, with some losses.</p> | <p>Overall: Fair</p> <p>Crosses: Poor</p> <p>Plinths: Good</p> <p>Kerbing and ledger (left): Good</p> <p>Kerbing and ledger (right): Fair</p> |

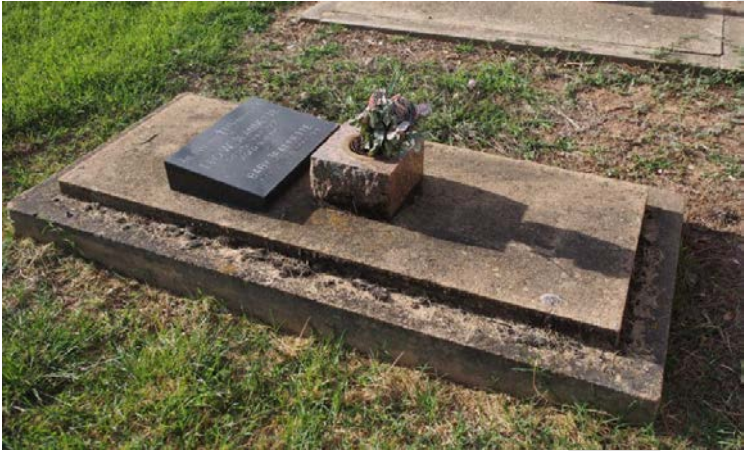
| Photograph | Description | Physical condition | Condition rating |
|---|---|---|---|
| | <p>A black granite plaque with carved inscription on top of a concrete slab ledger mounted on concrete or rendered brick kerbing. The plaque is accompanied by a square red granite flower vase with brass insert.</p> | <p>Concrete ledger and kerbing are colonised by mosses, lichens and exhibit dark biological staining. There is some minor chipping of the kerbing edge.</p> <p>Monument components are well aligned and appear firmly affixed to one another. The inscription is clear and legible.</p> | <p>Good</p> |

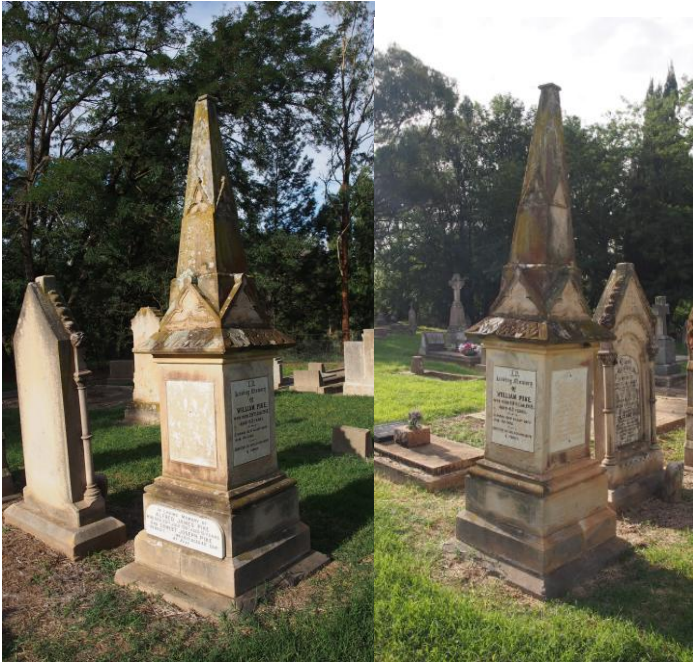
| Photograph | Description | Physical condition | Condition rating |
|---|---|---|---|
| | <p>A tall sandstone monument in the form of a steeple sitting on a tall square sandstone plinth with white marble plaques on four sides. An additional marble plaque is affixed to the western face of the bottom plinth</p> | <p>The monument is upright with a slight lean. All sections of the monument appear securely joined together.</p> <p>Carved ornaments are clear and legible, with some wear to upper elements. There is significant staining from biological growths on the steeple element and lower plinth to a lesser degree. Inscriptions are clear and legible.</p> | <p>Good</p> |

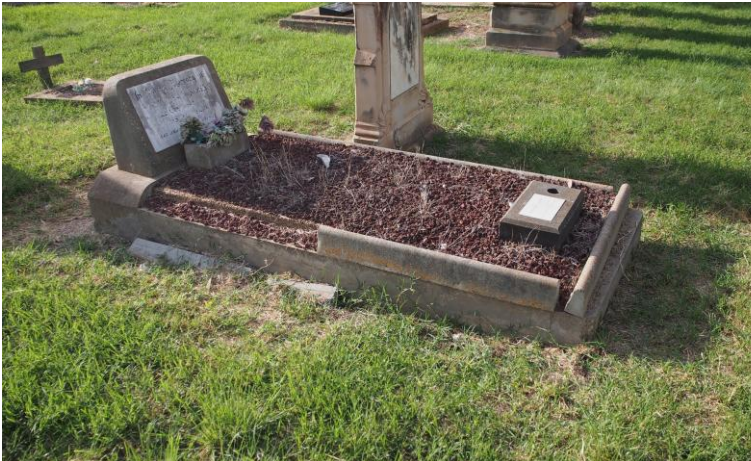
| Photograph | Description | Physical condition | Condition rating |
|---|---|---|---|
| | <p>A low, plain terrazzo or concrete headstone with a white marble plaque sitting on a plinth the width of the grave.</p> <p>Concrete kerbing with bullnose top forms the grave plot. A concrete slab ledger is topped with red-brown gravel.</p> <p>A plain rectangular concrete flower box is located at the head end of the grave.</p> <p>An additional low plinth with a metal plaque with the name of an additional deceased and small round hold is located at the foot end of the grave.</p> | <p>The headstone and plinth are complete and show minor weathering and biological staining.</p> <p>Kerbing is cracked in places, with a portion detached and fallen from the left side of the grave with pieces lying adjacent to the grave. The kerbing at the foot end is slightly dislodged.</p> <p>The secondary plaque is complete and the inscription is clearly legible.</p> | |

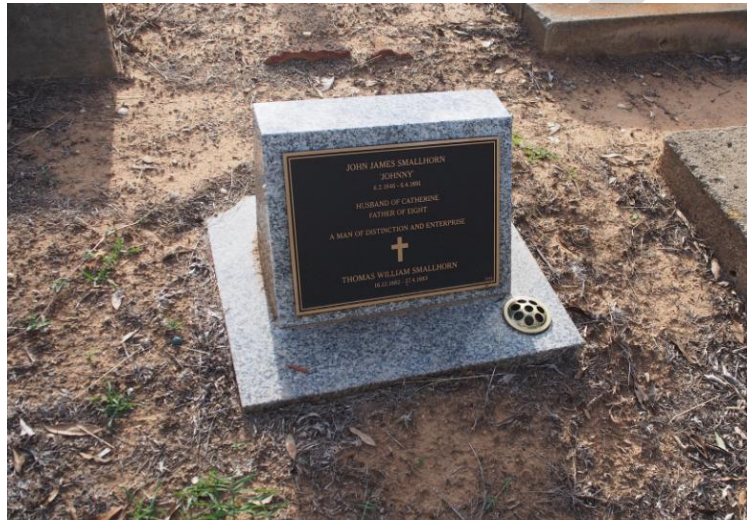
| Photograph | Description | Physical condition | Condition rating |
|---|---|---|---|
| | <p>A small granite monument on a low plinth with a brass or bronze plaque and small brass inset for flowers.</p> | <p>The monument is complete and there is no damage apparent above ground level. The plaque and flower holder appear well attached and are clean and legible</p> <p>Both monument and plaque are clear of biological staining.</p> | Good |

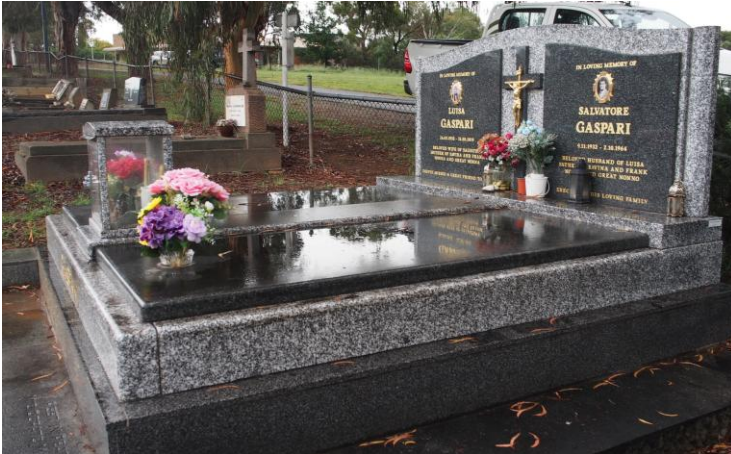
| Photograph | Description | Physical condition | Condition rating |
|---|---|---|---|
| | <p>A tall grey granite monument on a double plinth of grey and black granite, with black granite cross, plaques and ledgers.</p> <p>High grey granite kerbing forms a well-defined double grave plot and black granite ledgers close the top of the graves.</p> <p>The black granite cross is embellished with a gold crucifix, the name plaques have gilt-framed portraits of the deceased. There is a grey granite and glass opening case containing candles and religious figurines. There is a flower insert in the foot of each side of the grave.</p> <p>The entire grave is surrounded by a black granite apron.</p> | <p>There is no damage apparent to any of the elements of the monument, with all embellishments and glazed elements intact. There is staining likely from biological growth on the flat surfaces of the ledger.</p> | <p>Good</p> |

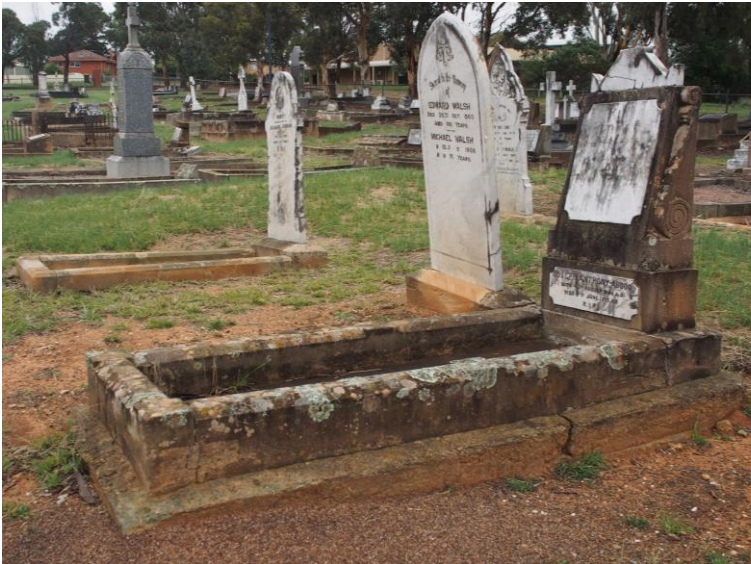
| Photograph | Description | Physical condition | Condition rating |
|---|---|---|---|
| | <p>A high sandstone monument with white marble element on top and white marble plaque with and inscription in Arabic, mounted on a sandstone block plinth with a second plaque with inscription in English.</p> <p>A concrete or rendered brick kerb forms a grave enclosure and is topped with a high sandstone kerb forming a double kerb.</p> <p>A cement or concrete infill/ ledger sits within the kerbing.</p> | <p>The monument is upright and complete. All elements are in good alignment and appear securely attached.</p> <p>All marble elements show dark staining, but inscriptions remain clear and legible</p> <p>There is minor lichen growth on the monument. The sandstone kerbing is complete with no breaks in the blocks apparent. There is extensive lichen growth on the stone kerbing.</p> <p>The bottom concrete kerbing is cracked in one section of visible areas, with the uphill side buried by soil runoff and obscured by soil.</p> <p>Concrete ledger is complete and appears secure.</p> | <p>Fair to good</p> |

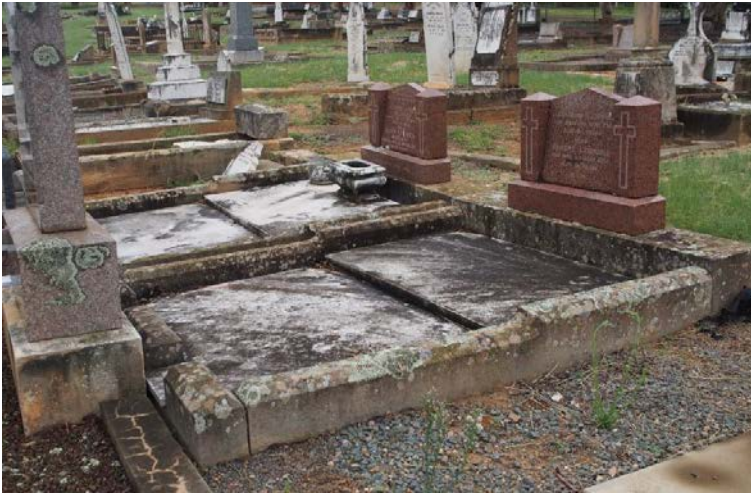
| Photograph | Description | Physical condition | Condition rating |
|---|---|---|---|
| | <p>A red granite monument on a wide sandstone plinth.</p> <p>Sandstone kerbing forms a double grave enclosure with stepped side kerbs and a sill at the foot at the grave.</p> <p>A concrete infill/ledger sits within the kerbing in two sections with the head section higher than the foot section to create a tiered profile.</p> | <p>The granite monument is well aligned and appears securely attached to the plinth. Inscriptions are clear and legible.</p> <p>Sandstone plinth and kerbs appear sound and are in good alignment. The stone shows minor wear and chips with no significant breaks or cracks.</p> <p>The ledger/infill is intact, with no apparent subsidence or cracking.</p> <p>There is extensive lichen growth and biological staining over the kerbing and ledger/infill.</p> | Good |

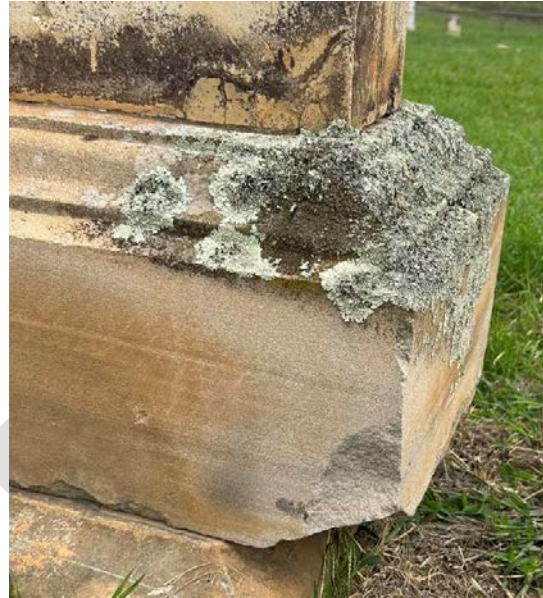
**Figure 67:** Biological growth on sandstone

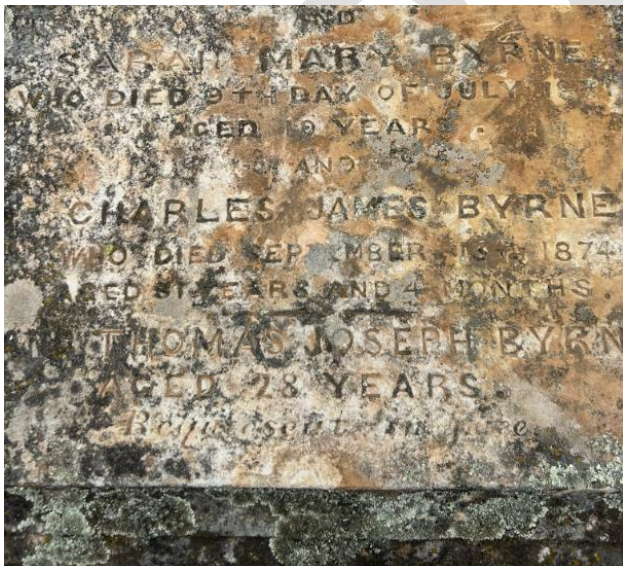
**Figure 68:** Discoloration of a sandstone element, the inscription remains legible on close inspection

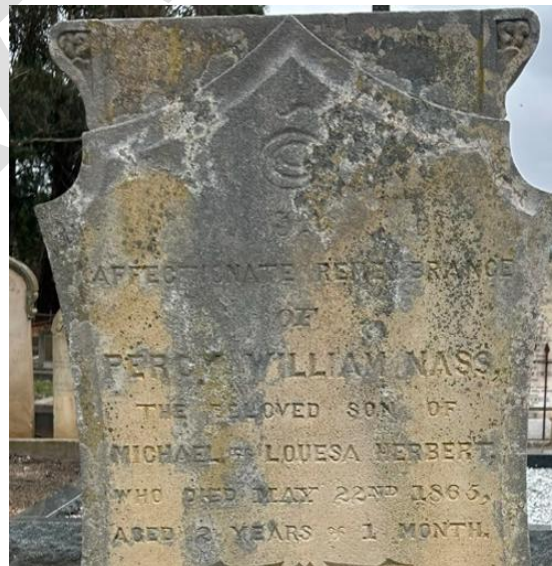
Organisms such as lichens, mould, and algae are significant contributors to the blackening of sandstone headstones. Lichens, which are symbiotic associations between fungi and algae or cyanobacteria, can colonise stone surfaces and produce dark pigments that stain the stone. The metabolic processes of these organisms can also produce acids that chemically interact with the minerals in sandstone, leading to further discolouration.

**Figure 69:** Sandstone discoloration resulting from biological growths

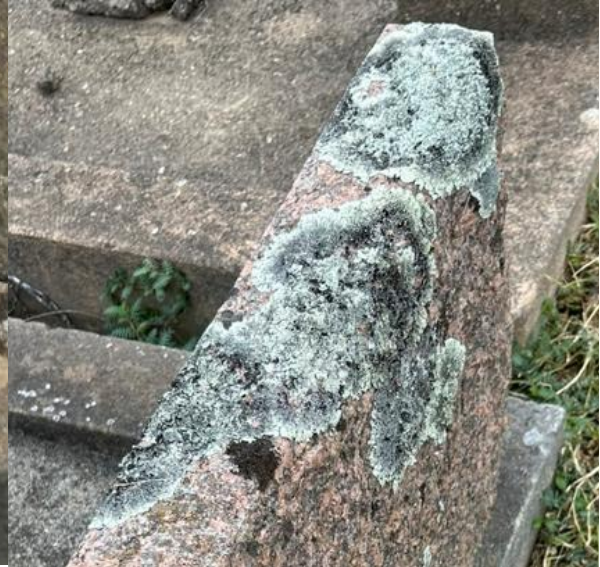
**Figure 81: Biological growth on a granite headstone**

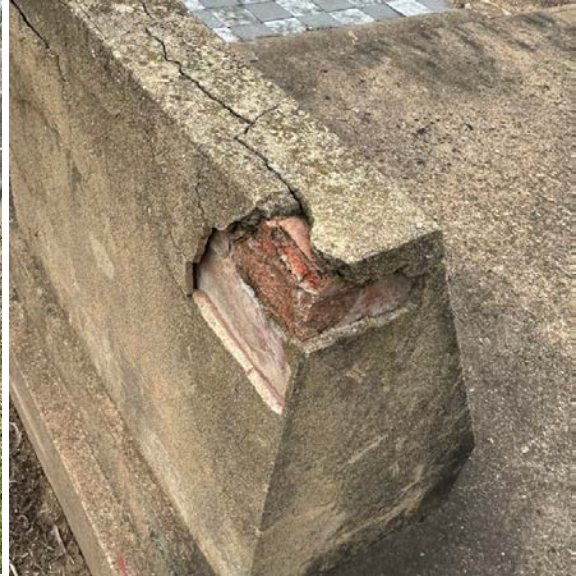
**Figure 87: An example of a concrete render cracking and dislodging from the monument**

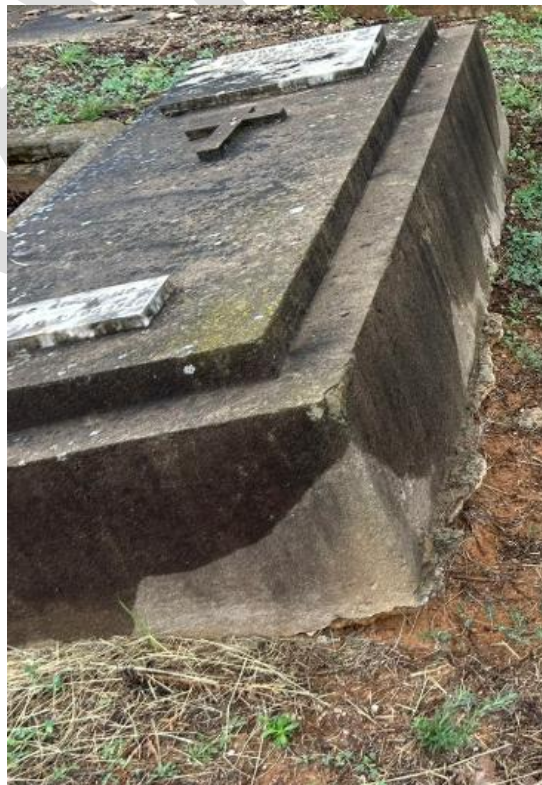
**Figure 93:** Example of subsidence leading to sinking of burial sites

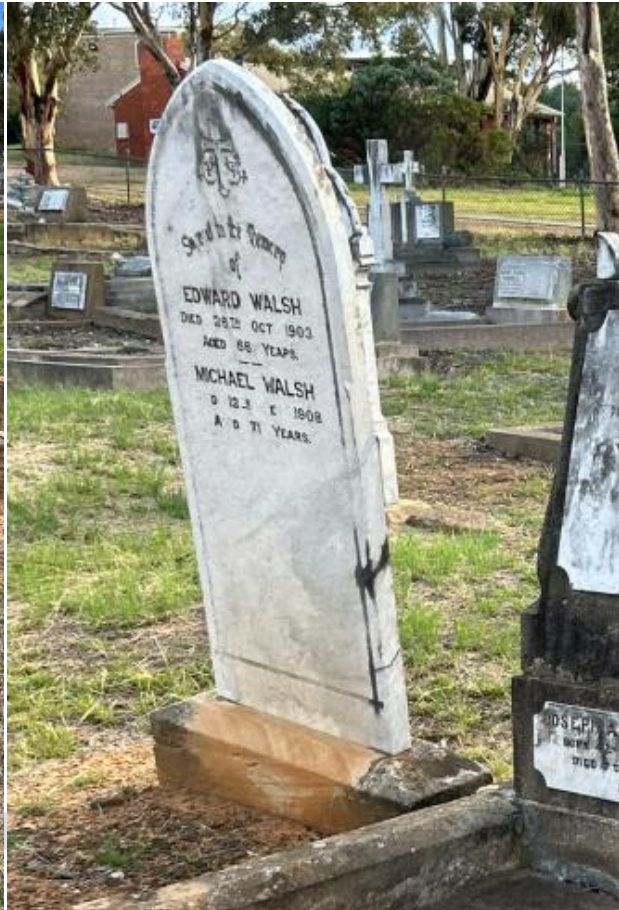
**Figure 97: A marble monument leaning**

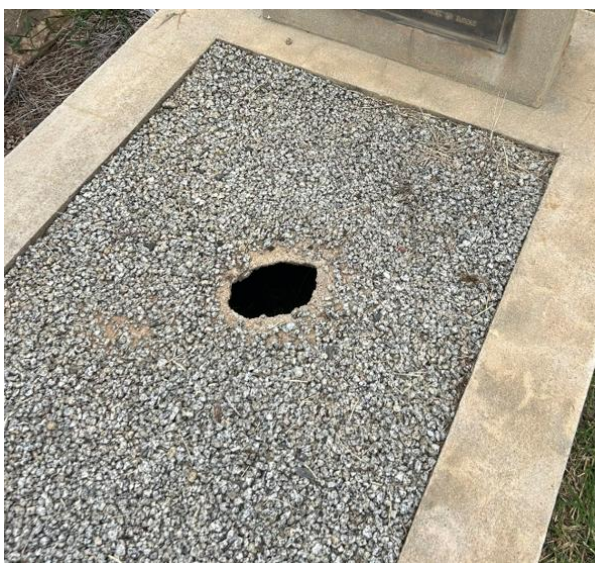
**Figure 102: Example of a hole in a thin concrete and pebble floor**

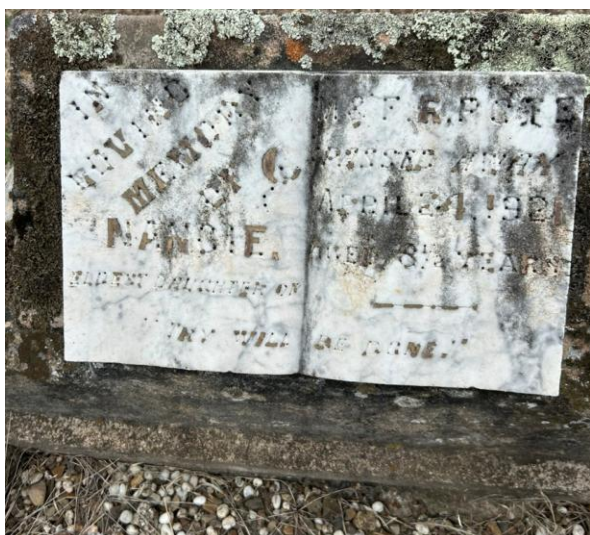
**Figure 104:** An example where lettering is missing

There are a number of headstones and monuments that display traditional lead lettering. In a number of examples this lettering has been dislodged. It is always preferable for the original lettering to be reattached to the stone rather than introducing new material. There is also evidence across the cemetery of deterioration of painted or gilded lettering. In some cases the lettering is incised, and the inscription remains legible.

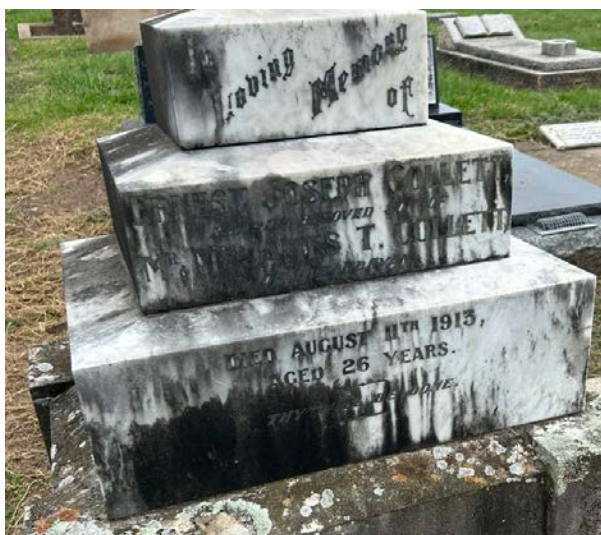
**Figure 105:** An example where discolouration is impacting the legibility of the inscription
