# Proposed cemetery site, Old Cooma Road, Googong: Hydrogeological Assessment

**Queanbeyan-Palerang Regional Council**

| <b>Project Name</b> | Old Cooma Road, Googong Groundwater Studies – Cemetery and Crematorium |

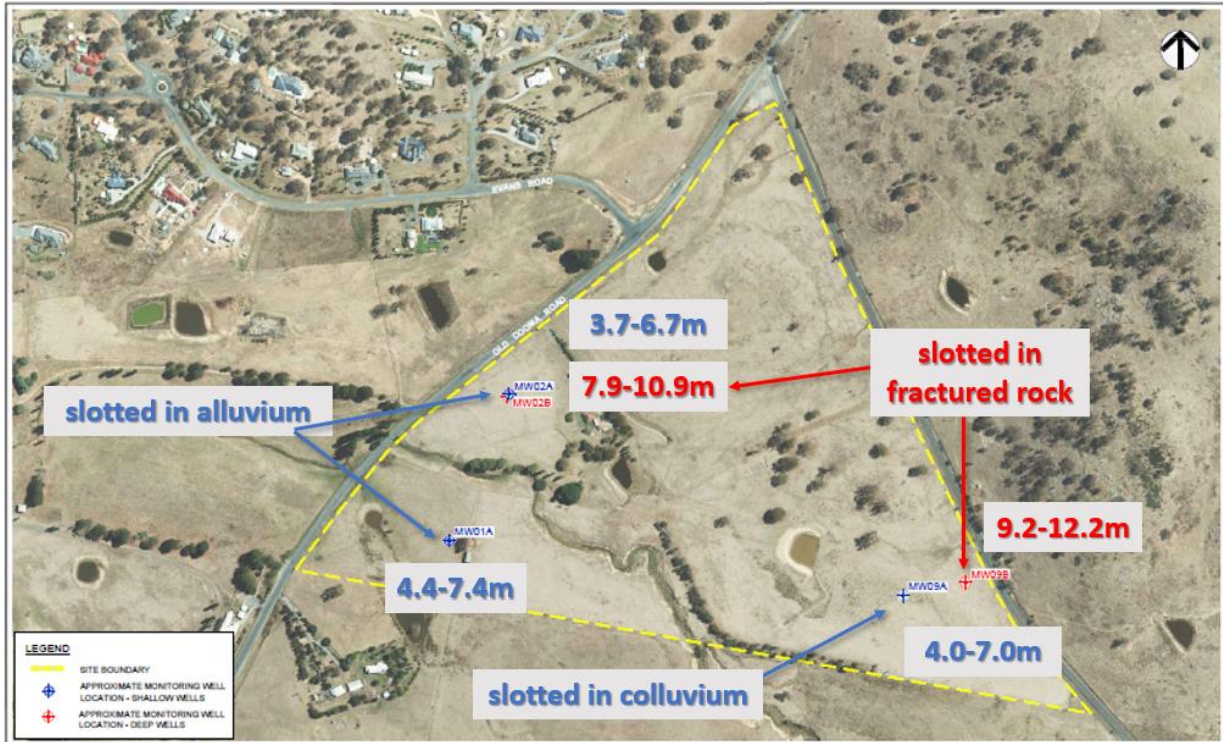
**Figure 3-1: Locations of the five new monitoring bores on the Site showing slotted intervals for each bore**

Based on the drilling records, the three new shallow bores (at sites 1A, 2A and 9A) are constructed within clayey sand-sandy clay alluvium/colluvium with the remaining two deep bores (named 2B and 9B at site 2A and 9A, respectively) constructed to monitor groundwater in the dacite (weathered and fractured) bedrock.

Five (5) new bores across 3 locations have been installed on behalf of QPRC to provide groundwater information for the Site. Details of bore installation and initial sampling results are provided in Appendix B (Coffey, 2019). These bores were installed in January 2019 and were located to coincide with three of the previously installed geotechnical holes: 1A, 2A and 9A.

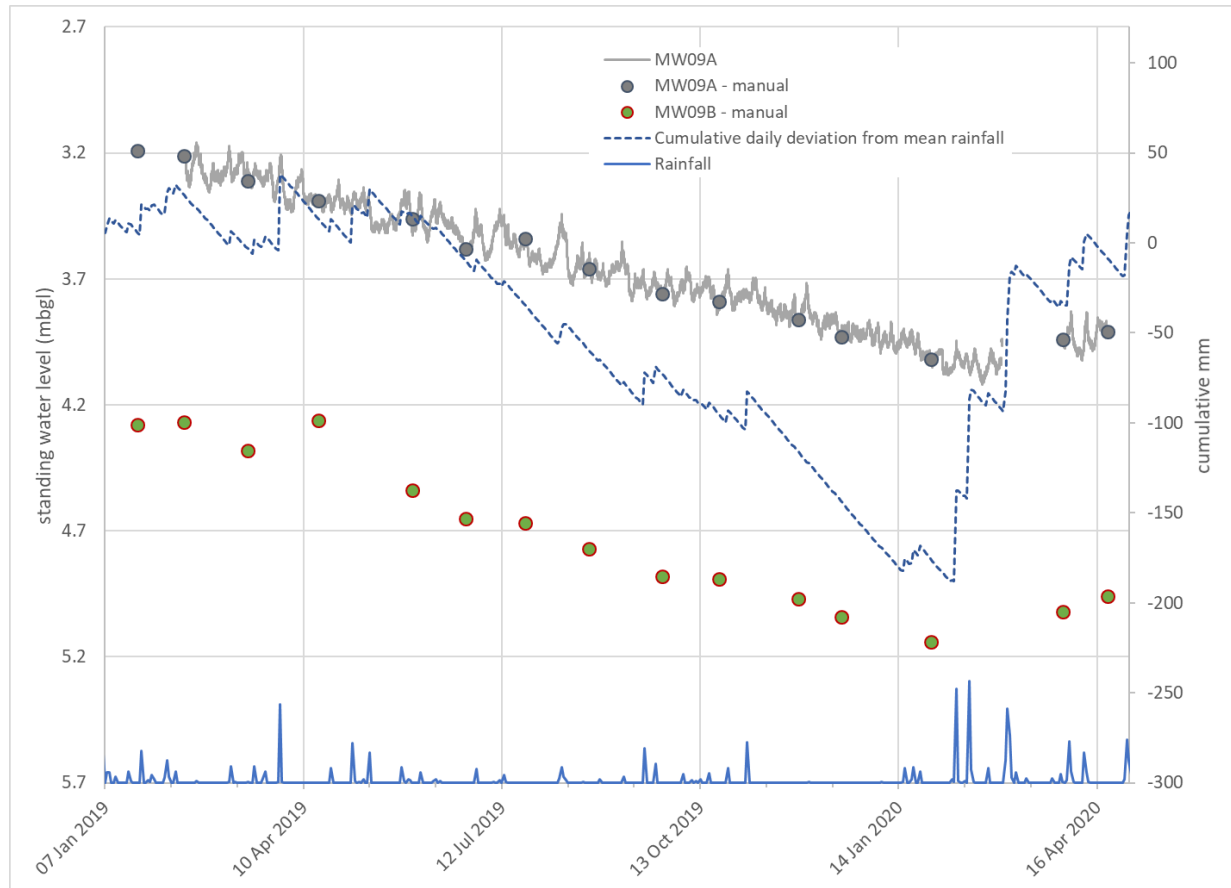
**Figure 4-4: Water levels recorded at site 9 since January 2019 compared to regional rainfall.**

Significant rainfall events at the beginning of this year (two events greater than 50 mm in February and a four-day event in March precipitating 83 mm) realised a reversal in the downward trend for the previous year, though not a significant rise.

Water levels at the south-eastern bore location show a more subdued response to significant rainfall events (Figure 4-4).

The bores to the south-east (MW9a and MW9B) show a subdued response to rainfall, with an apparent 2 week lag when sufficient rain falls (>100 mm) to cause a water level response (Figure 4-4).

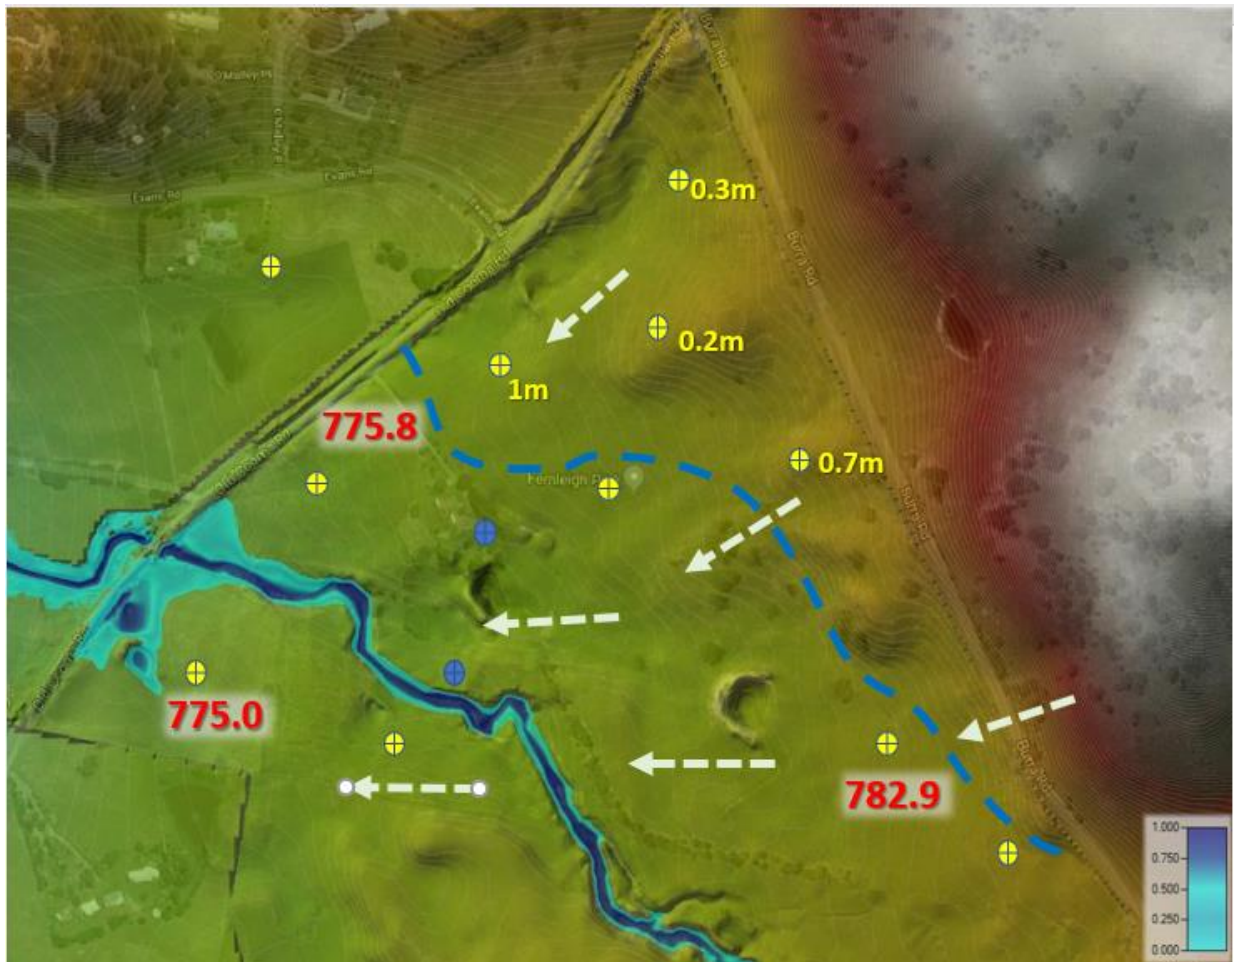
**Figure 4-5: Groundwater flow (white arrows) overlain on modelled stream-flow. Maximum height of groundwater (mAHD) indicated for the shallow water table. Zone of very shallow soil/weathered zone indicated by the dashed line**

Groundwater elevations, however, are comparable under normal conditions, for both aquifers (~775 mAHD at site 2 and ~783 mAHD at site 9), reflecting a common recharge source and flow direction.

Comparison of water levels across the Site show a fall in level from east to west; from high ground in the east down to uniform heights across the Church Creek floodplain (Figure 4-5). Indicative flow lines suggest that the creek acts as a drainage feature and boundary influence on shallow groundwater flow. Discordant response to external stimuli (presumed to be pumping from different bores) at locations 1 and 2 support the compartmentalisation of groundwater sources north and south of the creek. The

observed opposite level response for bores 2A and 2B at the same location strongly suggest the shallow alluvium and colluvium aquifer is separated from the deeper bedrock aquifer by a confining layer, likely the clayey-sand in the weathered zone above the dacite.

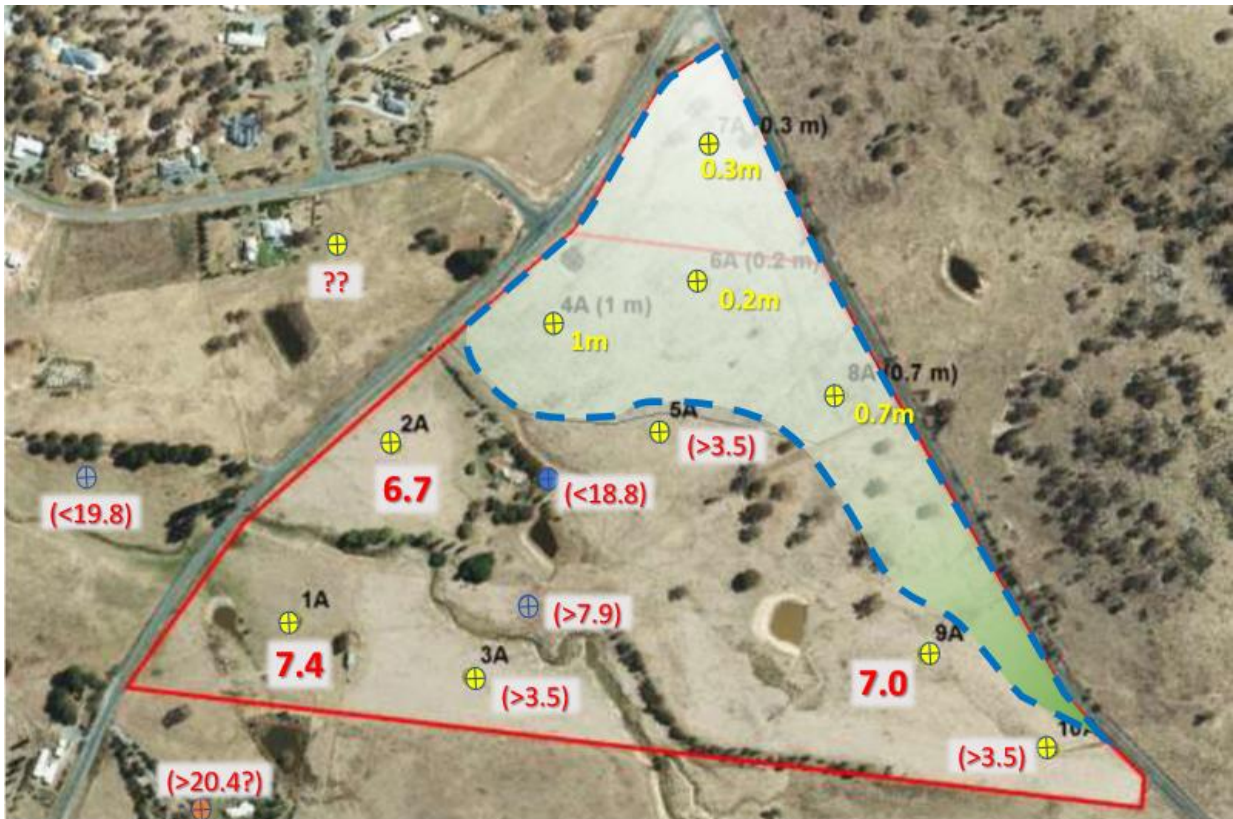
Figure 4-6: Depth to competent bedrock. Shaded area marked where bedrock is less than 3 m below ground. Numbers in brackets inferred from bore construction records.

All locations investigated to the south of the shallow soil zone had suitable materials for soft excavation. Topsoil and alluvium ranges up to 4 m where logged, increasing to the south and west. Beneath this, incompetent weathered material extends up to 7 m on site and likely deeper to the south and west. Lower horizons tend to be clay-rich and form confining layers above the fractured dacite bedrock.

The additional bore logs generated through installation of the new monitoring bore network provide further ground material information to assess the capability of the Site to host grave sites. Specifically, depth to competent rock can now be estimated for much of the Site and this defines a zone where depth to hard rock is less than 3 m and therefore not suitable for grave sites (Figure 4-6).

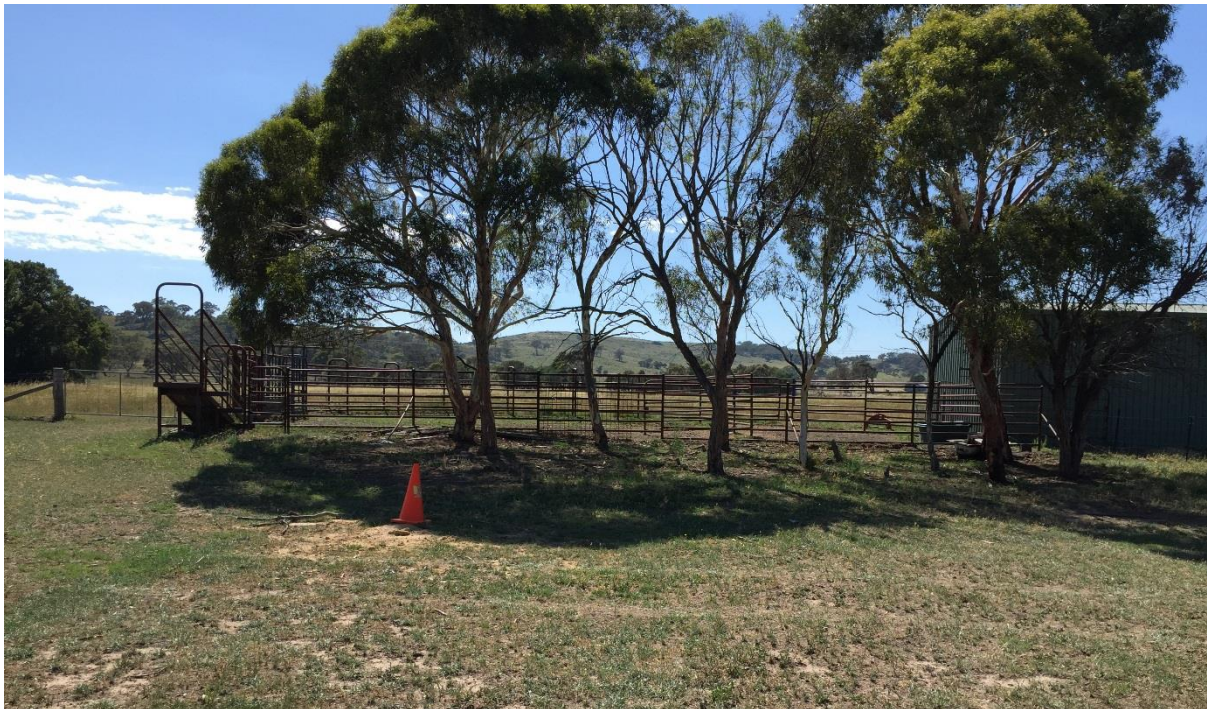
*Figure 1 - Location of MW01A in the south west portion of the site, marked by an orange traffic cone. Borehole MW01A was positioned adjacent to a shed and stockyard, on generally flat alluvial soils.*

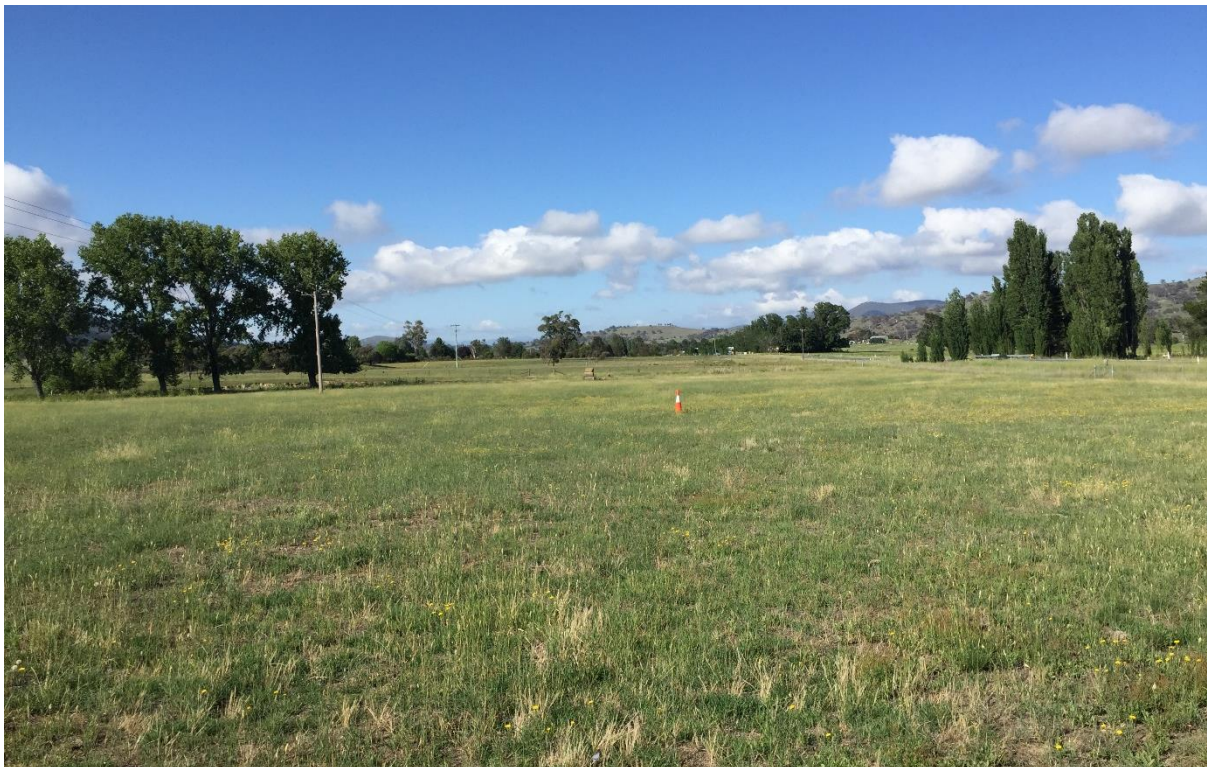
*Figure 2 - Location of MW02A and MW02B, in the western portion of the site, marked by an orange traffic cone. Boreholes were situated on flat alluvial soil and spaced approximately 1.5m apart.*

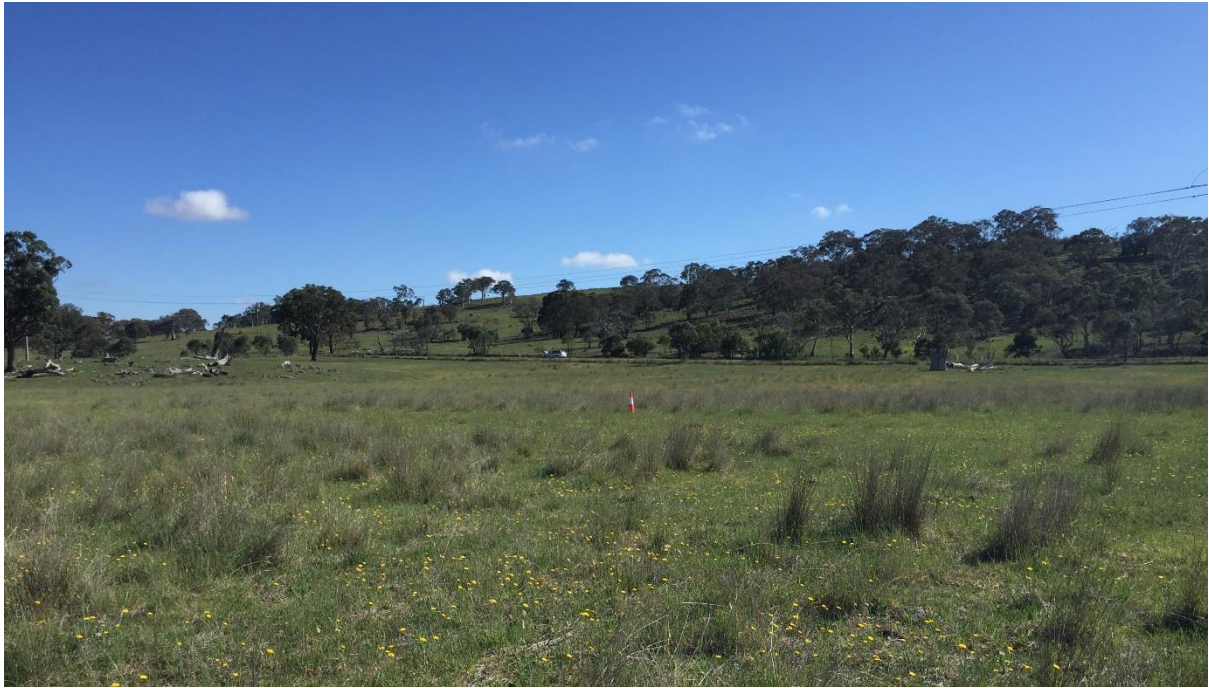
*Figure 3 - Location of MW09A, in the eastern portion of the site, marked by an orange traffic cone. Borehole MW09A was excavated into alluvial soil in a slight valley.*

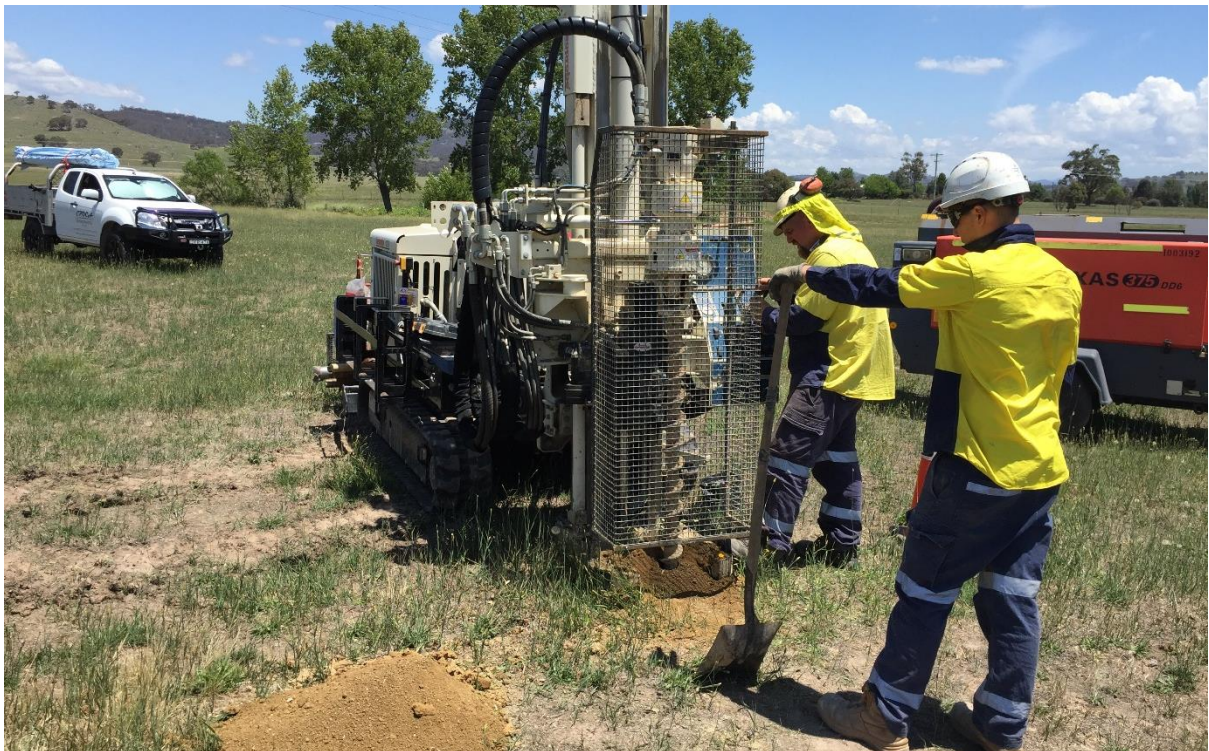
*Figure 4 – Drilling borehole MW02B. Boreholes were excavated using a solid stem flight auger attachment from 0.5m bgl until auger refusal in bedrock, below which, deeper boreholes (MW02B and MW09B) were drilled into bedrock using an air hammer methods.*

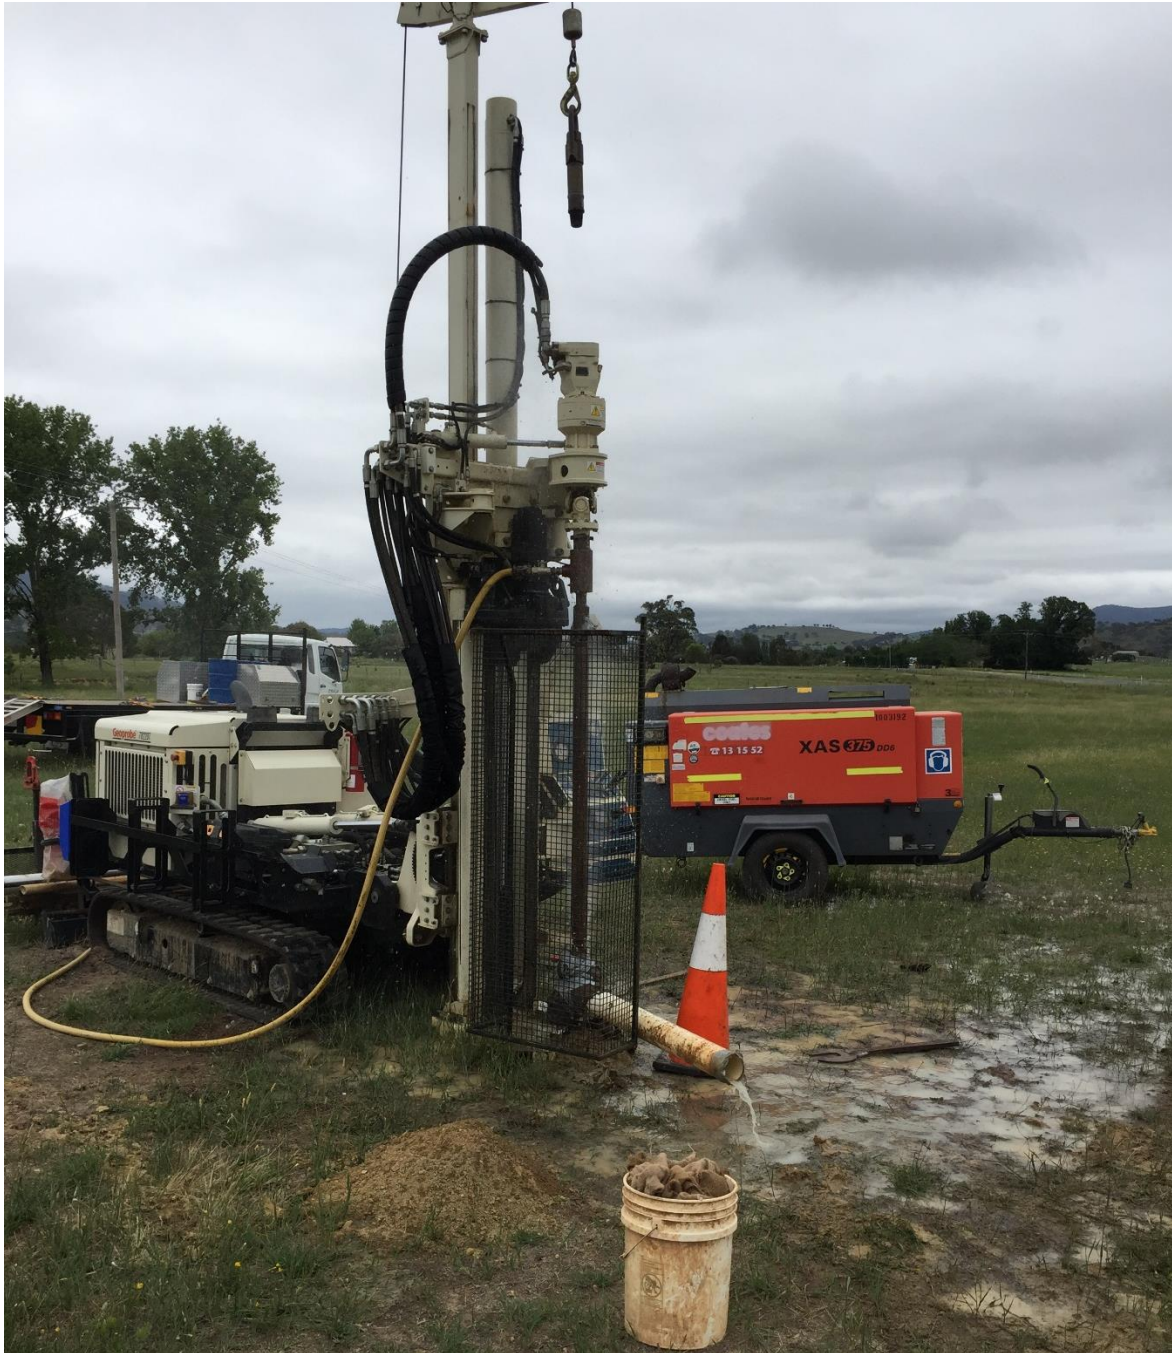
*Figure 5 - Groundwater encountered during drilling for MW02B, using an air hammer attachment.*

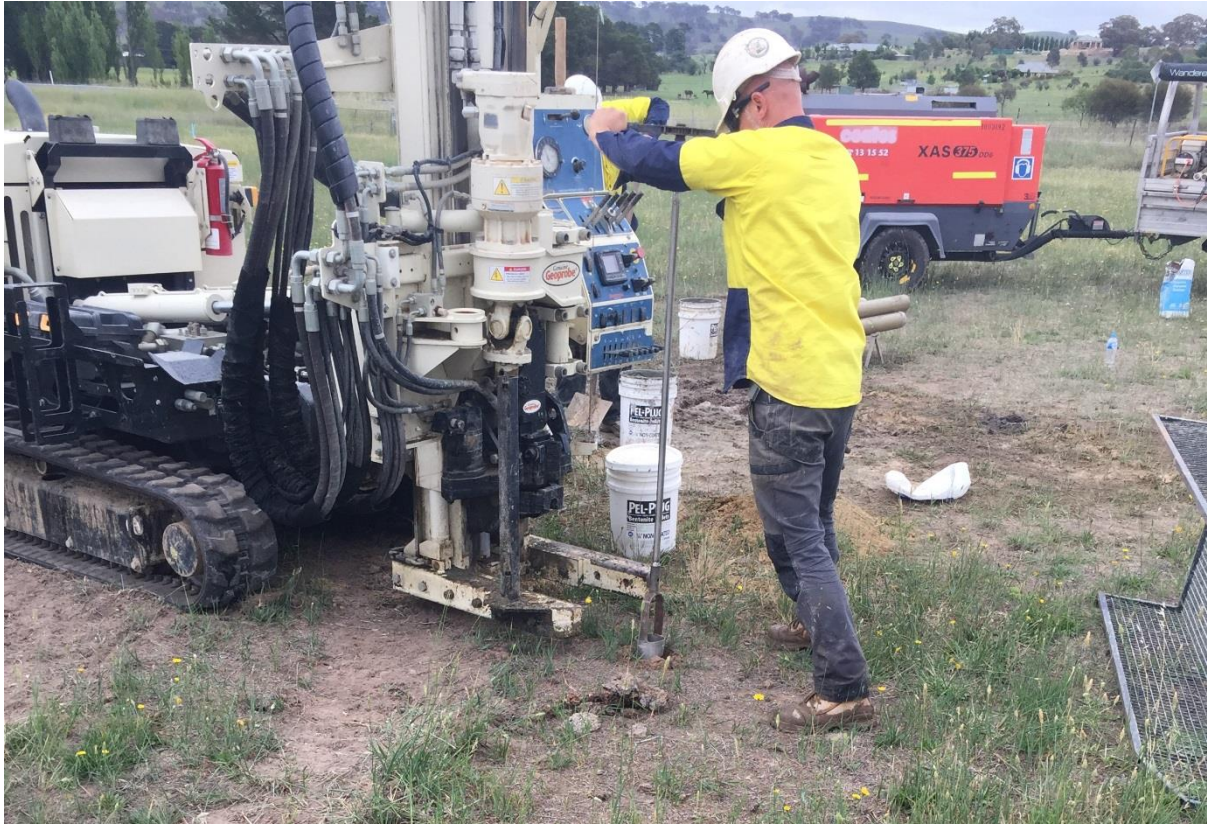
*Figure 6 – Hand auger excavation in borehole MW02A. All boreholes were excavated/drilled using hand auger methods within the upper 0.5m bgl to minimise the likelihood of damage to underground services.*
